INCIDENT

Aircraft Type and Registration:	Airbus A320-233, SP-HAI	
No & Type of Engines:	2 IAE V2527-A5 turbofan engines	
Year of Manufacture:	1999 (Serial no: 1007)	
Date & Time (UTC):	21 February 2016 at 1311 hrs	
Location:	Birmingham International Airport	
Type of Flight:	Commercial Air Transport (Passenger)	
Persons on Board:	Crew - 6	Passengers - 99
Injuries:	Crew - None	Passengers - None
Nature of Damage:	None	
Commander's Licence:	Airline Transport Pilot's Licence	
Commander's Age:	61 years	
Commander's Flying Experience:	13,952 hours (of which approximately 10,000 were on type) Last 90 days - 60 hours Last 28 days - 23 hours	
Information Source:	AAIB Field Investigation

Synopsis

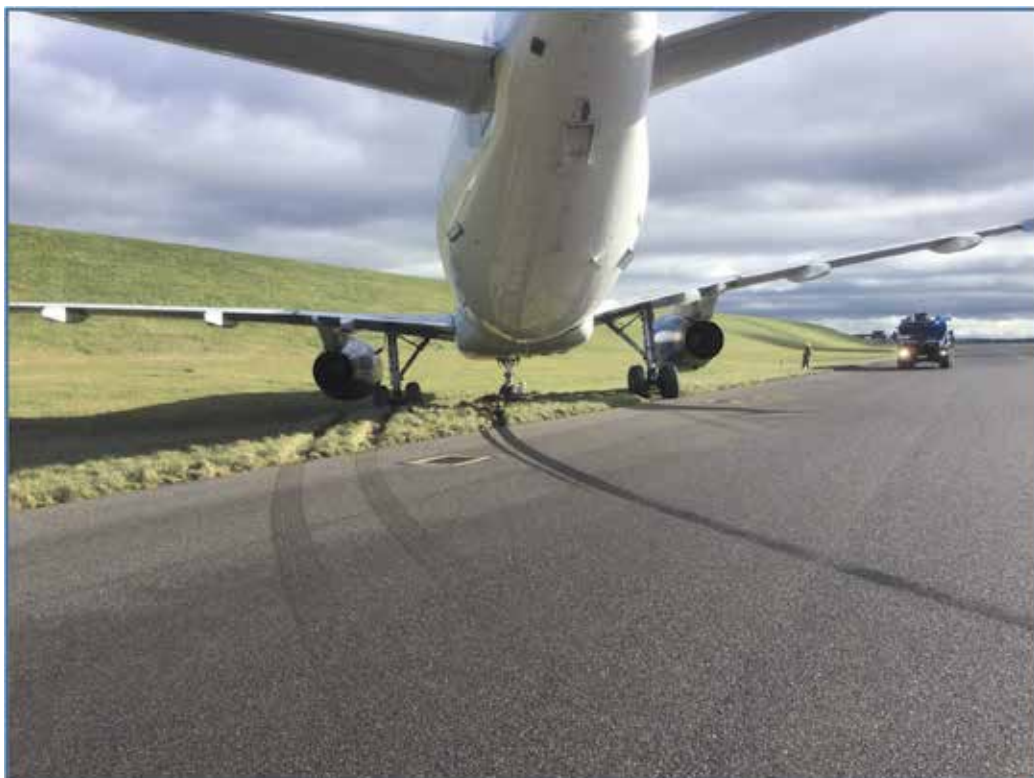
Figure 1

Photographs taken shortly after the incident confirm the commander's report that the taxiway surfaces were damp. There was a dry strip along the outer edge of Taxiway Alpha, across which could be seen moisture tracks left by the aircraft's mainwheel tyres (Figure 1).

From the distinctive nosewheel skid marks and furrows in the grass, it was clear that the nosewheels had begun to skid very soon after the turn started, and that it adopted, and remained at, a high angle of deflection.

Incident site immediately following excursion.
Note nosewheel skid marks, mainwheel tracks, taxiway condition and nosewheel angle
(*photo courtesy of Birmingham Airport*)

The taxiway marks indicated that the nosewheels had started to skid relatively early in the turn and had remained in this state until they left the paved surface. This is supported by the FDR data, which shows that the rate of turn was approximately constant from the initiation of the turn. It was evident from the nosewheel skid pattern and the furrow in the grass that the nosewheels had adopted a high angle of deflection, which was maintained until the aircraft had come to a stop. There was limited wheel braking and no visible evidence of mainwheel skidding.
