ACCIDENT

Aircraft Type and Registration:	Cessna 402B, G-MAPP	
No & Type of Engines:	2 x Continental Motors Corp TSIO-520-EB piston engines	
Year of Manufacture:	1974 (Serial no: 402B-0583)	
Date & Time (UTC):	14 January 2016 at 1214 hrs	
Location:	East Midlands Airport	
Type of Flight:	Training	
Persons on Board:	Crew - 2	Passengers - 1
Injuries:	Crew - None	Passengers - None
Nature of Damage:	Damage to the left main landing gear, left wingtip and aileron, and blade tips of the left propeller. Left engine shock-loaded	
Commander's Licence:	Commercial Pilot's Licence	
Commander's Age:	39 years	
Commander's Flying Experience:	3,900 hours (of which 2,800 were on type) Last 90 days - 38 hours Last 28 days - 11 hours	
Information Source:	AAIB Field Investigation

Synopsis

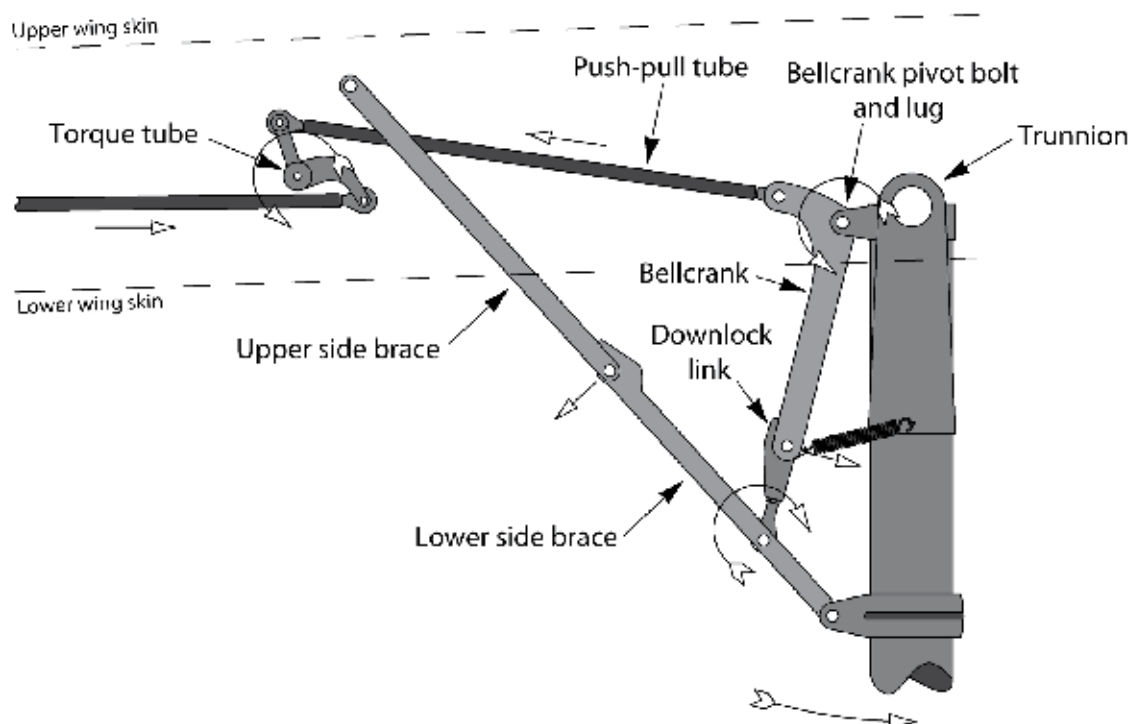
Figure 1

The landing gear retraction system is powered by an electric motor that drives, via a reduction gearbox, a series of rods, torque-tubes and bellcranks that move the landing gear legs. The main landing gear is held in the 'down and locked' position by a folding side brace. A downlock link, driven by a bellcrank, applies a force to the side brace to keep it in an over-centre position when the landing gear is down, Figure 1.

Schematic of the landing gear downlock mechanism

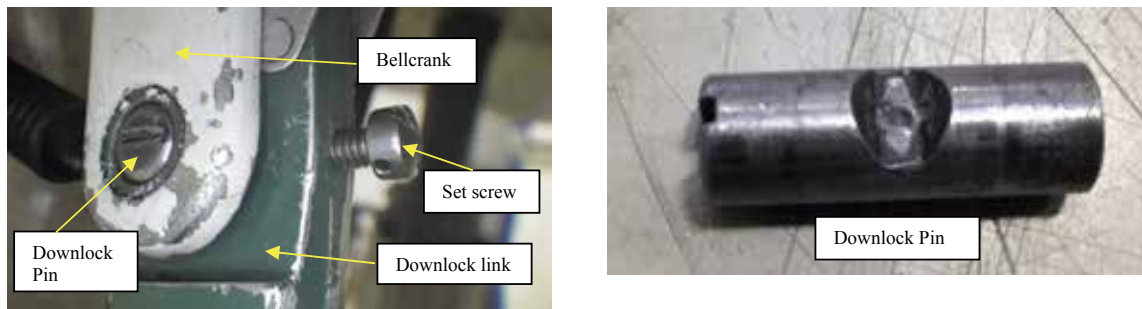
Figure 2

When the main landing gear leg is down and locked, the downlock link and bellcrank should be in an over-centre position, to hold the side brace over-centre and prevent it from folding. A microswitch, mounted on the downlock link, closes when it is over-centre and illuminates the green DOWN instrument panel light for that landing gear leg. The bellcrank is connected to the downlock link by a pin, which is secured in place by a set screw. To ensure that the screw engages in the detent in the pin, an arrow, which is stamped in the end of the downlock pin, must be aligned with the set screw, Figure 2.

Downlock pin and set screw

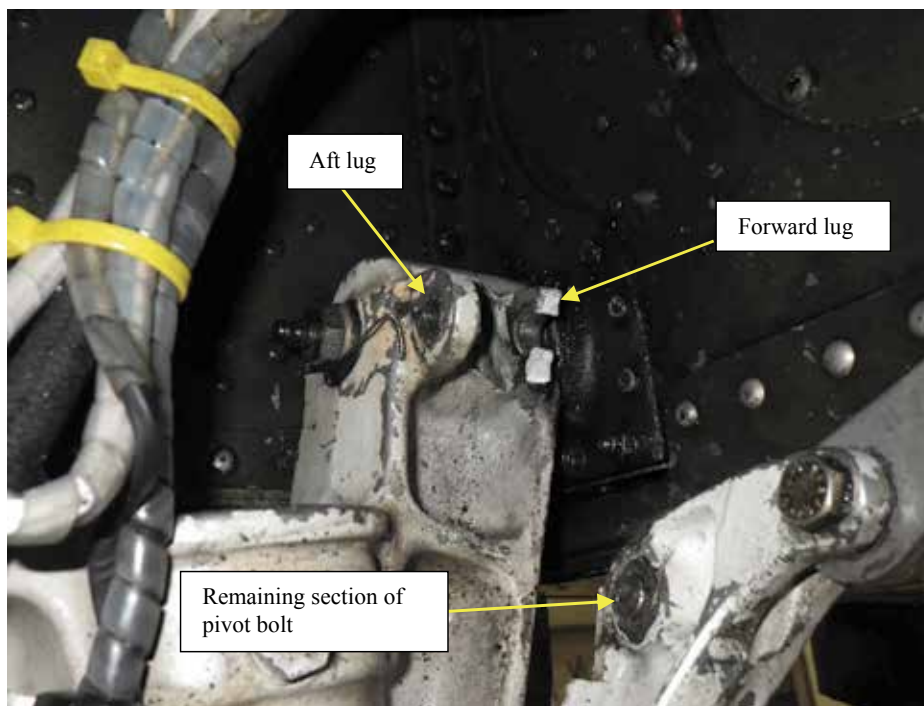
Figure 3
Pivot bolt and mounting lugs

On the left landing gear, the head of the bellcrank pivot bolt was missing and the remainder of the bolt, which was still attached to the bellcrank, had moved forwards out of the aft mounting lug. The forward mounting lug had fractured across the bolt hole. The Airport Fire Service (AFS) recovered the outer section of the forward lug from the runway, Figure 3.

The fracture surfaces on the pivot bolt and the lugs on the bellcrank and landing gear were inspected by a metallurgist, who advised that the surfaces showed no evidence of a pre-existing crack and had all failed in overload. The lower forward lug had failed as a result of the lug bending forwards.

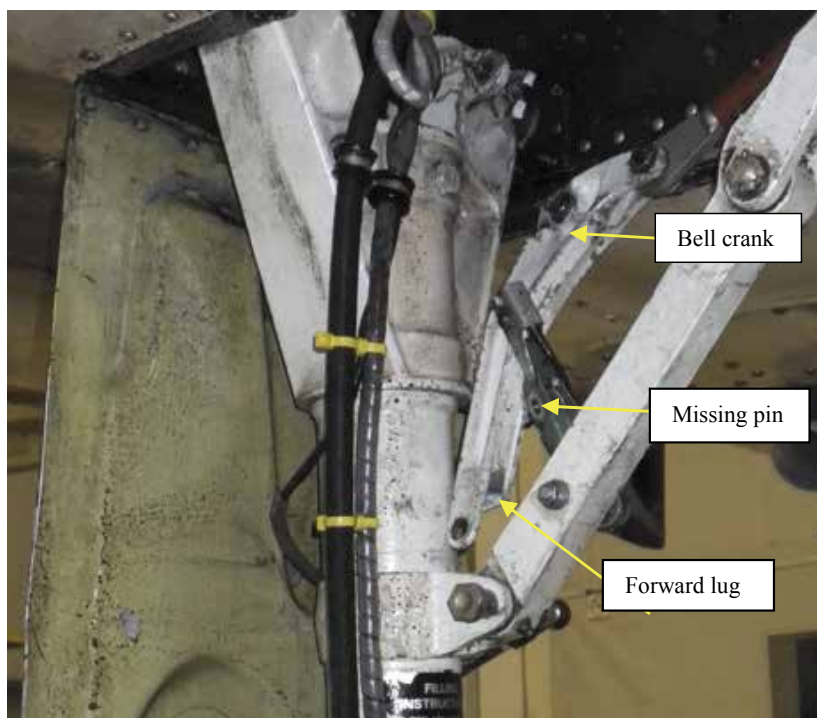
Figure 4
Downlock link

The downlock pin and its associated bushes were missing. The forward lower lug on the bellcrank had fractured and was recovered from the runway by the AFS. The bolt hole on the rear lower lug, which remained attached to the bellcrank, was damaged. The spring which holds the downlock link in the over-centre position was still attached to the landing gear leg and the downlock link, Figure 4.

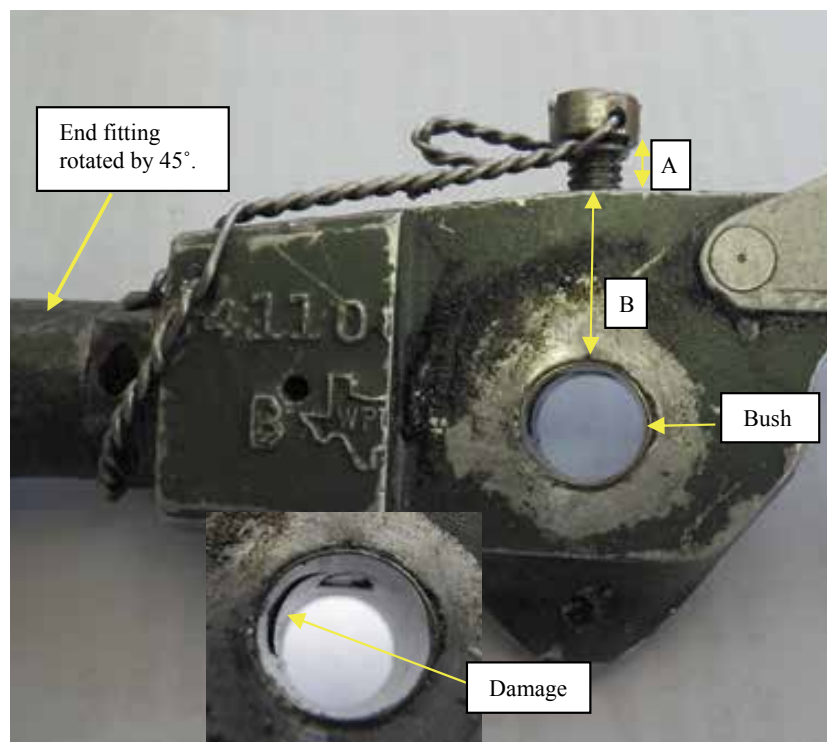
Figure 5
Downlock link

Examination of the downlock link revealed that the end fitting that connects to the lower side brace had rotated clockwise by approximately 45°, Figure 5. The set screw was still wire locked to the casting and the head of the screw sat proud of the casting by 4 mm, with approximately five threads showing (Item A). The end of the set screw was flush with the wall of the bore in the casting and did not appear to have entered the hole in the bush. The bush had circumferential damage approximately 4 to 5 mm from the forward face of the downlock. The aft face of the downlock was undamaged, whereas the bore where it exited the forward face of the casting was distorted.

The measurements showed that with the head of the set screw 4 mm above the casting, the right downlock pin would have been locked in place, whereas the left downlock pin would have been free to move. The height of the set screws was checked on one of the operator's Cessna 310R aircraft where the clearance between the head of the screw and the casting was found to be approximately 2 mm (two threads).

The most likely explanation, therefore, is that the set screw had not been inserted a sufficient distance to secure the left downlock pin, which subsequently moved forward out of the aft lower fork on the bellcrank. The force through the retraction linkages would then have been taken by the lower forward fork on the bellcrank, causing it to splay outwards. As the downlock pin continued to migrate forward, damage would have occurred to the inside of the bore and the forward face of the downlock link. The eventual effect of the splaying of the fork would have been to shorten the bellcrank and downlink assembly such that the side brace was no longer over centre. As the left landing gear started to retract during the landing roll, the loads transmitted through the retraction mechanism would have caused the fork, mounting lugs and pivot bolt to fail in overload.

In addition, the operator introduced a new local procedure, following the disturbance of the downlock pin, to ensure that the set screw had been inserted a sufficient distance to lock the pin in place.

- 1) Back off set screw.*
- 2) Ensure arrowed pin can rotate.*
- 3) Ensure arrow (indicating flat surface) located on end of pin is aligned towards set screw.*
- 4) Tighten/secure set screw*
- 5) Ensure arrowed pin cannot rotate.*
- 6) Safety wire set screw to side brace lock link.'*

It is recommended that Textron Aviation informs operators of Cessna 300 and 400-series aircraft of the actions required to ensure that the set screw, which retains the main gear downlock pin, is properly installed in the side brace downlock link and, in addition, amends the aircraft maintenance manuals to include this information.
