## ACCIDENT

<b>Aircraft Type and Registration:</b>	Dragon Chaser, G-CHNP
<b>No &amp; Type of Engines:</b>	1 Polini Thor 250 piston engine
<b>Year of Manufacture:</b>	2012 (Serial no: 84)
<b>Date &amp; Time (UTC):</b>	31 October 2015 at 1457 hrs
<b>Location:</b>	Near Pitsford Water, Northamptonshire
<b>Type of Flight:</b>	Private
<b>Persons on Board:</b>	Crew - 1                      Passengers - None
<b>Injuries:</b>	Crew - 1 (Fatal)          Passengers - N/A
<b>Nature of Damage:</b>	Aircraft damaged beyond economic repair
<b>Commander's Licence:</b>	National Private Pilot's Licence
<b>Commander's Age:</b>	71 years
<b>Commander's Flying Experience:</b>	242 hours (of which 2 were on type) Last 90 days - 17 hours Last 28 days - 4 hours
<b>Information Source:</b>	Field Investigation

## Synopsis

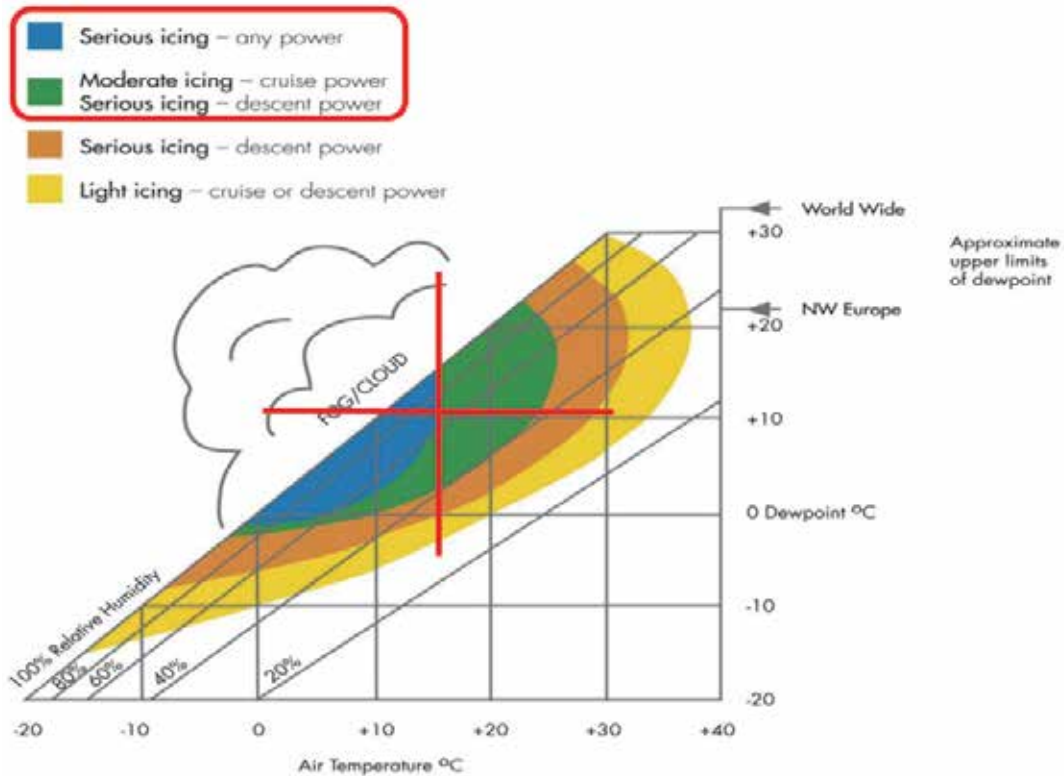
**Figure 1**

The CAA has published advice on carburettor icing<sup>1</sup>, including a graph showing a range of values of temperature and dewpoint and the degree of icing which might be expected. The values reported at Cranfield are shown as red lines on Figure 1, illustrating that the conditions were on the boundary between '*serious icing – any power*' and '*moderate icing – cruise power/serious icing – descent power*'.

CAA Carburettor Icing chart  
 (The temperature and dewpoint reported at Cranfield Airport  
 are shown by the two red lines)

Descriptions of the engine note changing or ceasing suggest the engine power may have reduced, either in response to a pilot input or as a consequence of an engine problem. The combination of dew point and temperature indicate that conditions were on the border between those in which '*serious icing*' of the carburettor might occur at any power and '*moderate icing*' at cruise power; '*serious icing*' might occur at descent power, but carburettor icing leaves no evidence and thus no conclusion could be reached in this regard.

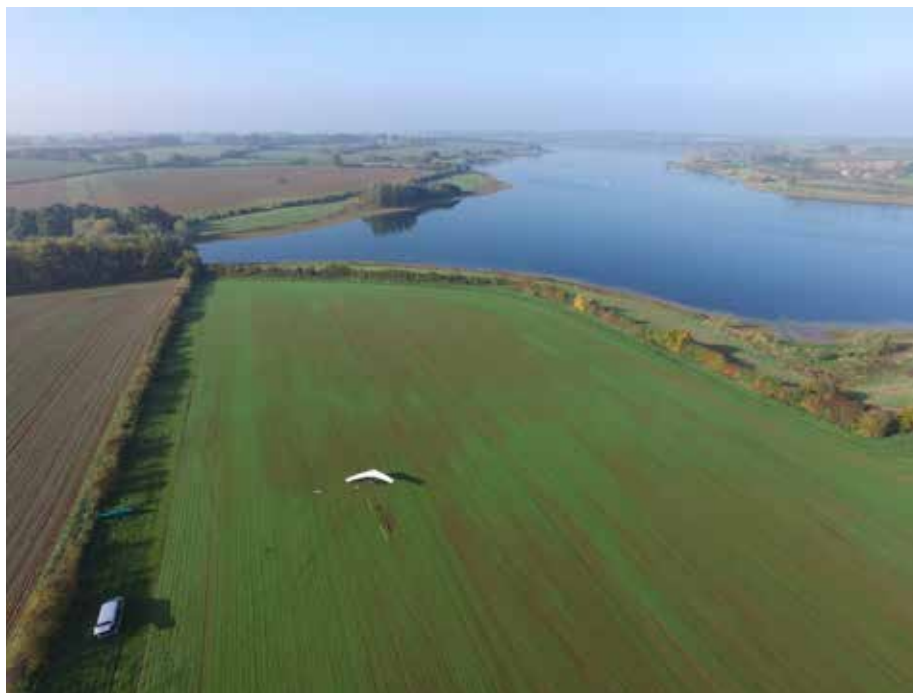
**Figure 2**

The aircraft crashed in a large field adjacent to Pitsford Water (Figure 2). The field was approximately 400 m long and 100 m wide, and the wreckage was found at the top of a gently sloping knoll. The ground was smooth and there was a grassy crop, approximately 1-2 cm high, growing in the field. The land owner had not been asked for permission to land in the field.

There were several ground marks all located within approximately 16 m from the nose of the aircraft. These marks were consistent with the nose wheel striking the ground heavily in a direction approximately parallel with the hedge running along the edge of the longest side of the field. The aircraft appeared to have performed a 'somersault', which resulted in two holes in the ground being made, first by the apex of the wing and then by the top of the mast, before the aircraft came to rest in an upright position. The ground marks were aligned on a bearing of between 240° and 245°T.

The accident site viewed in approximately the direction of the aircraft's travel

The field in which the aircraft crashed was suitable for a landing, either pre-planned or forced; because the land-owner's permission had not been sought, an intentional landing seems unlikely. In either event, any landing could have been challenging because the approach would have been almost directly into a low, setting, sun, and on the knoll before a slightly-down-sloping surface.
