ACCIDENT

Aircraft Type and Registration:	Thruster TST Mk1, G-MTKA	
No & Type of Engines:	1 Rotax 503 piston engine	
Year of Manufacture:	1987 (Serial no: 867-TST-021)	
Date & Time (UTC):	14 May 2016 at 1328 hrs	
Location:	Manchester/Barton Aerodrome	
Type of Flight:	Private	
Persons on Board:	Crew - 1	Passengers - 1
Injuries:	Crew - None	Passengers - None
Nature of Damage:	Wing spar distorted, left mainwheel detached and propeller damaged	
Commander's Licence:	Private Pilot's Licence	
Commander's Age:	63 years	
Commander's Flying Experience:	567 hours (of which 16 were on type) Last 90 days - 2 hours Last 28 days - 1 hour	
Information Source:	Aircraft Accident Report Form submitted by the pilot and information from the airport operator

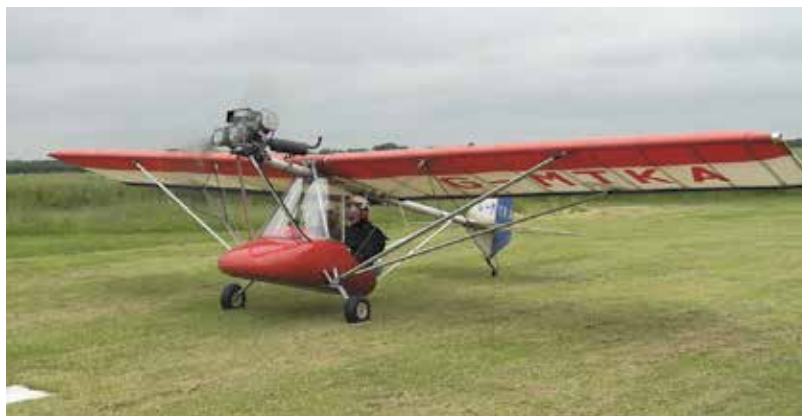
Figure 1
Thruster TST Mk1, G-MTKA

When commencing takeoff on grass Runway 26L, the pilot believed there was a moderate crosswind from his right. As he reached flying speed, his rudder and aileron control inputs suddenly seemed ineffective. The right wing lifted and the aircraft (Figure 1) yawed quickly to the right through 90°. The left wheel dug into the ground and detached and the left wing then struck the runway. This caused the aircraft to yaw left, while pitching nose-down until the propeller made ground contact. The aircraft then fell back onto its tailwheel and right mainwheel and the two occupants vacated, without assistance.

Airport records indicated the wind direction that afternoon was predominantly northerly, at 10 kt or less but with occasional gusts of up to 15 kt. Approximately six minutes before the accident, it veered east of north and, before takeoff, the pilot was informed that the wind was from 030° at 7 kt. However, he recalled seeing no downwind component for Runway 26L on the windssock situated nearest the threshold. Immediately after the accident, he sensed the wind was extremely variable and suspected a sudden wind shift caused the loss of control.
