## Foundering of fishing vessel *Majestic* (LK678) 5 nautical miles off Yell, Shetland 21 January 2016

### SUMMARY

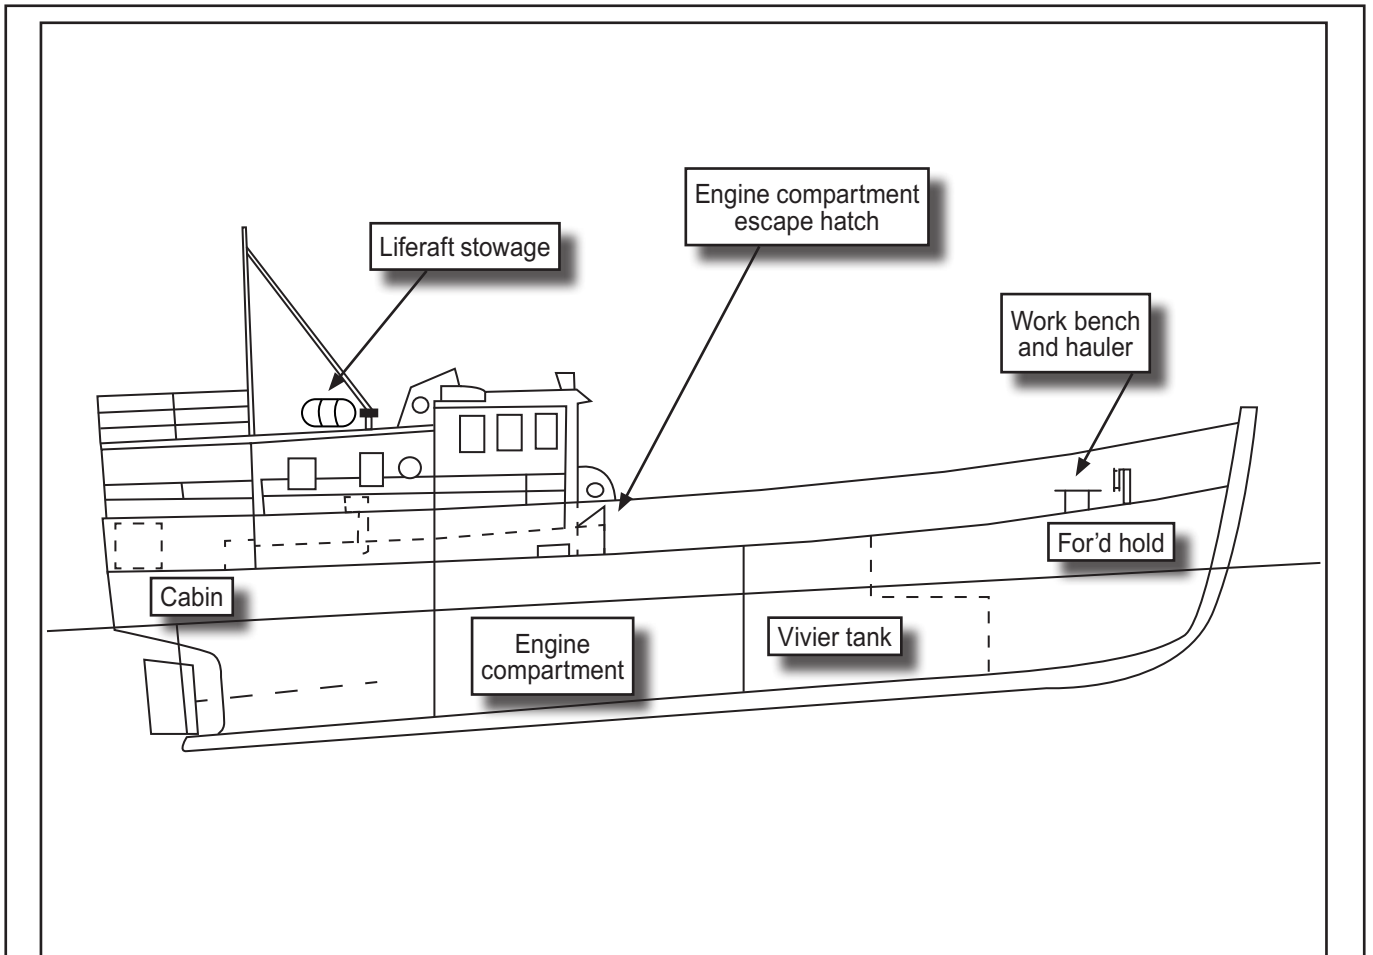
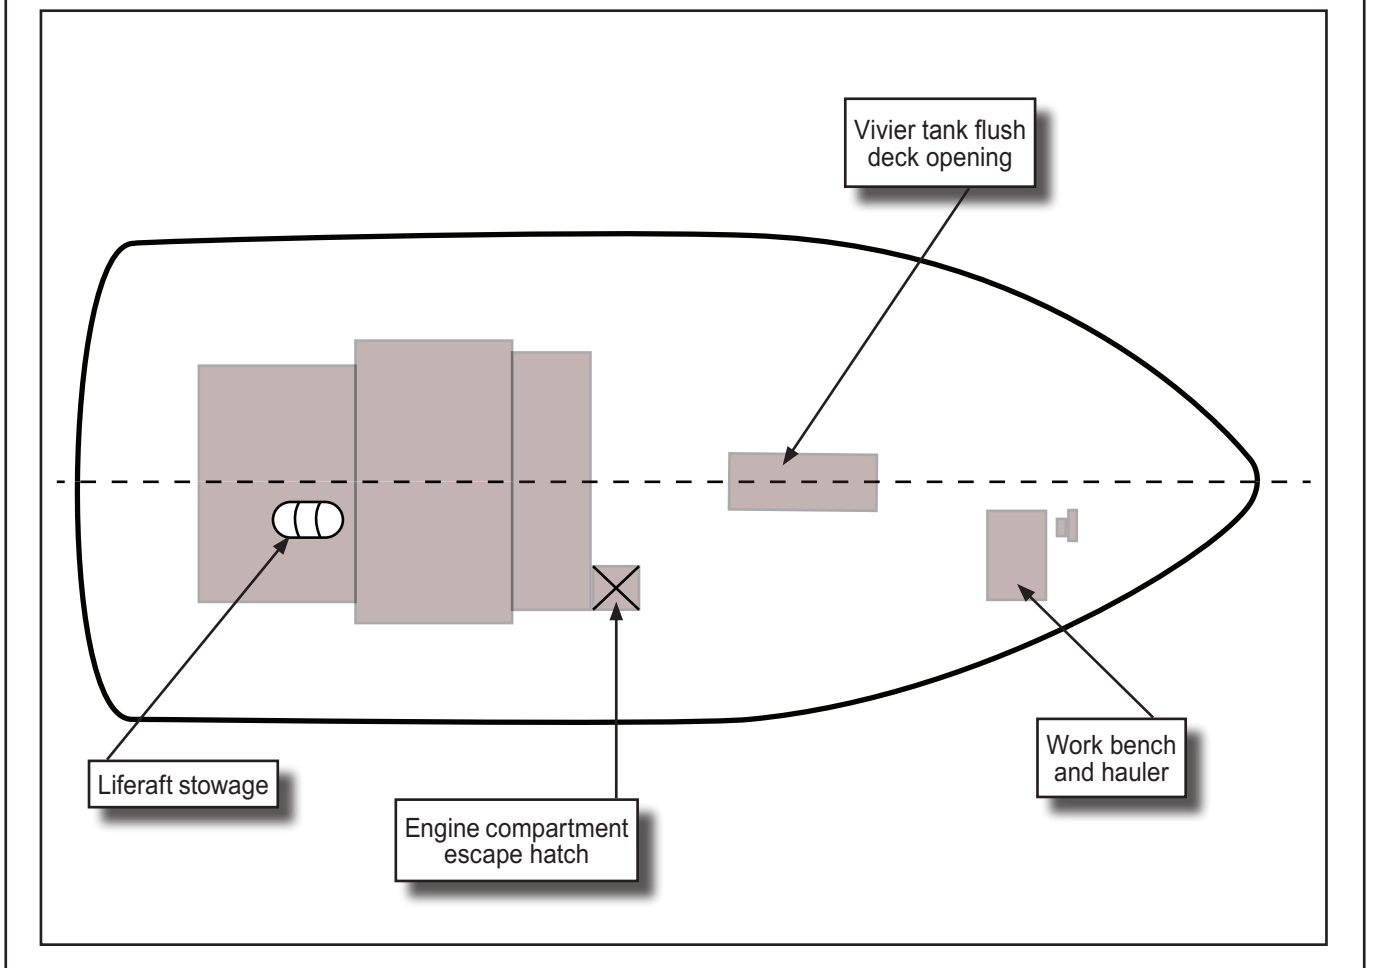
**Figure 2: Vessel layout**

At about 1000, the skipper went to the wheelhouse and heard the engine room's bilge alarms sounding. He opened a forward wheelhouse window and shouted to the crewman on the deck below to check the engine room for flooding. Accordingly, the crewman lifted the engine room escape hatch (**Figure 2**). The skipper leant out of the wheelhouse window and he and the crewman saw that the engine room was flooded. The water level was above the deck plates, half way up the side of the engine casing.

*Majestic* was built in 1977 to a traditional wooden design with oak frames and iroko planking. The vessel complied with The Fishing Vessels (Safety Provisions) Rules 1975 and comprised three main internal compartments: fish hold (that contained a vivier<sup>5</sup> tank), engine room and accommodation (**Figure 2**). The vessel's bulkheads were not required to be watertight but the bulkhead between the fish hold and the engine room was required to be of solid and substantial construction. The bulkhead between the engine room and the accommodation, and the engine room deck head were steel and met the B15 fire rating standard<sup>6</sup>.

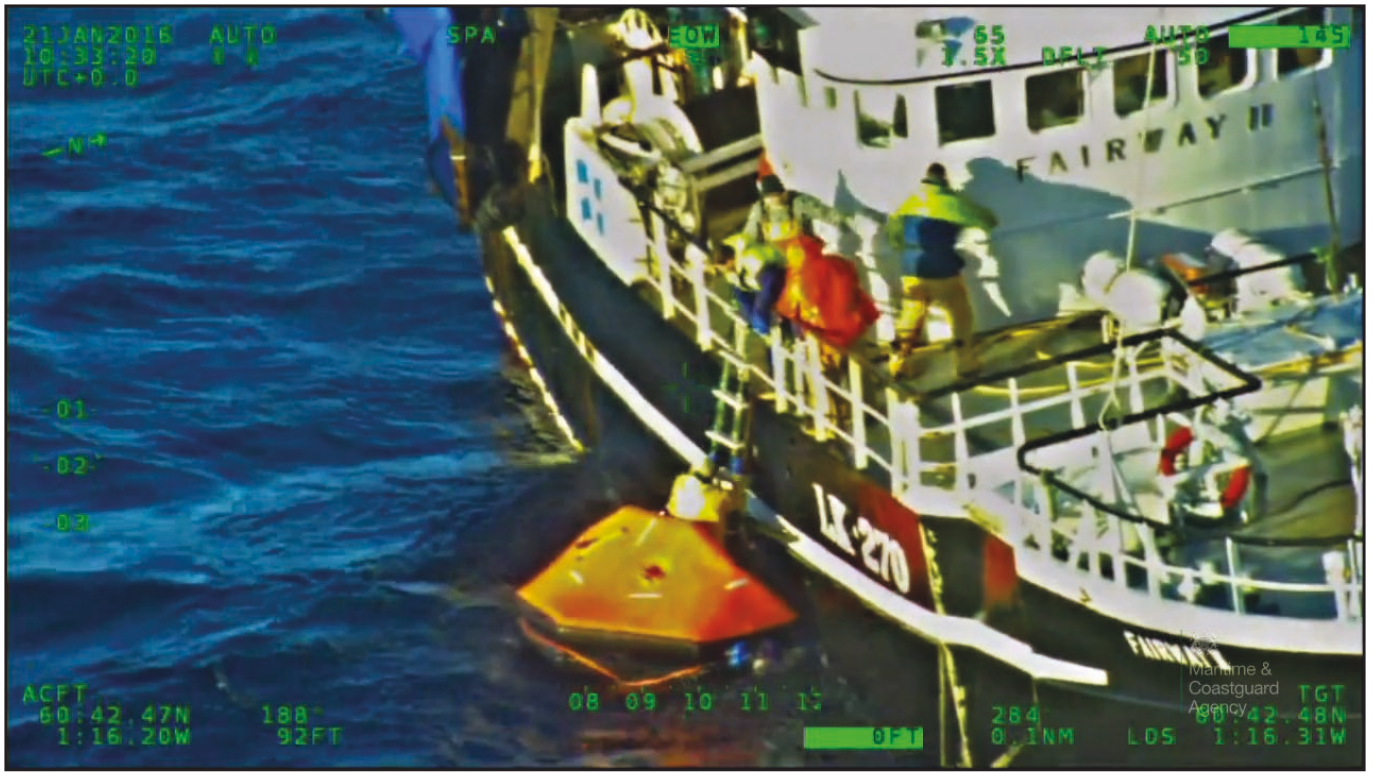
Figure 3: Majestic's crew recovered by Fairway II

At about 1022, R900 arrived on scene soon followed by *Fairway II*. At 1033, *Majestic's* skipper and crewman were recovered from the liferaft onto the fishing vessel (**Figure 3**). *Majestic* remained upright and on an even keel (**Figure 4**) and over the next 4½ hours the vessel drifted towards the Orka Vow gas pipeline to the north (**Figure 1 inset**); *Fairway II* and *Kestrel* were in attendance. Shetland CGOC informed British Petroleum (BP), the pipeline's owners, of the situation and, at 1333, the coastguard also discussed the possibility of taking *Majestic* in tow with *Fairway II's* skipper. However, *Fairway II's* skipper considered it too dangerous to put anyone on board.

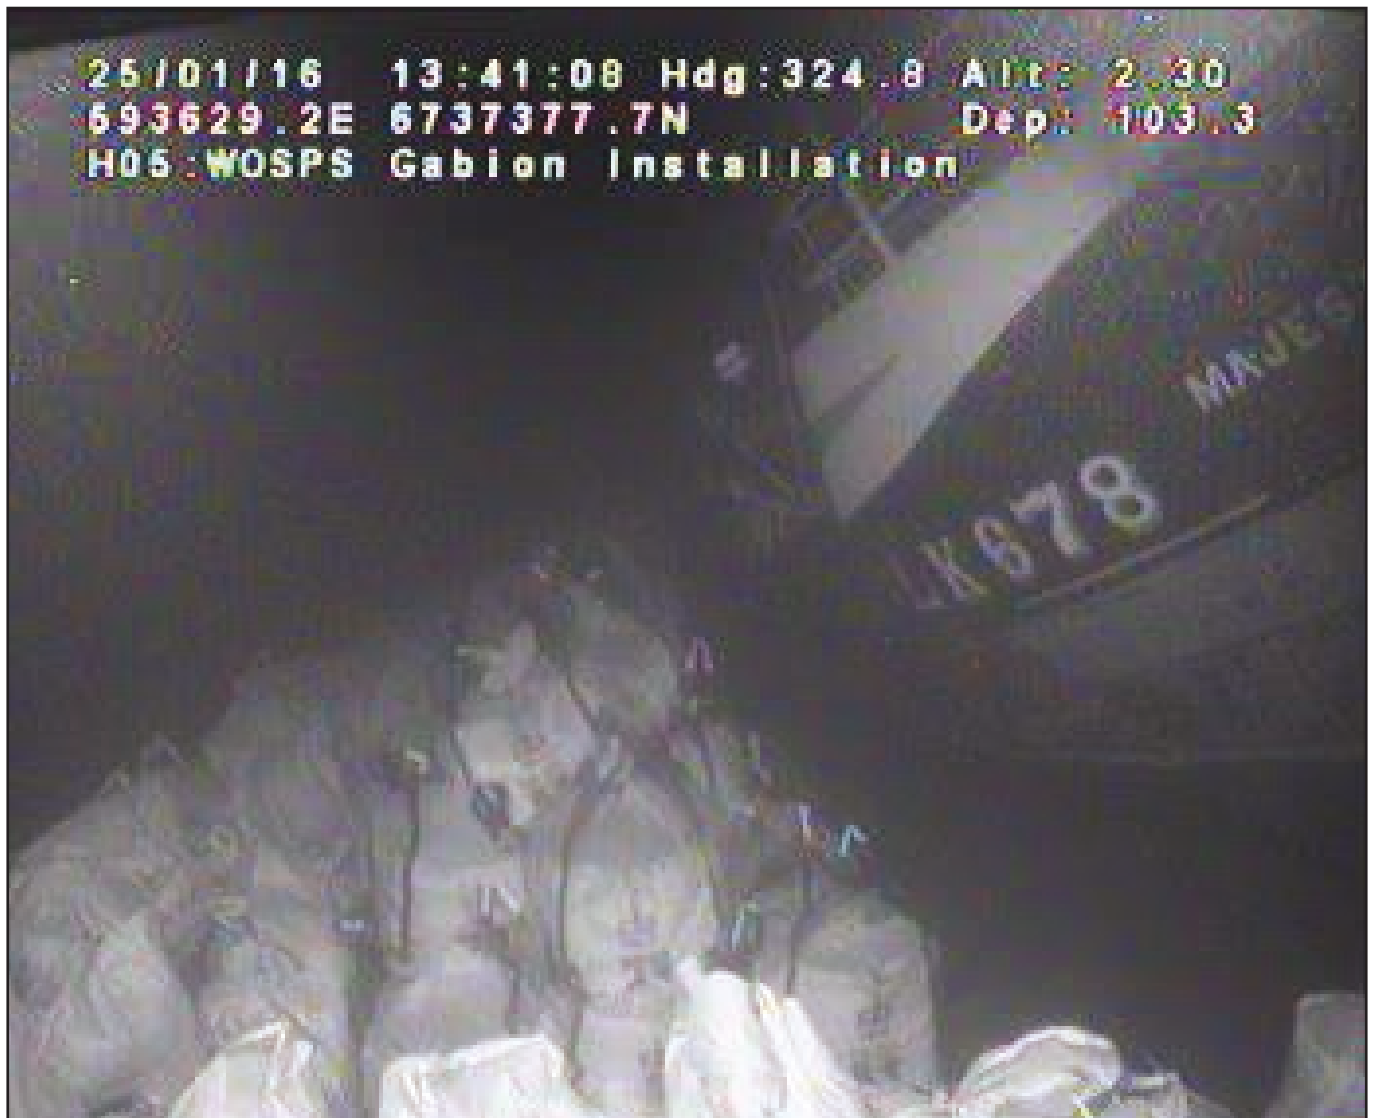
**Figure 5:** Sandbags positioned against the wreck

A 500 metre temporary exclusion zone was established over the site of *Majestic's* wreck and BP deployed a guard vessel to the area. A remotely operated vehicle (ROV) survey identified that *Majestic* had settled on the seabed 2 metres from the gas pipeline; the vessel was heeling towards the pipeline. As a precaution, the ROV was used to place large sandbags between *Majestic* and the pipeline to prevent the wreck from toppling (**Figure 5**).
