# Rail Accident Report

## Overspeed at Fletton Junction, Peterborough 11 September 2015

Report 14/2016  
August 2016

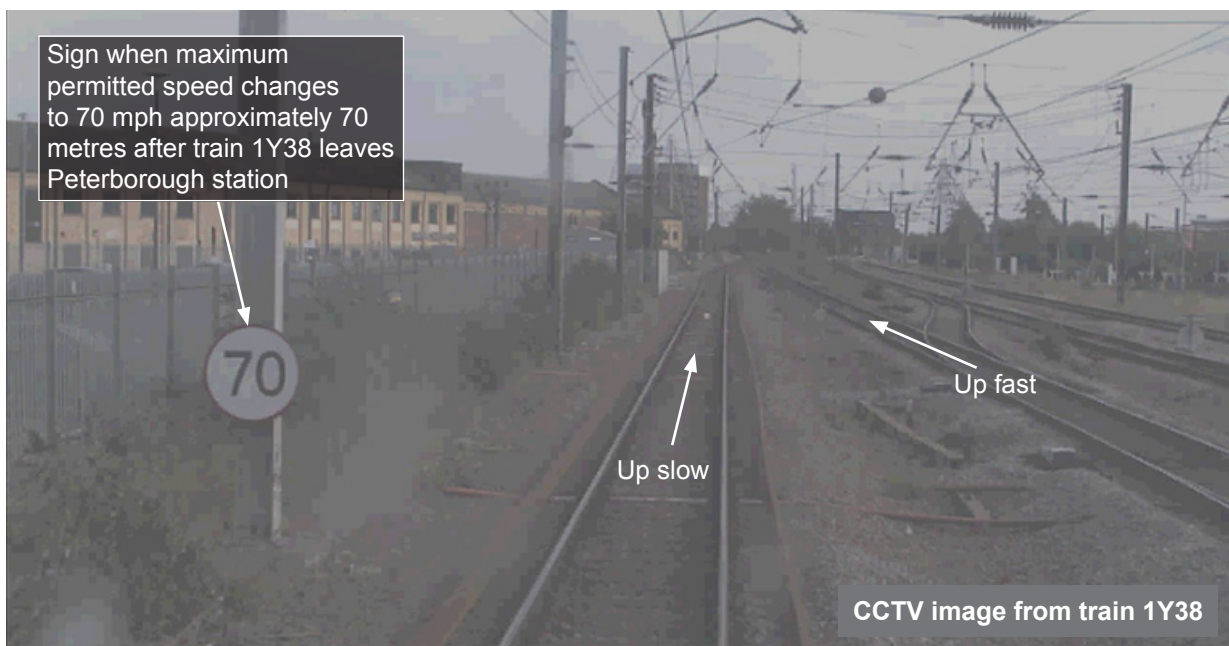
Figure 4: Speed limit sign at location where speed changes (courtesy VTEC)

- 15 Speed limit signs (referred to as *permissible speed indicators* in the railway rule book) are provided on both the up slow and up fast lines at the locations where a new maximum permitted speed applies (figure 4). A 115 mph sign is provided on the up main line, shortly after Fletton Junction, to advise drivers joining from the up slow line that they are now subject to the limit which already applies to trains travelling from the up fast line.

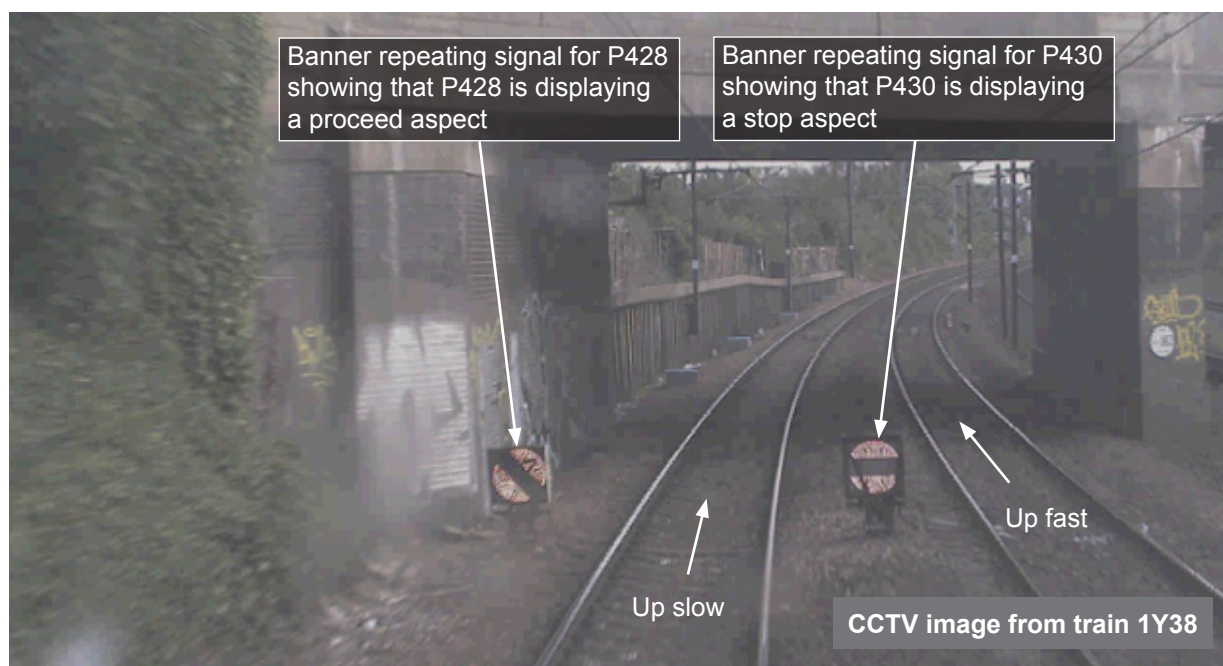
Figure 5: Banner repeating signals (courtesy VTEC)

- 18 Signal P428 is also preceded by a *banner repeating signal* (figure 5) which displays a horizontal black bar if signal P428 is showing a red aspect, and a diagonal bar if it is showing a proceed aspect. The banner repeating signal is provided because a bridge over the railway means that drivers do not have a clear view of the signal until they are relatively close to it. Banner repeating signals mean that train drivers do not have to drive as slowly towards a signal they cannot see if it is showing a proceed aspect.

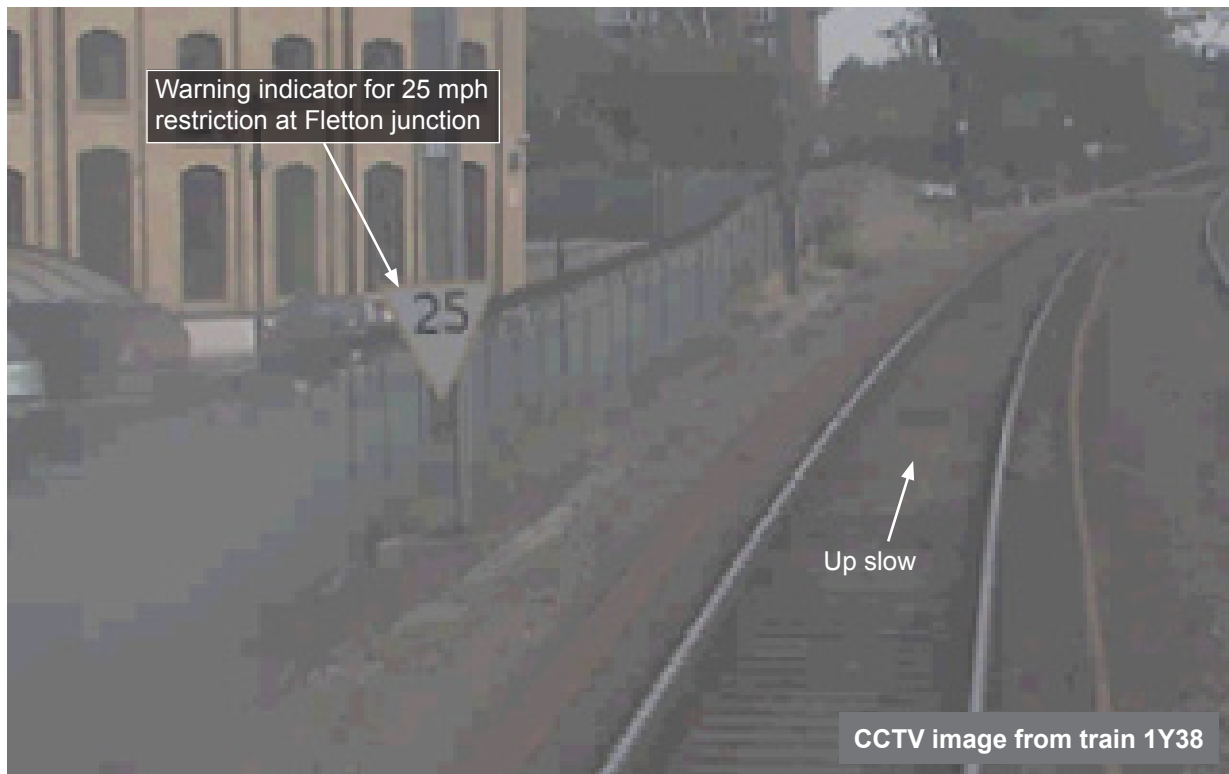
Figure 6: Warning indicator (courtesy VTEC)

- 19 A *warning indicator* for the 25 mph (40 km/h) speed restriction at Fletton Junction is provided by a triangular sign (figure 6) 1200 metres from the start of the restriction (400 metres from Peterborough station). This has an associated AWS permanent magnet which always gives a warning signal and is located 1390 metres from the start of the speed restriction (210 metres from Peterborough station). Paragraph 59 explains why this particular 25 mph (40 km/h) speed restriction requires a warning indicator.

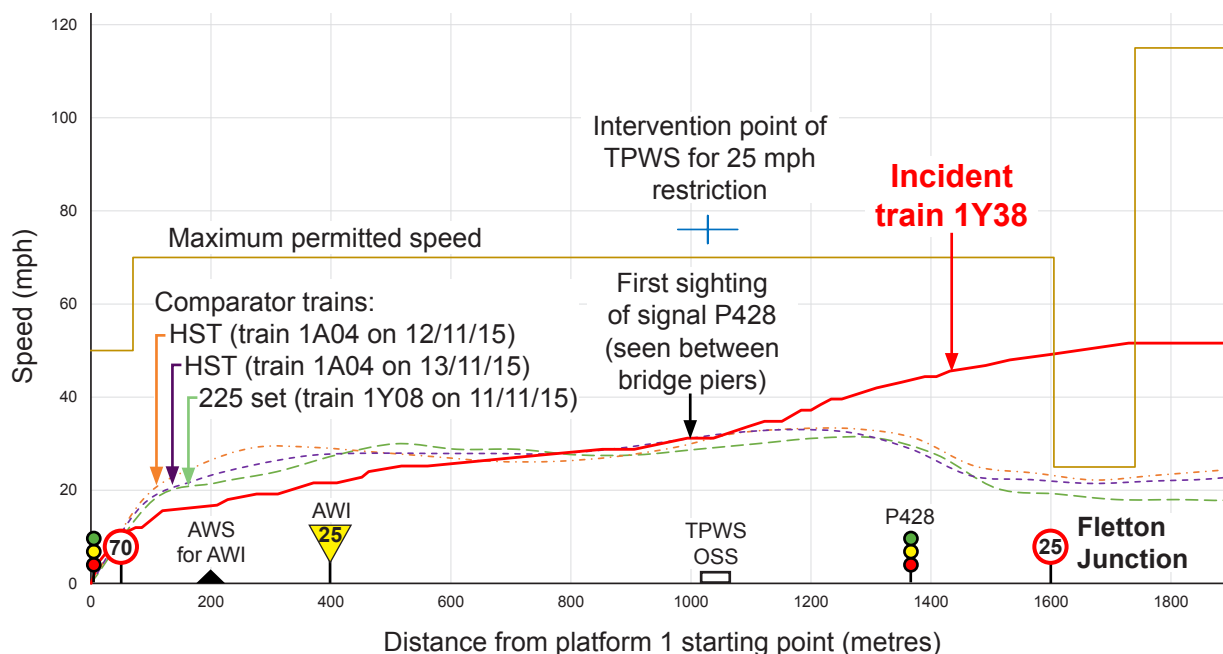
Figure 7: Speed profiles for trains on up slow line

- b. TPWS is not effective for trains which accelerate after they have passed the OSS loops. This is a normal condition for trains which start from platform 1 as demonstrated on figure 7 which shows that train 1Y38 and the sample of other trains were both accelerating as they passed the OSS.

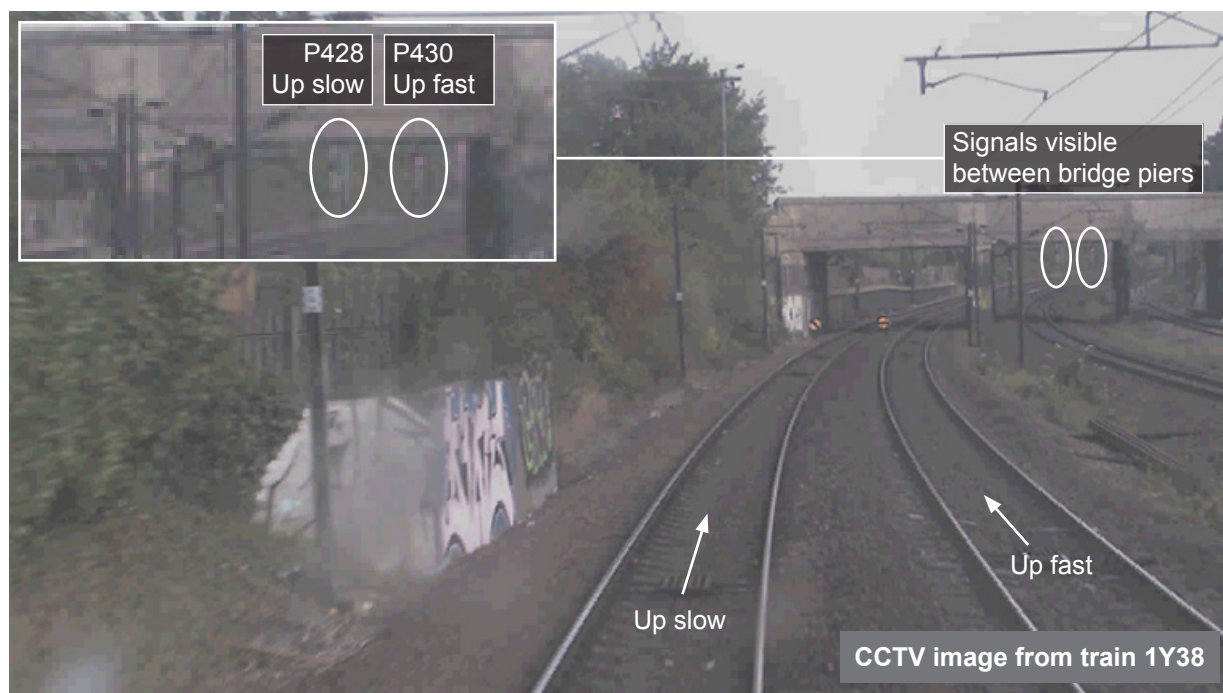
Figure 8: First sighting of signal P428 (courtesy VTEC)

- b. When applying full power after sighting signals P428 and P430, signal P430 (the fast line signal) was displaying a red aspect which should have caused the driver to stop if he believed he was on the up fast line (table 1, 125 seconds, figure 8).

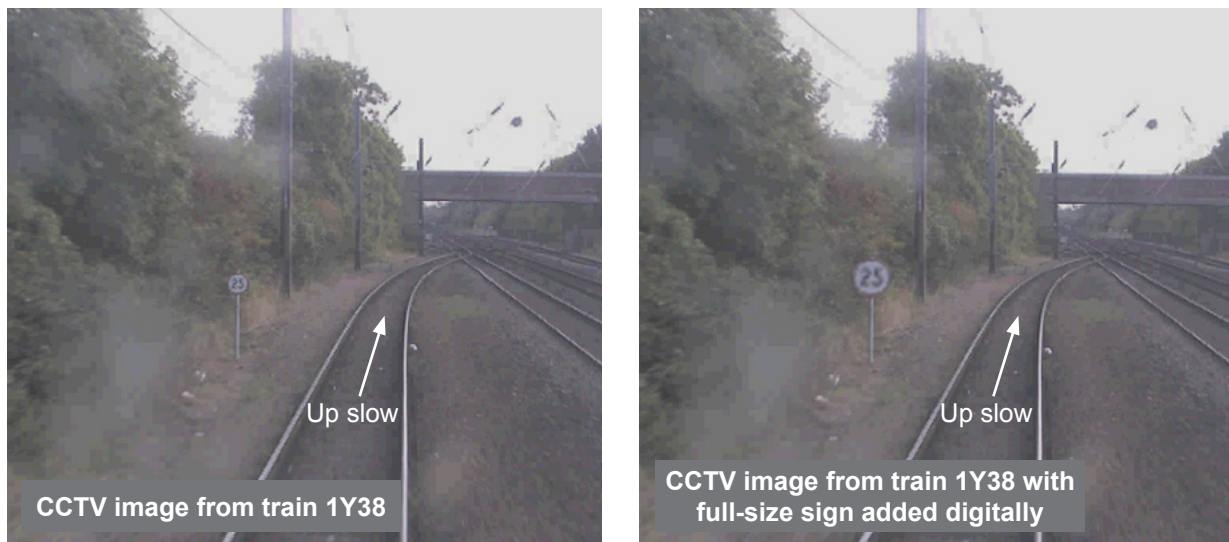
Figure 10: Speed limit sign size comparison (original image courtesy VTEC)

- 64 Drivers' route knowledge should include an awareness of permitted speeds and speed signs, provided in accordance with Railway Group standard GK/RT0075, are intended as a supplement to this knowledge and as a means of marking the exact location at which permitted speeds change. Speed signs are normally 900 mm in diameter but the sign on the up slow line approaching Fletton Junction was 450 mm in diameter. Signs of this size are known as miniature type permissible speed indicators; they are normally used to repeat speed information, to indicate that trains may now travel at a greater speed than previously, and at locations where limited clearances restrict fitting a full-size sign. None of these conditions applied on the approach to Fletton Junction. A full-size sign provides a greater opportunity for drivers to see the sign, and apply any necessary braking, before reaching it.

- 65 A full-size sign would have been more apparent (figure 10) and, if noticed by the driver of train 1Y38 at the sighting distance for this type of sign (in excess of 200 metres<sup>9</sup>), it would have provided enough distance for him to slow the train to comply with the speed restriction. The driver did not notice the miniature sign, probably due to distraction (paragraph 39), so it is not certain whether, or when, a bigger sign would have caught his attention.

122 Network Rail has replaced the non-compliant miniature permitted speed restriction sign at Fletton Junction with a full-sized sign compliant with current standards.

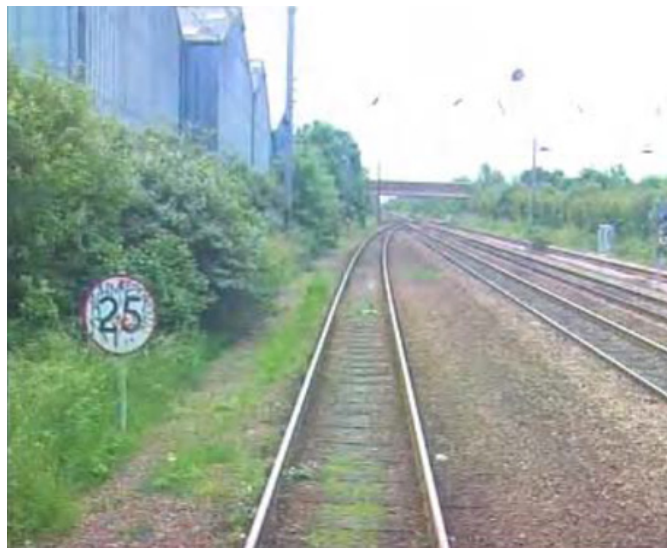
*Figure 11: Full-size permissible speed indicator at Fletton Junction in 2002 (image courtesy of Network Rail)*

- 87 **Network Rail's procedures did not identify that the speed restriction sign at Fletton Junction was smaller than required by its standards and this is a possible underlying factor.**
- 88 It is possible that a full-size permissible speed indicator at start of the 25 mph (40 km/h) speed restriction, rather than the miniature sign actually provided, would have caught the driver's attention and resulted in the driver reducing the train's speed before reaching Fletton Junction (paragraph 63).
- 89 A forward facing closed circuit television (CCTV) image taken on 18 June 2002 shows a full-size permissible speed indicator at Fletton Junction (figure 11). Network Rail has not been able to determine when the sign was replaced by the miniature sign, or why.

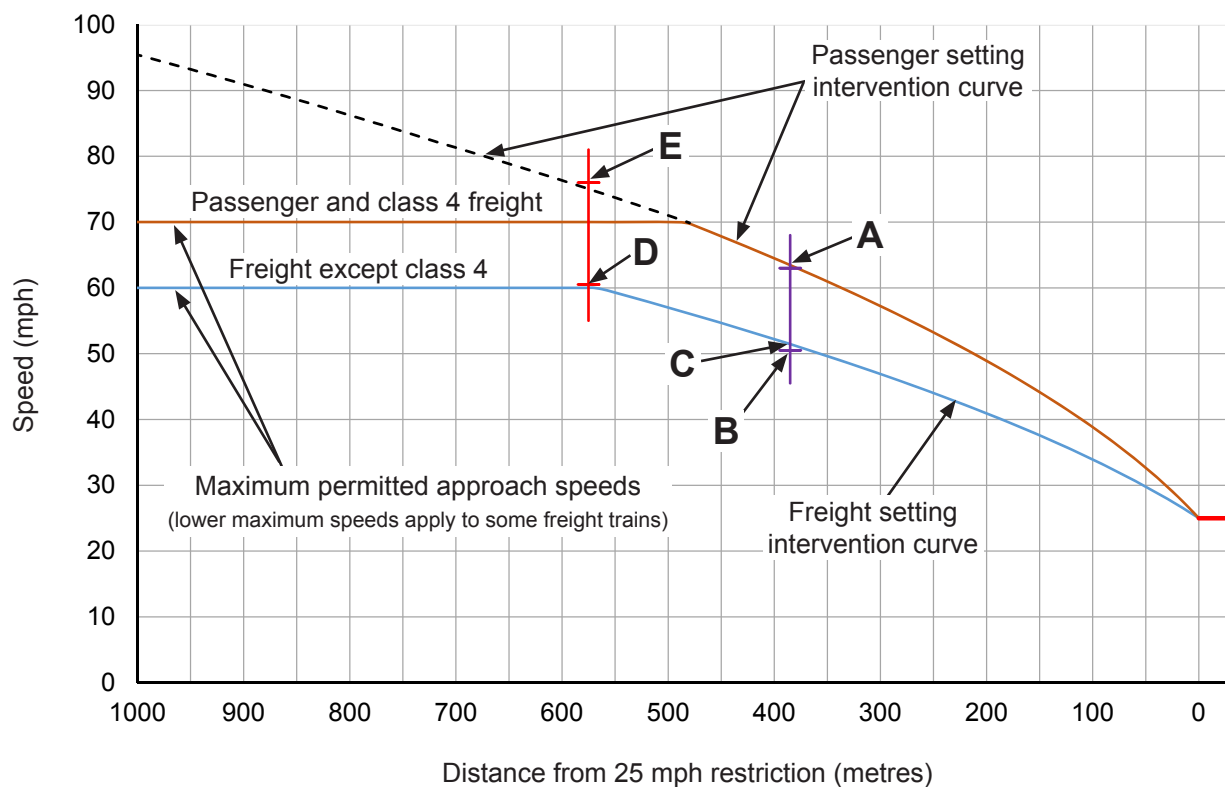
Figure D1: Positioning TPWS OSS for permanent speed reduction at Fletton Junction

- 8 It would be possible to increase the likelihood of TPWS preventing a significant overspeeding event at Fletton Junction by restricting the approach speed of trains using the freight setting and by adding additional OSS loops intended to stop trains which accelerate inappropriately after passing over earlier OSS loops. The first could be opposed by the freight operating companies and the second would be a non-standard arrangement which, if justified at Fletton Junction, would also be justified at similar locations elsewhere on the rail network. The difficulty of configuring TPWS to prevent all overspeeding events at speed restrictions is probably because TPWS was originally developed to reduce the likelihood of serious accidents caused by trains passing signals displaying a stop indication.
