## *St Apollo* (BA 359) Grounding and flooding in Inninmore Bay, Sound of Mull, Scotland 24 August 2015

### SUMMARY

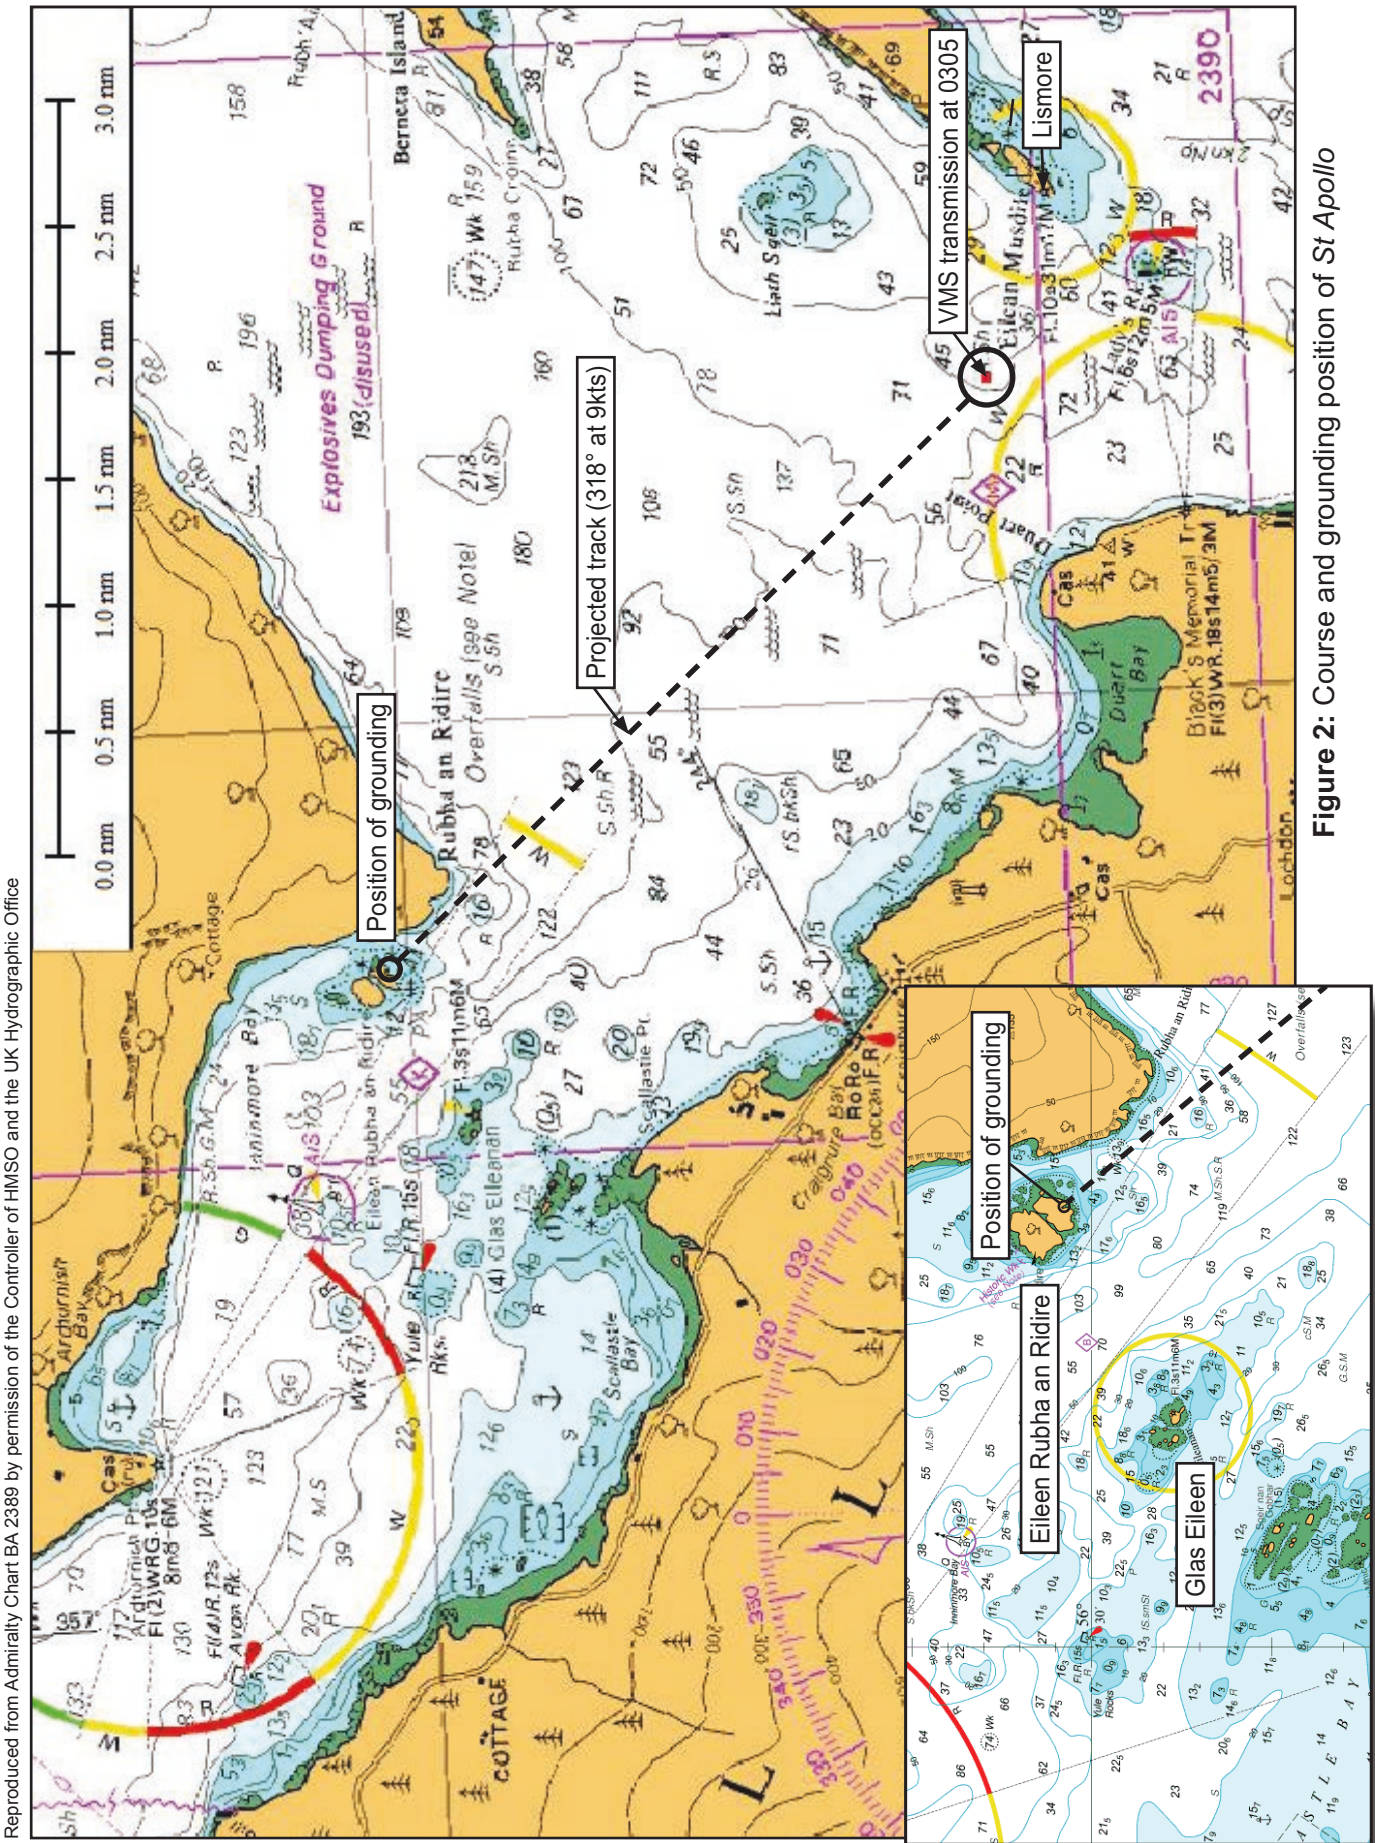
Figure 2: Course and grounding position of *St Apollo*

The skipper was woken by the watchkeeper's shouts. He got up, put on jogging bottoms and shoes and made his way to the wheelhouse. As he did so, *St Apollo* grounded on the south shore of Eilean Rubha an Ridire (**Figure 2**), a small island on the north side of the eastern end of the Sound of Mull.

If, as reported, *St Apollo*'s navigational track through the south-east end of the Sound of Mull, was equidistant from the dangers off Eilean Rubha an Ridire to the north-east and Glas Eileanan to the south-west (**Figure 2**), the vessel clearly grounded as a result of being to the north of the intended track. However, the absence of a record of the route in use, any positional data immediately before the grounding, or any material evidence of an electronic or mechanical failure, prevents a detailed and accurate analysis of the circumstances. Therefore, it is difficult to determine whether *St Apollo*'s grounding was due to navigational error, equipment malfunction, or a combination of both.

The width of the navigable channel between Eilean Rubha an Ridire and Glas Eileanan was 0.42nm. At a speed of 9kts, it would have taken *St Apollo* approximately 3.5 minutes to travel from the intended track to its grounded position (a distance of 0.5nm assuming a 30° turn to starboard from the base course). Therefore, as *St Apollo* grounded very quickly after the sudden and unexpected change of heading was noticed, it is likely that the vessel was already significantly to the north of the planned route.

A projection of *St Apollo*'s course and speed made good (318° at 9kts) from the position transmitted by VMS at 0305 (**Figure 2**), runs directly to the grounding position at 0327 and possibly suggests that the vessel's heading was not altered during the intervening period. However, it is evident from the absence of the watch alarm sounding in the accommodation, and the watchkeeper's shout to the skipper before the grounding, that the watchkeeper had not fallen asleep.

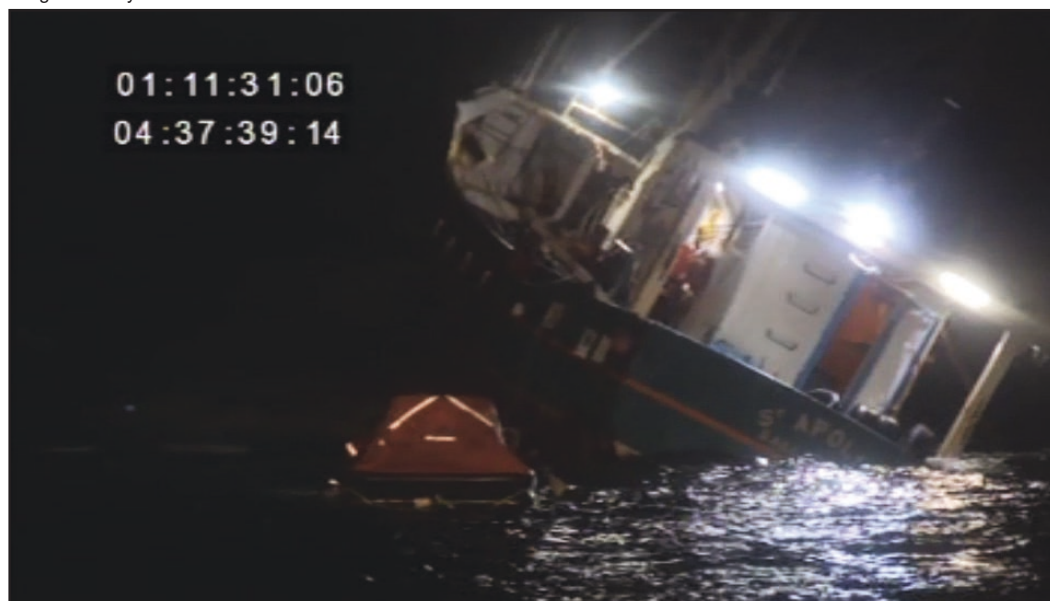
**Figure 3:** *St Apollo*'s crew abandoning the vessel

Stornoway Coastguard tasked the Oban all weather lifeboat (ALB) and rescue helicopter R177 to assist. The Oban ALB arrived on scene at 0426. By 0435, *St Apollo*'s starboard list had increased to approximately 35° and water had started to flood over the starboard bulwarks. The skipper and the crew abandoned into the liferaft (**Figure 3**), which they then paddled to the waiting ALB.

The skipper's actions following *St Apollo*'s grounding were generally well considered and timely. Despite being woken from sleep, he quickly arranged the assessment of the vessel's watertight integrity before attempting to re-float the vessel. His alerting of the coastguard was also timely and the abandonment was managed effectively and was well-judged. However, had more effort been made to close and secure all watertight doors, hatches and openings to prevent the ingress of water (**Figure 3**) the outcome for the vessel might have been less catastrophic.

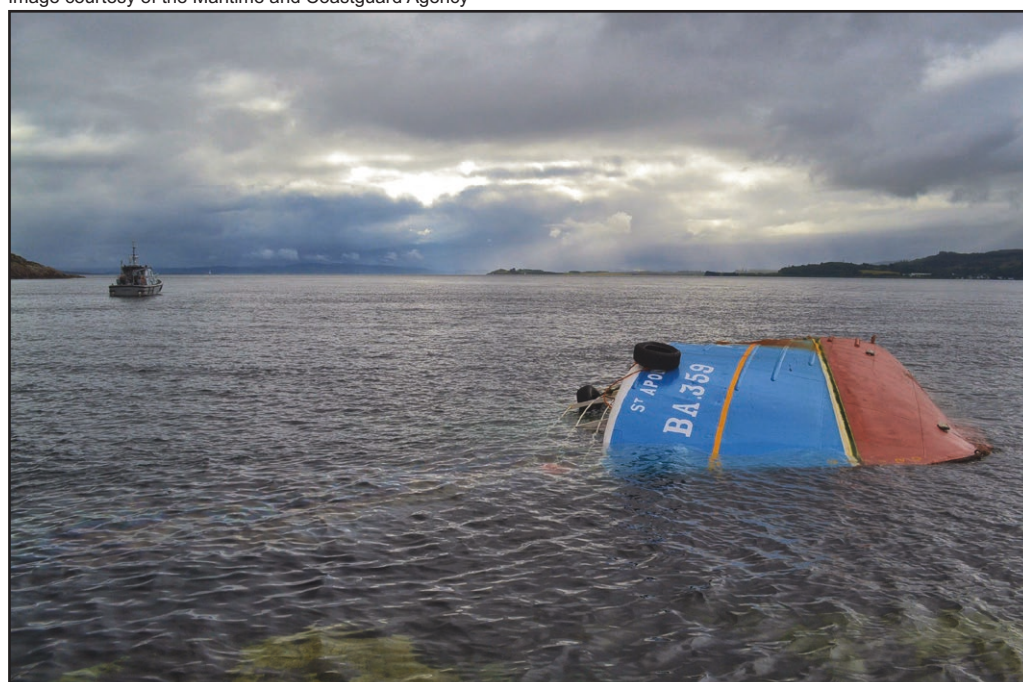
**Figure 4:** *St Apollo* partially submerged

At 0505, *St Apollo* toppled onto its starboard side and was partially submerged (**Figure 4**) in approximately 5m of water. The ALB returned to Oban with *St Apollo*'s crew. On arrival, the police breathalysed the skipper for alcohol and the test was clear. The crew were not breathalysed.

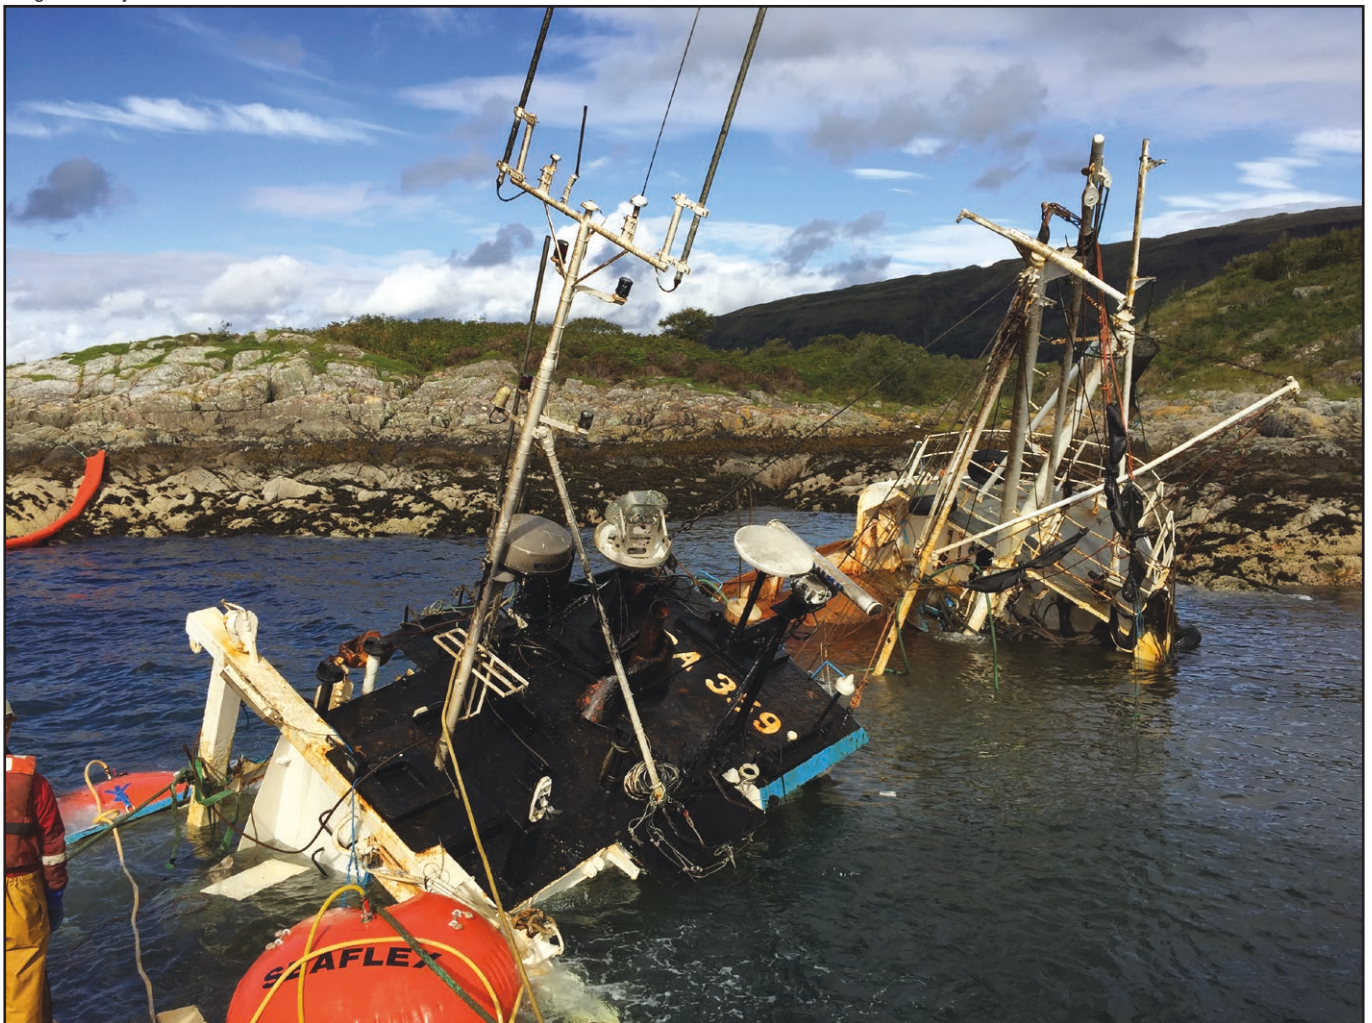
**Figure 5:** *St Apollo* being salvaged

On 15 September 2015, *St Apollo* was salvaged by North West Marine Ltd on behalf of the vessel's insurers. Flotation bags were used to bring the vessel upright (**Figure 5**) and entrained water was then pumped out. *St Apollo* had sustained little damage to its hull apart from slight distortion in way of the foot of the keel, forward. However, water ingress had damaged the vessel's engines and electrical systems. *St Apollo* was towed to Oban where it was determined to be beyond economical repair. The vessel was subsequently declared a constructive total loss.

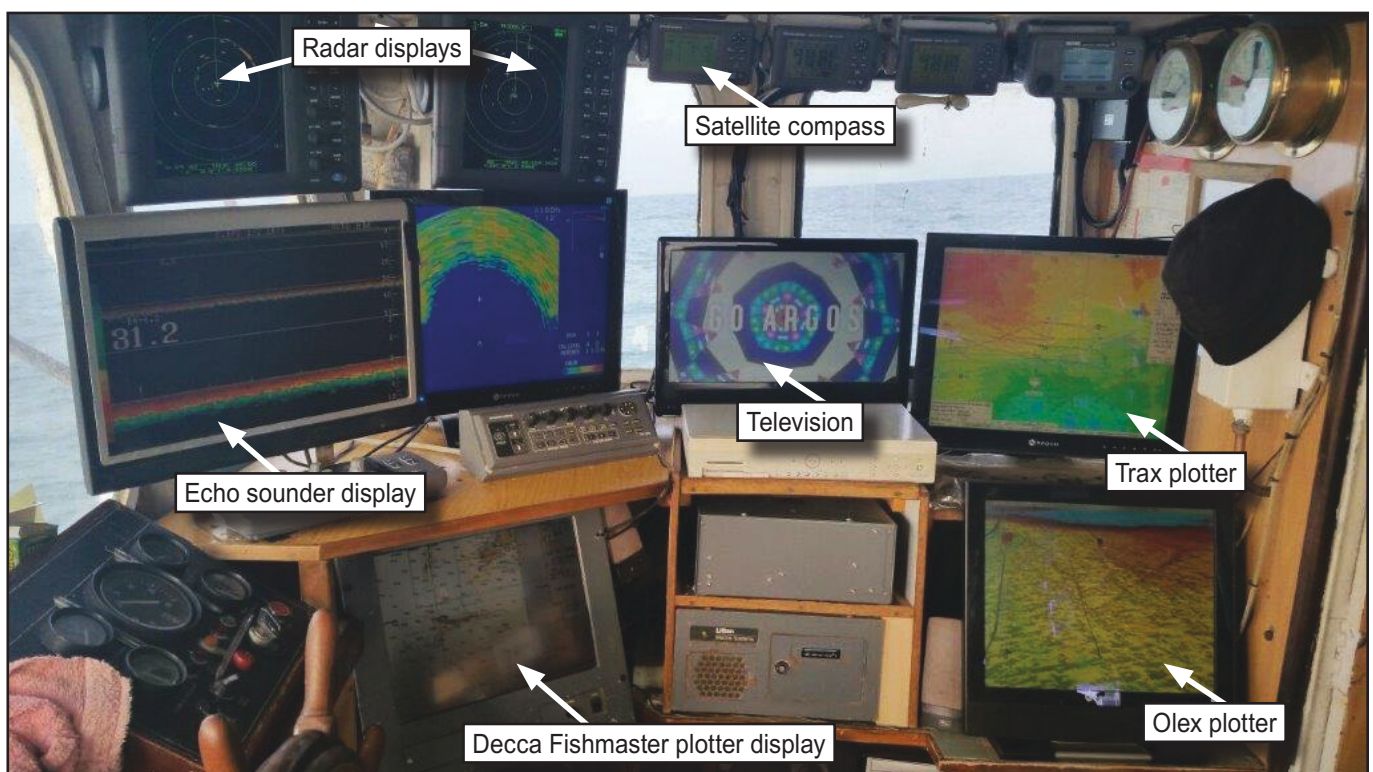
**Figure 6:** *St Apollo*'s wheelhouse equipment (starboard side)

**Figure 6** shows the electronic equipment fitted on the starboard side of the wheelhouse.
