Road Traffic Injury on Rural Roads in Tanzania: A study to determine the causes and circumstances of motorcycle crashes on low-volume rural roads/

FINAL REPORT, v1.1

Tom Bishop and Deepani Jinadasa, Amend

AFCAP/TAN/115

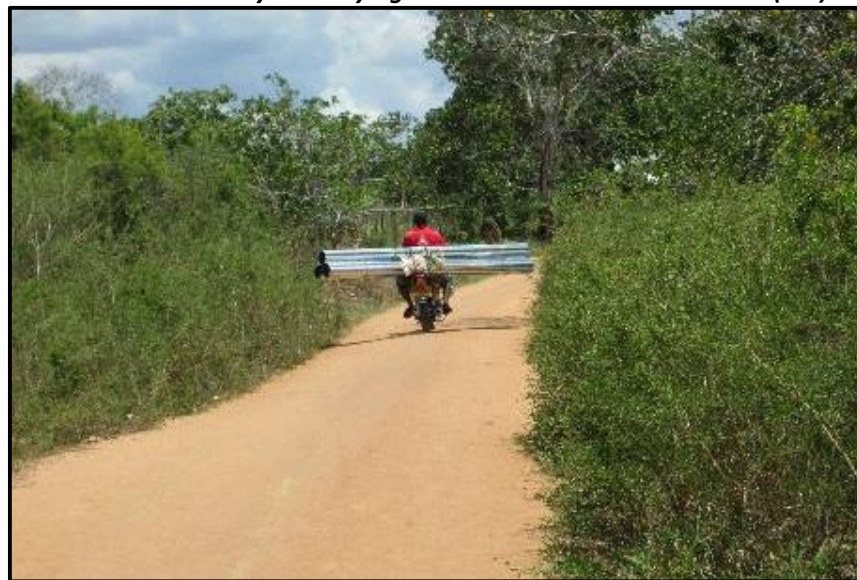
Photo 2: A Motorcycle Carrying a Wide Load on a Narrow Road (B-T)

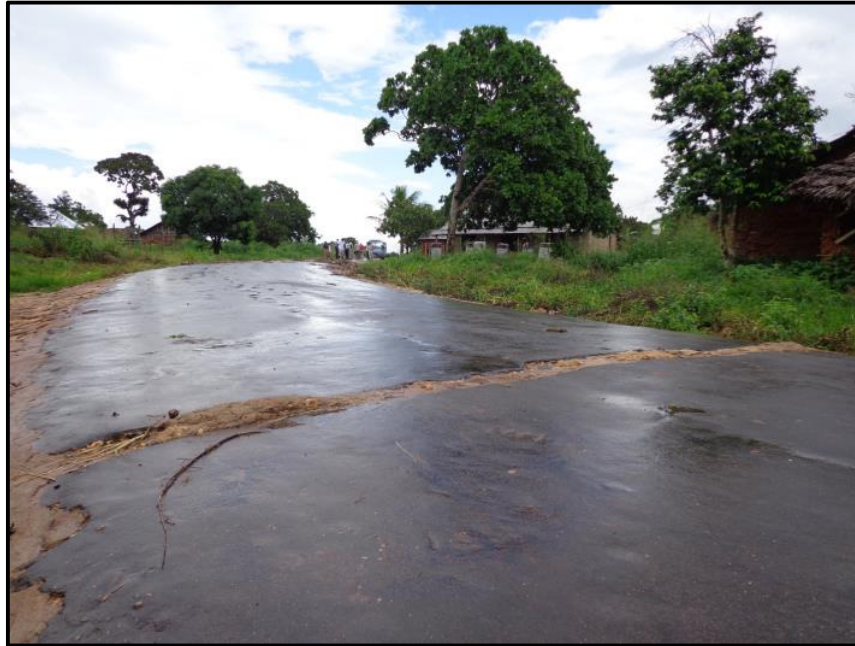
Photo 4: Smooth and Wet Double Sand Seal Surface (B-T)

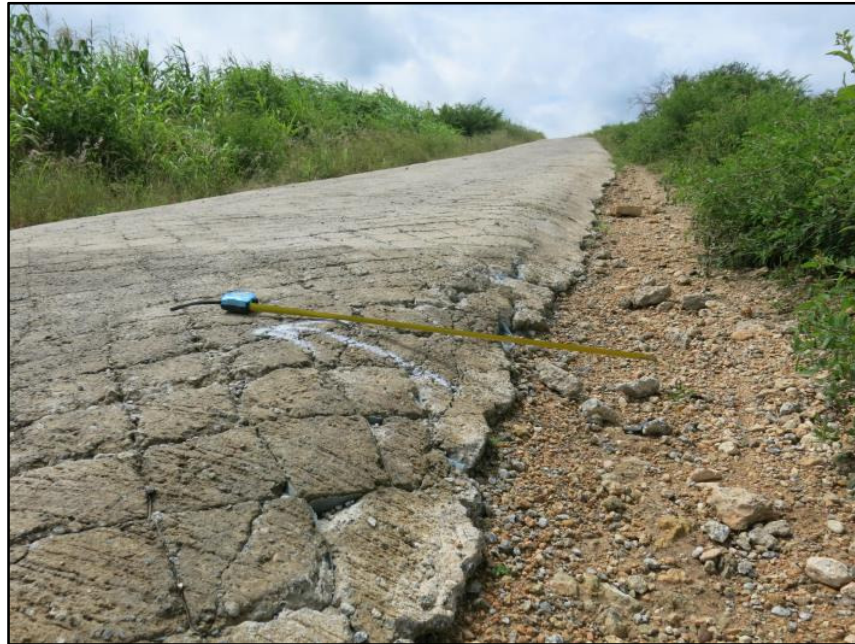
Photo 5: Edge Drop on Concrete Geocells (B-T)

The Motorcycle Safety Expert found the Concrete Geocells to generally be a good riding surface, with good grip in both dry and wet conditions. However, in places the surface had become rough with erosion in the interstices between the cells, and with some cracks. Excessive roughness causes vibration, creating tiredness in the driver's hands and the risk of loss of control.

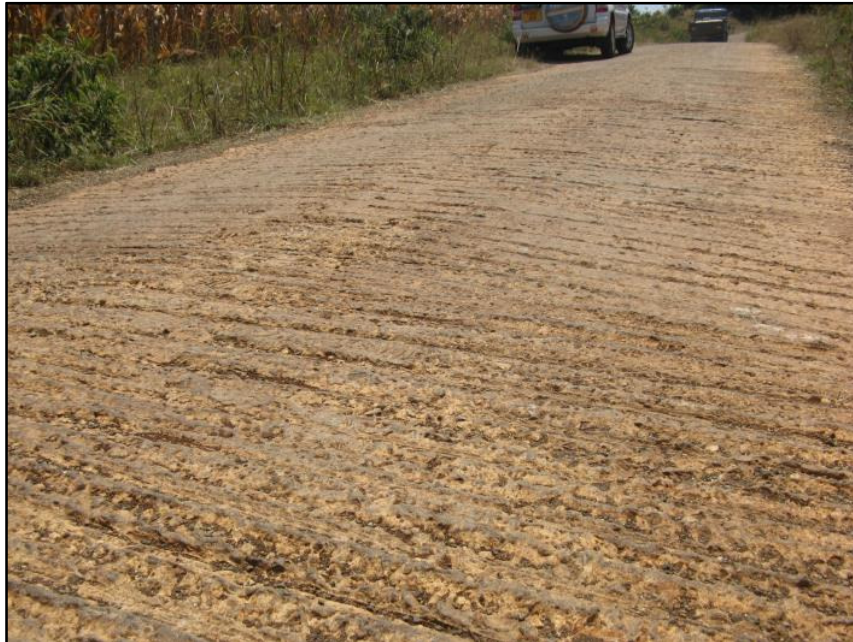
Photo 7: Excessive Grooving on Concrete Slabs (L-K)

Some cracking of the concrete slabs was evident, but again not to the degree that it would to cause problems for motorcyclists.

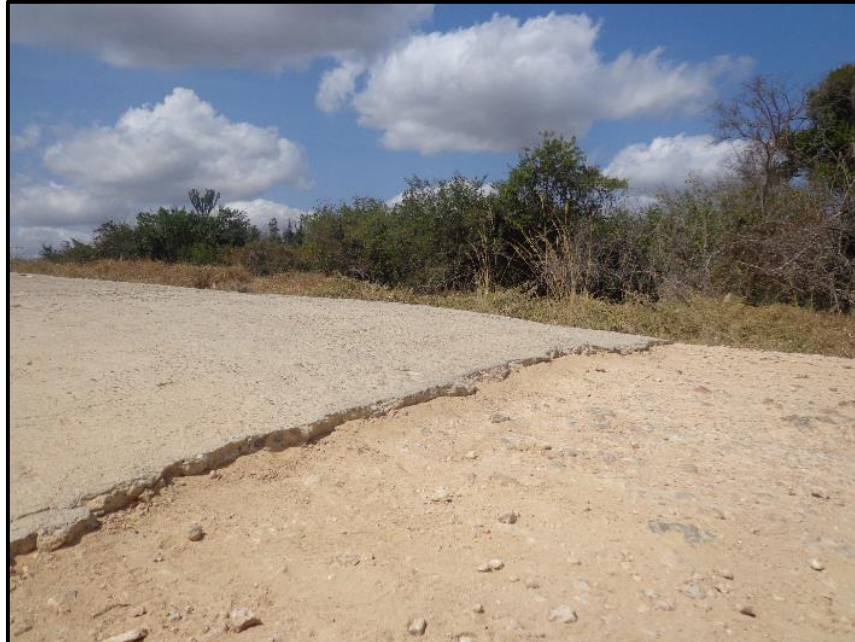
As with the Concrete Geocells, in places the difference in level at the join between the Concrete Slabs and an unpaved surface could create a risk for motorcyclists. Along the Lawate to Kibong'oto road, ascending drivers were observed driving along the shoulder and up onto the concrete at the side of the slab, to avoid the lip at the join of the slab and the engineered natural earth.

Photo 8: Un-level Join between Surface Types (B-T)

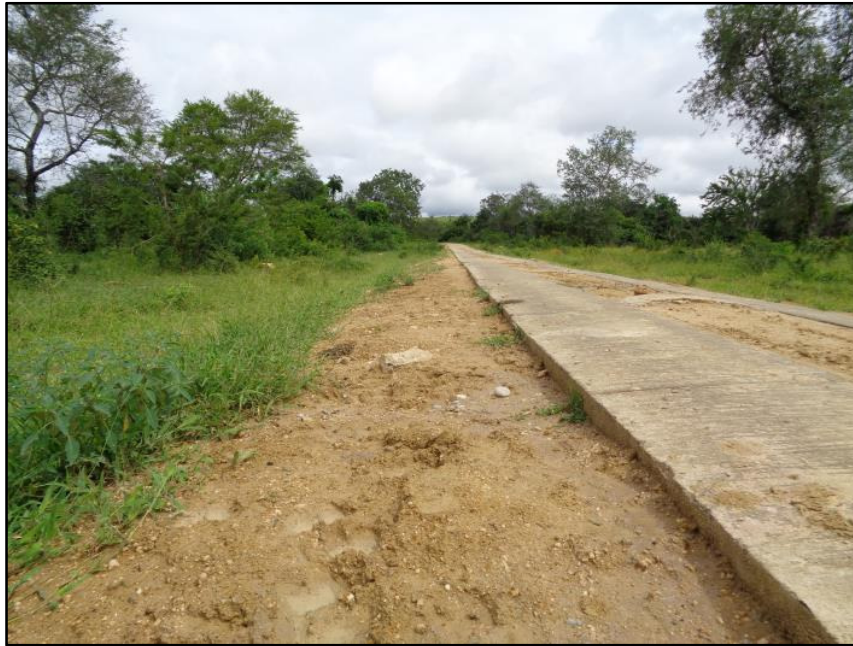
Photo 9: Severe Edge Drop on Parallel Concrete Strips (B-T)

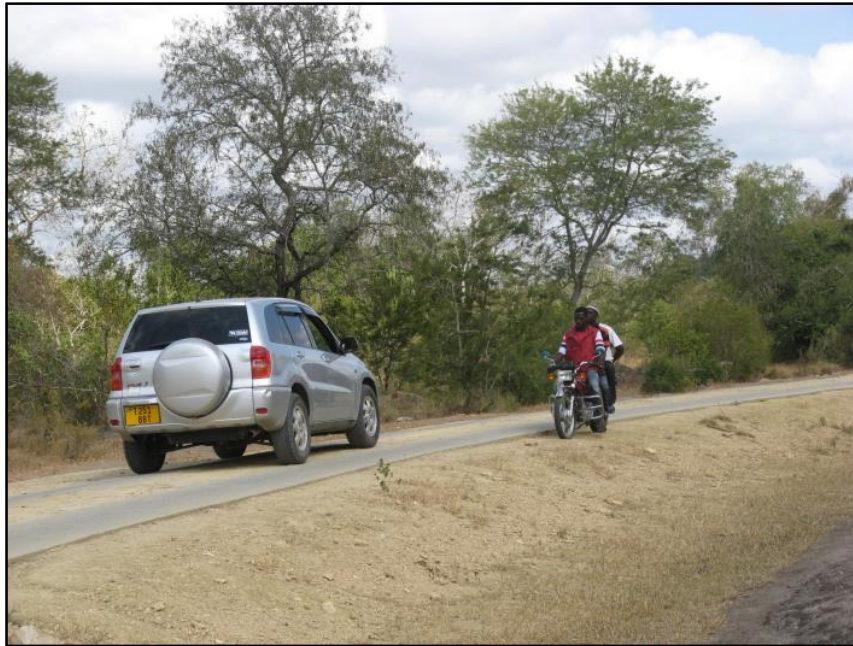
Photo 10: Absence of Adequate Shoulder with Parallel Concrete Strips (B-T)

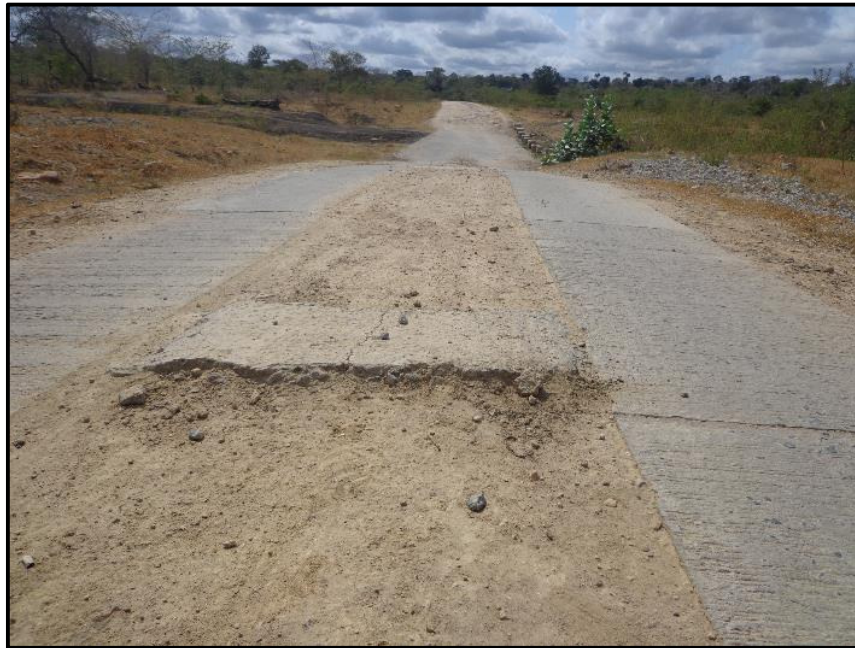
Photo 11: Chevron Piece is a Minor Obstacle (B-T)

Secondly, and less important, the chevron blocks (which have to be set slightly above the road surface in order to divert the run-off water) can act as an obstacle when motorcyclists are overtaking one another.

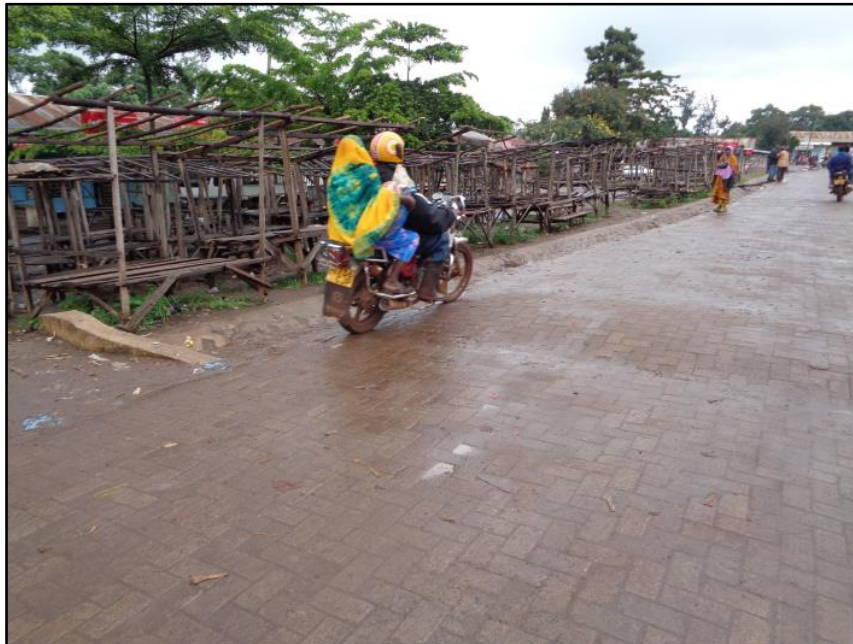
Photo 12: Boda-Boda Passing around the End of a Speed Hump on Paving Bricks (L-K)

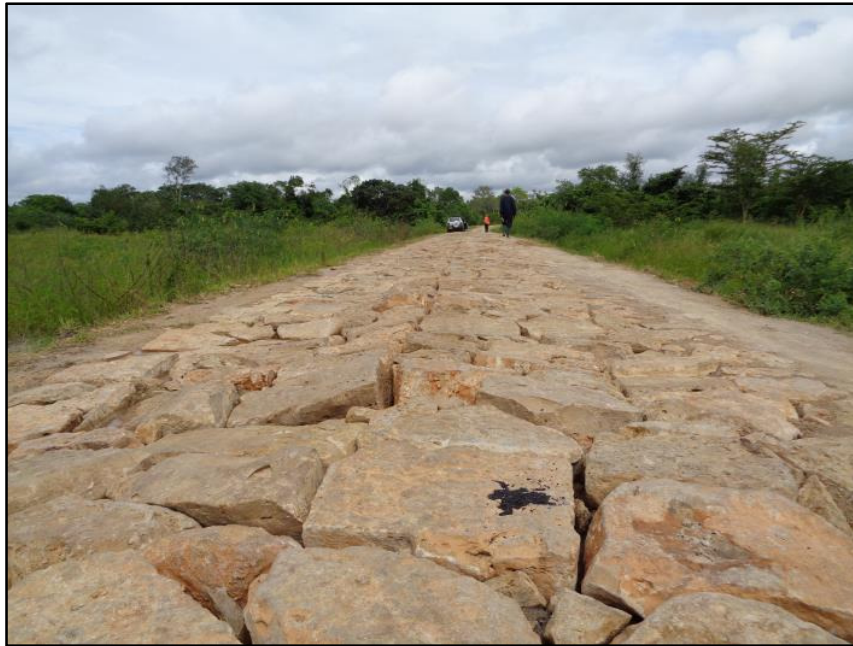
Photo 13: Rough Hand-Packed Stone Blocks (B-T)

The unevenness of the stones could increase the severity of injury in the event of a motorcyclist falling on this section of road.

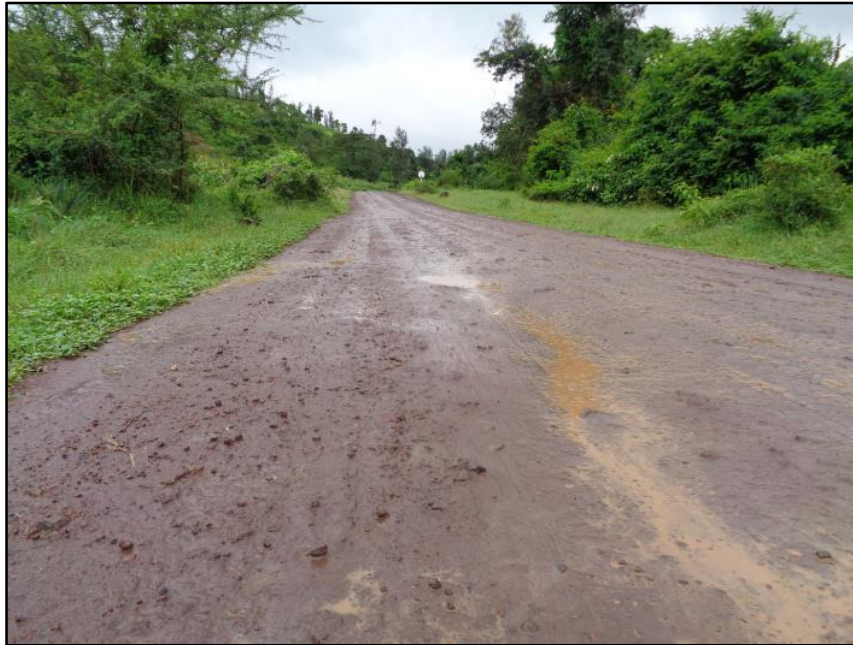
Photo 14: Wet and Slippery Unpaved Surface (L-K)

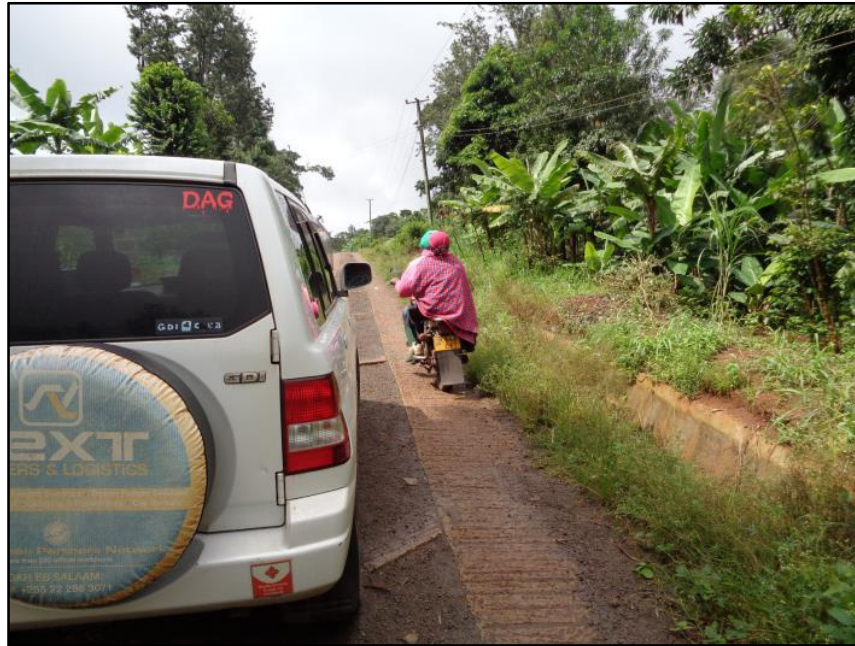
Photo 15: Narrow Roads Create Difficulty for Motorcycles to Pass Other Vehicles (L-K)

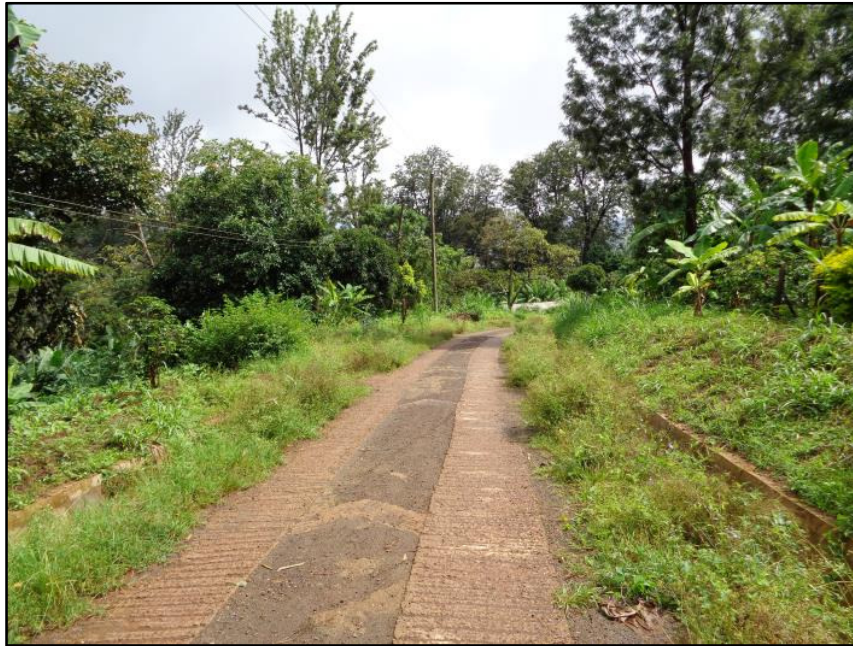
Photo 16: Shoulders Covered By Vegetation (L-K)

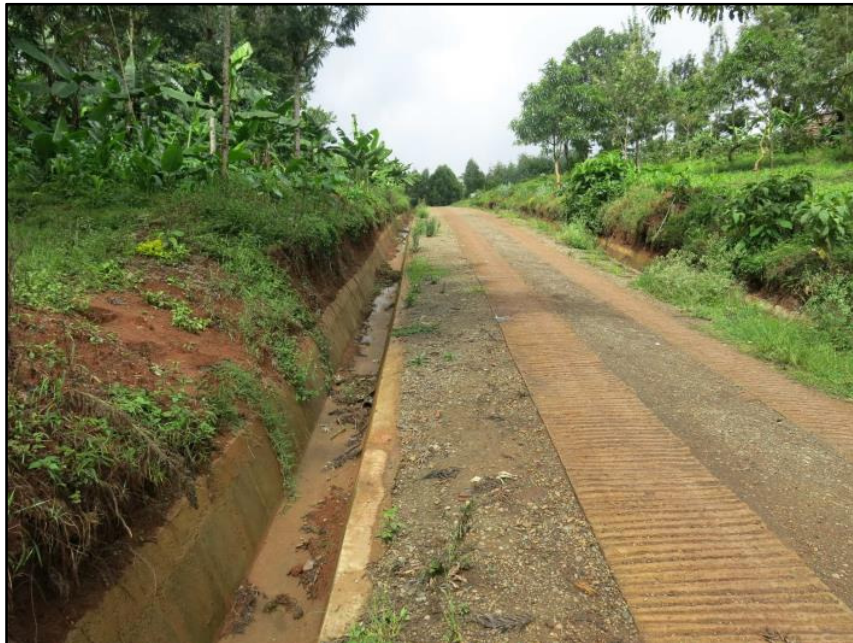
Photo 17: Hazardous Drain (though it helps support the shoulder) (L-K)

Along many stretches of the Lawate to Kibong'oto road, deep rectangular drains have been constructed at the side of the road. Where these are present, they strengthen the shoulder of the road, creating a firm shoulder surface for motorcyclists to use if they encounter a four-wheeled vehicle coming in the opposite direction.

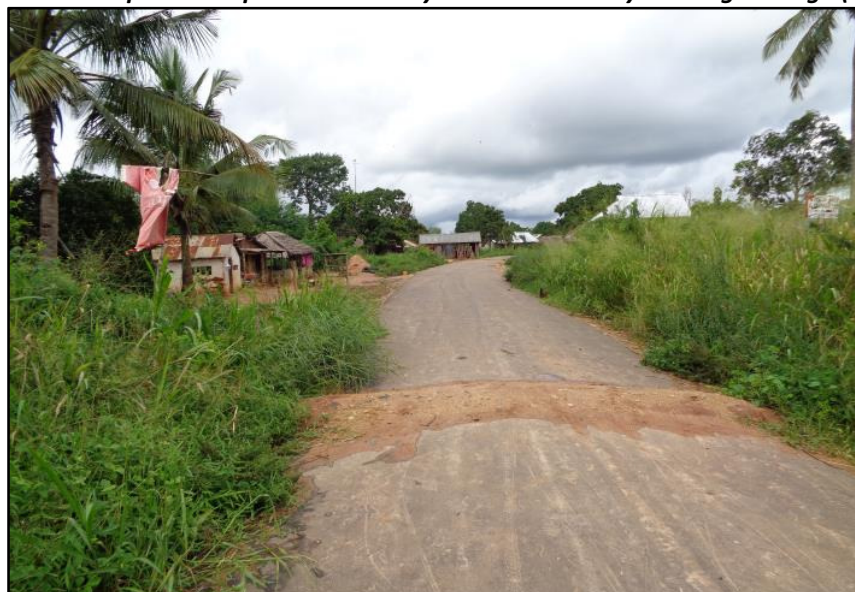
Photo 18: A Speed Hump Constructed By Local Community in Ludiga Village (B-T)

The speed humps along both roads are effective at slowing motorcyclists down, although those along the Bago to Talawanda road are not signed and so have the potential to cause loss of control for motorcyclists who do not see them.
