DFID South Sudan Education Programme Construction & Rehabilitation of Education Facilities

Construction Review

Nigel Wakeham, Consultant Architect

March 2012

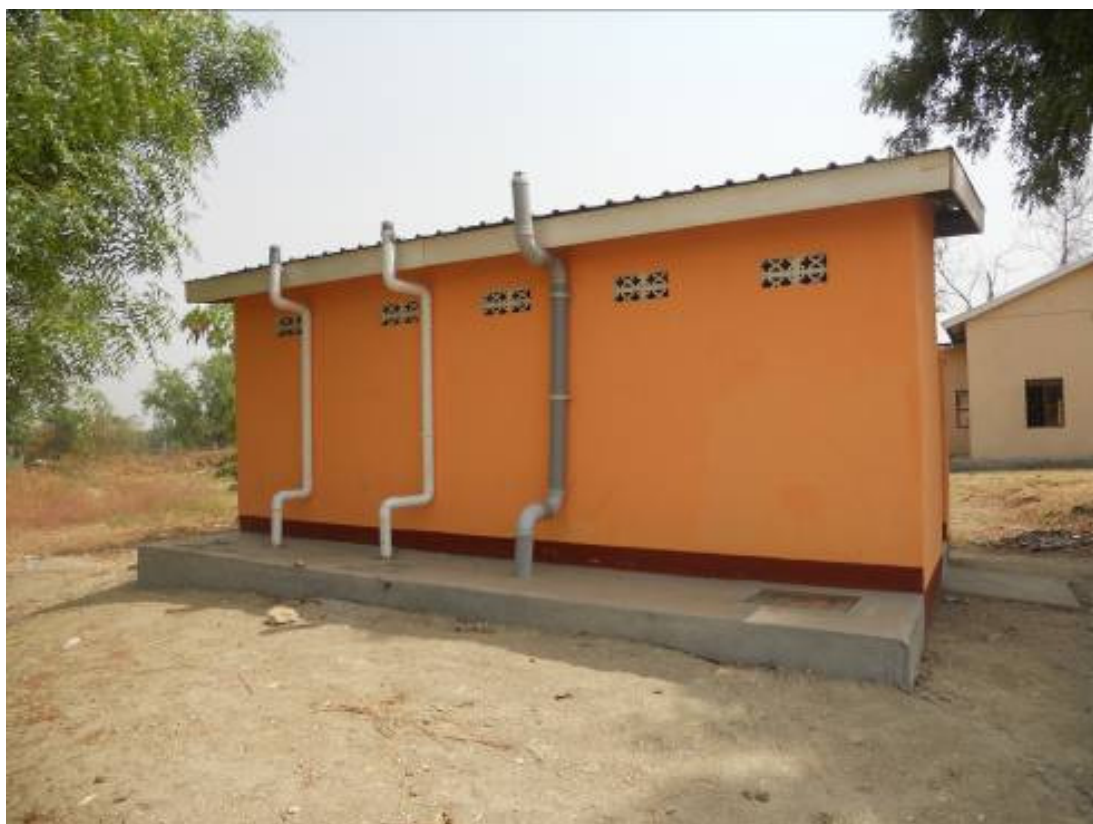
VIP latrines and wash rooms. There are two blocks of VIP latrines/wash rooms, one for men and one for women and they are situated well away from each other at opposite ends of the site. They are also a long way from the dormitories. Each unit has two wash rooms and three latrines. The buildings seem quite well constructed and have colour-coated steel roof sheets on timber purlins and rafters, rendered and painted block walls and steel doors. The steel doors are however not very good quality and there are some design issues. The vent pipes to the pits are not straight but have bends in them meaning that they will not function as intended (they should be the sole source of light in the pits in order to attract flies); there are no insect screens to the tops of the vent pipes and the access manholes to the pits are very small meaning that emptying will be very difficult if not dangerous.

Plate 1 VIP latrines and washrooms show cranked vent pipes

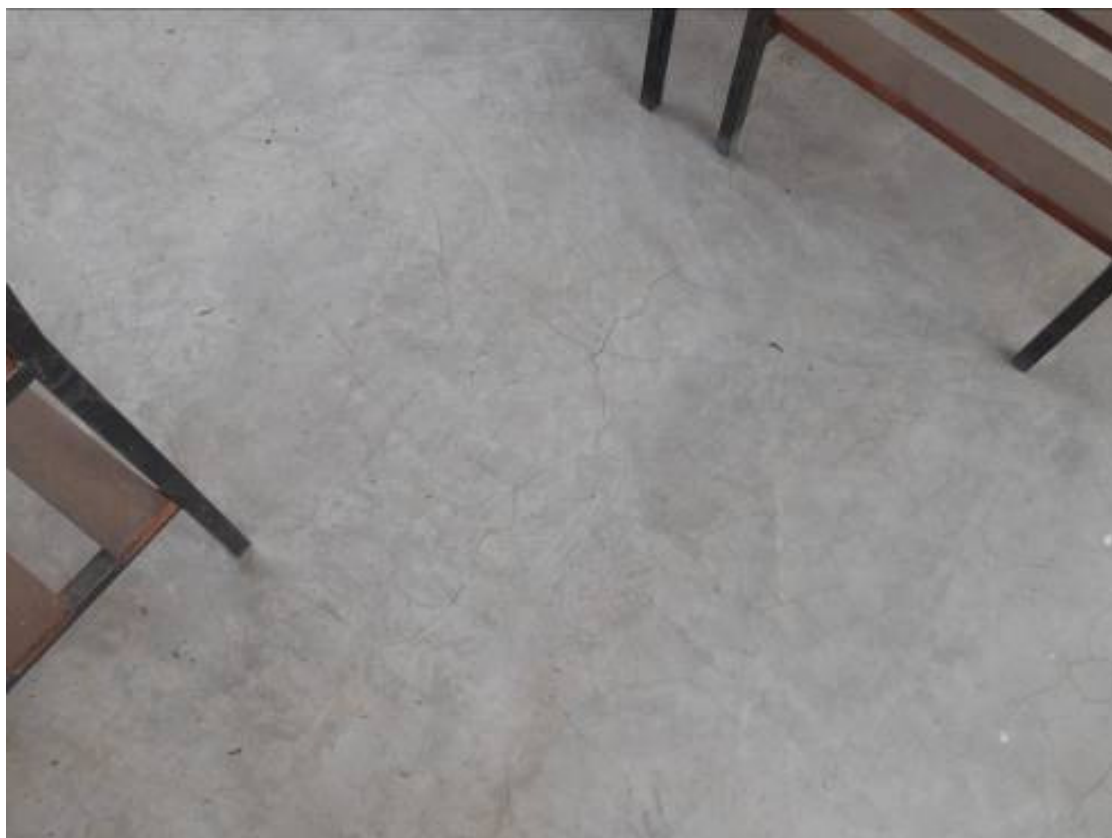
- The screeds in all buildings are cracking up probably because the mix was too wet when the screeds were laid, there was too much cement in the mix and because the screeds are too thin. They should be broken up and re-laid.

Plate 2 Typical screed floor showing badly cracked screed

Recommendations: unless screeds are laid the next day after the floor slab is cast and unless the mix is accurate, it is very likely that the screeds will crack (see notes under Supiri TTI visit). A better stronger finish will be achieved therefore if the screeds are omitted and the concrete floor slab is finished to a smooth surface with a steel trowel. The top of the slab will have to be protected until the rest of the work is completed. It is also recommended that more movement joints are built into the concrete floor slabs to control movement and avoid cracks.

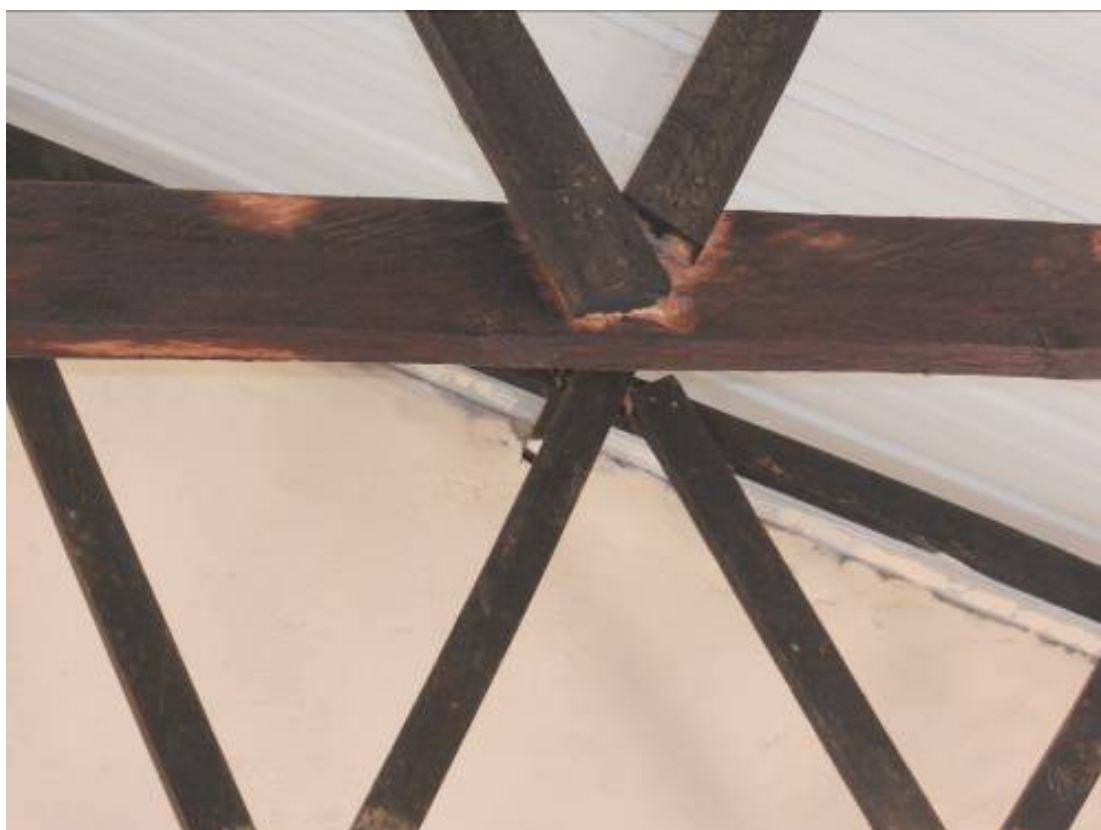
- The roof timbers everywhere have not been properly treated against termites and the roof trusses where visible (apart from in the hall) have inadequate joints which should be strengthened.

Plate 3 Typical roof truss showing very badly made joints

It should be noted that, according to the Centre Leader the contractor had employed some youths attending the Centre to assist with the construction of the roof trusses. As the roof trusses are badly made this does not seem to have been very successful. If youths are going to be used in this way then they will require much more training on the job and better supervision if they are going to gain useful experience. There also seems to have been a failure in the overall supervision of this project given the poor quality of the sandcrete blocks, the floor screeds and of the roof trusses.

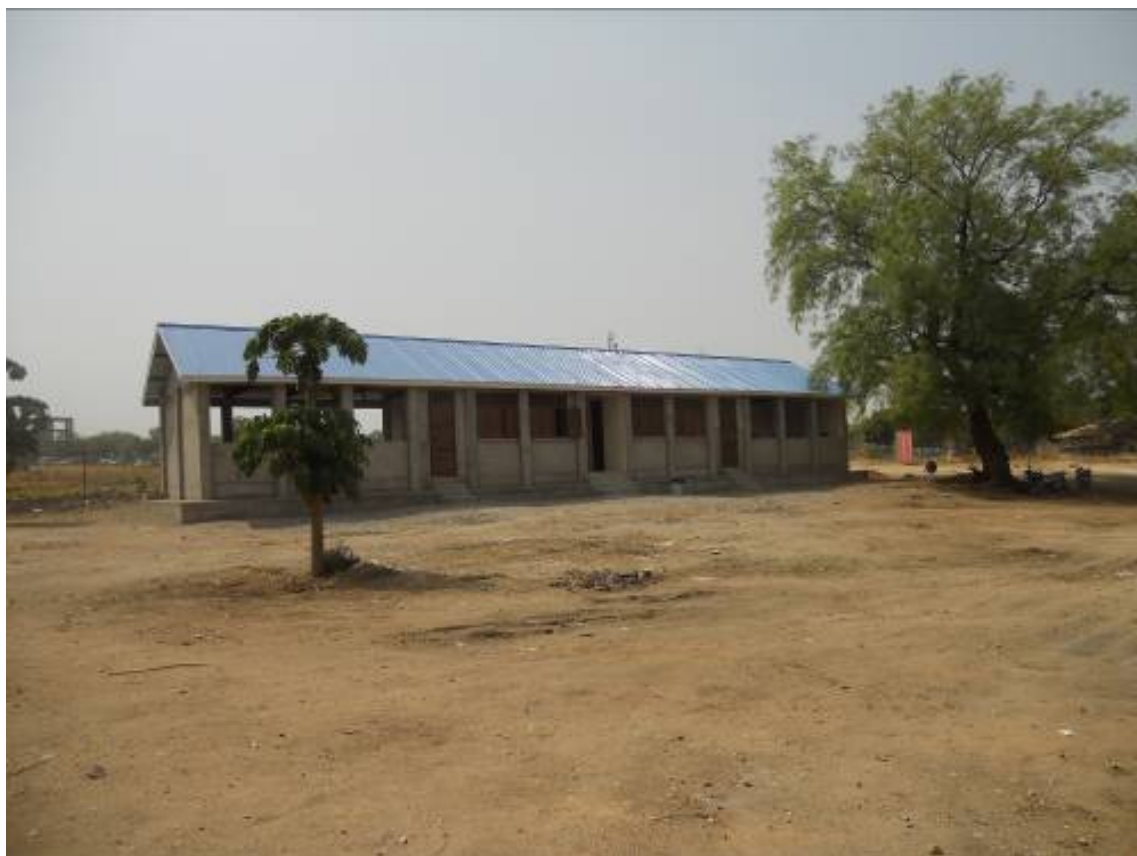
Plate 4 YEP Centre showing poor location and lack of access veranda

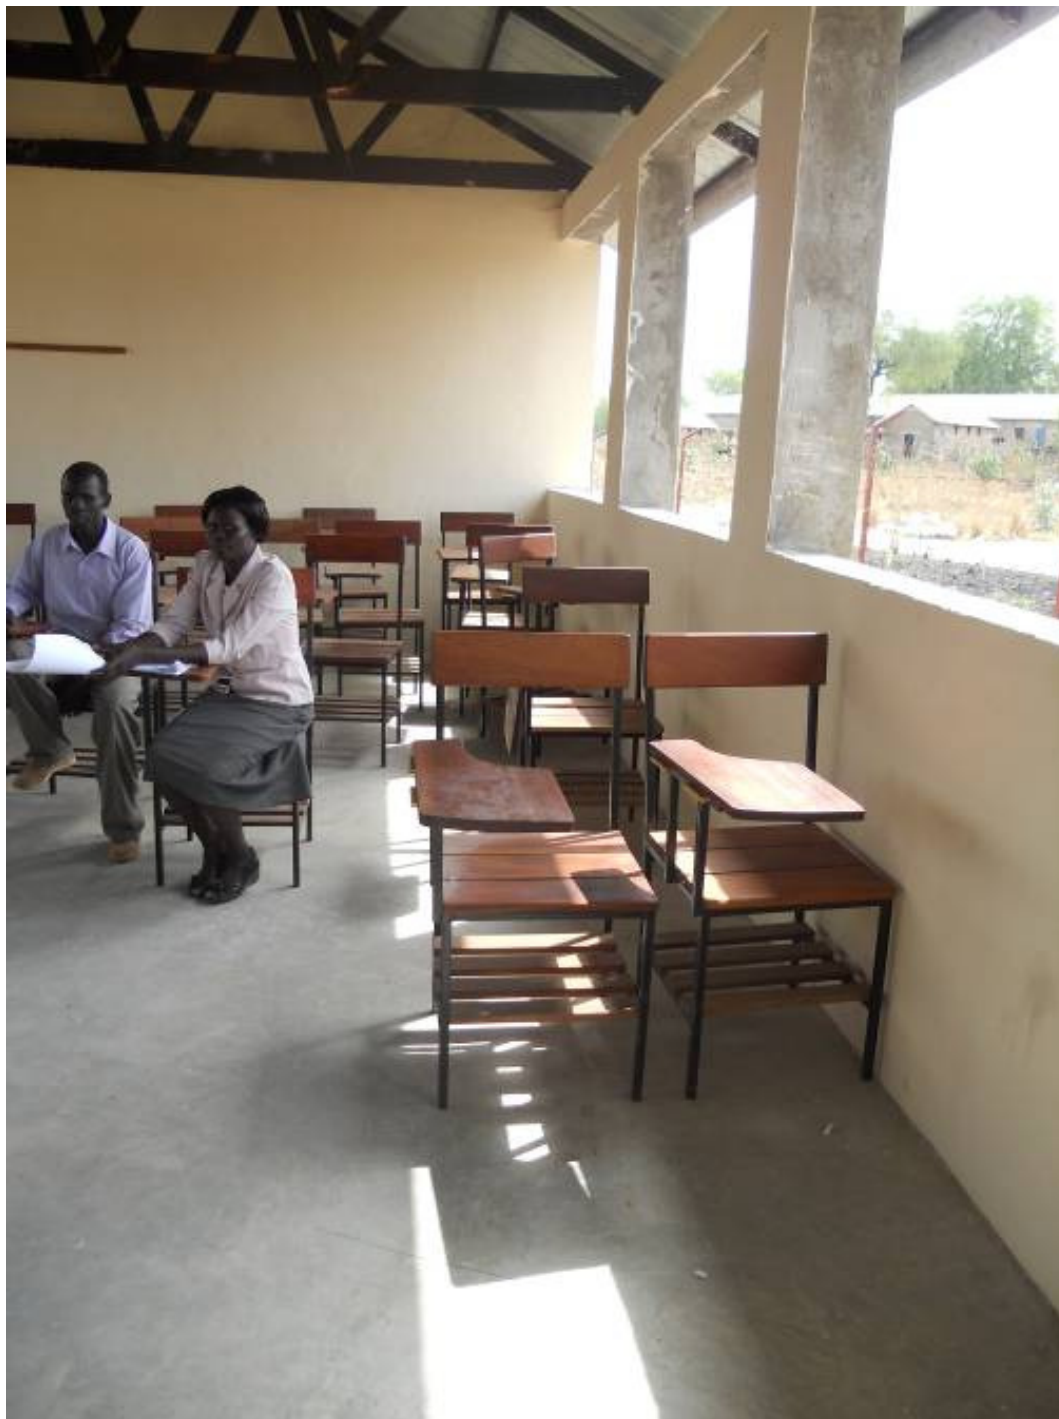
- the YEP Centre should have been oriented to face north/south in order to reduce solar gains. All buildings in the tropics should if possible be oriented

Plate 5 YEP classroom showing sun entering classroom in afternoon due to poor orientation

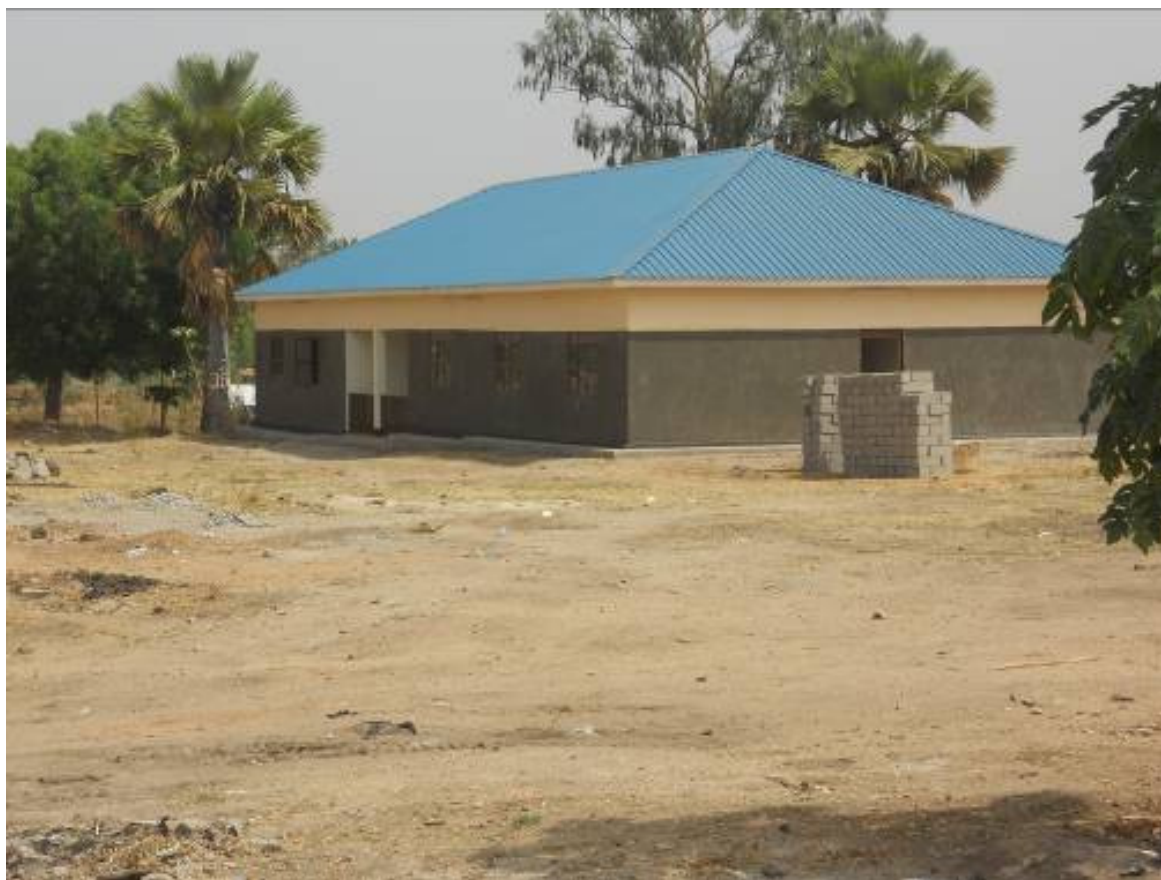
Plate 6 Dormitory showing lack of windows and poor design

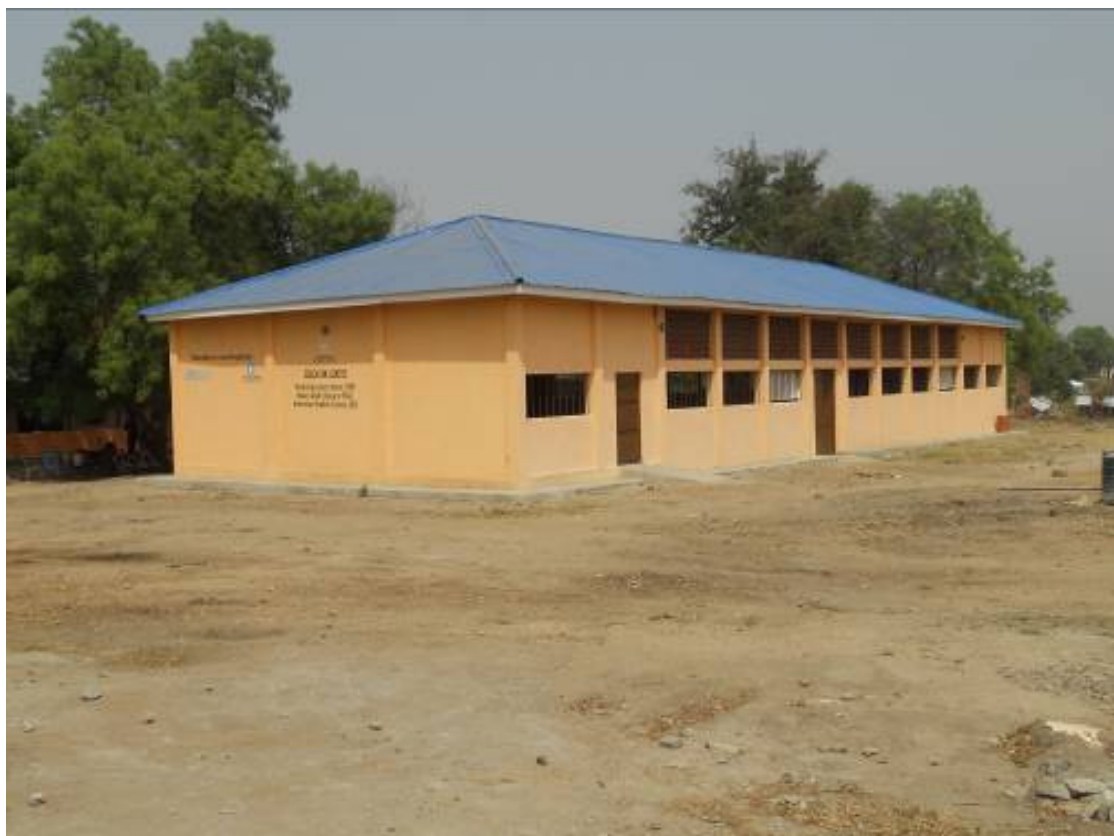
Plate 7 Central hall showing lack of protection to openings in walls

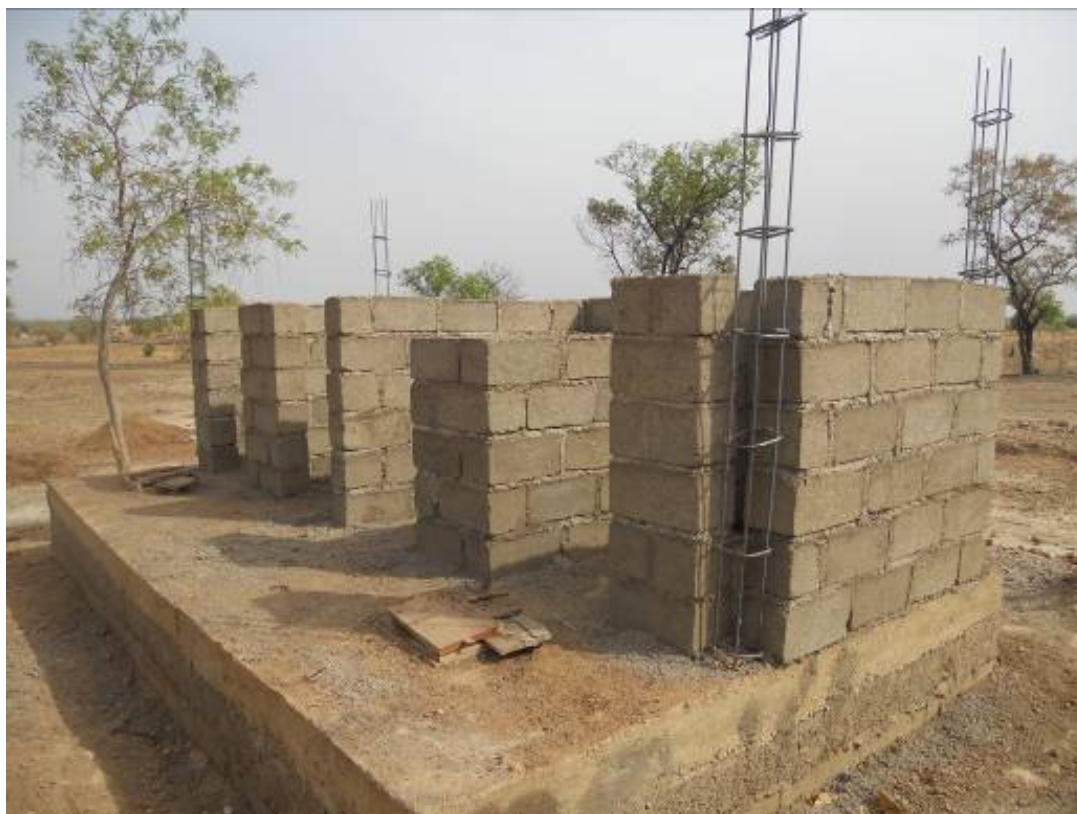
Plate 1 VIP latrines showing columns with no ties to block walls

Recommendations: omit all reinforced concrete columns and column bases. These are unnecessary and a waste of money. They also weaken the construction unless properly tied into the block walls.

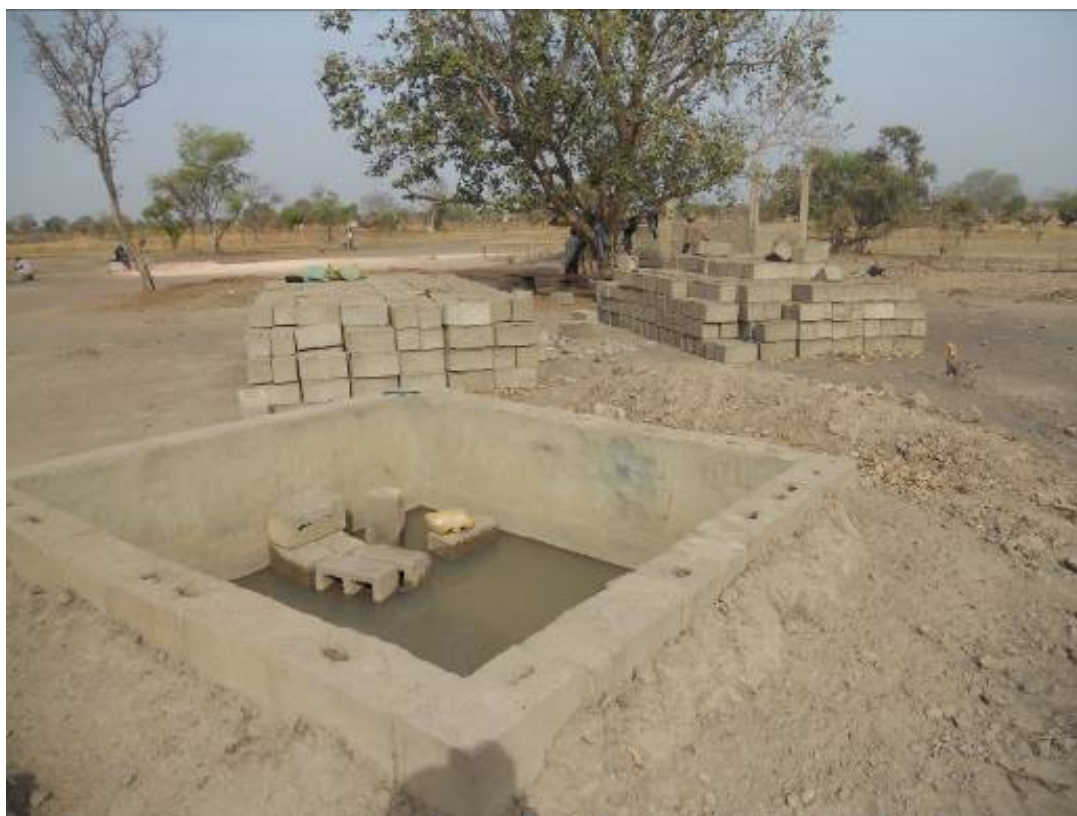
Plate 2 Blocks being made in the open with no cover and no chance therefore of being properly cured

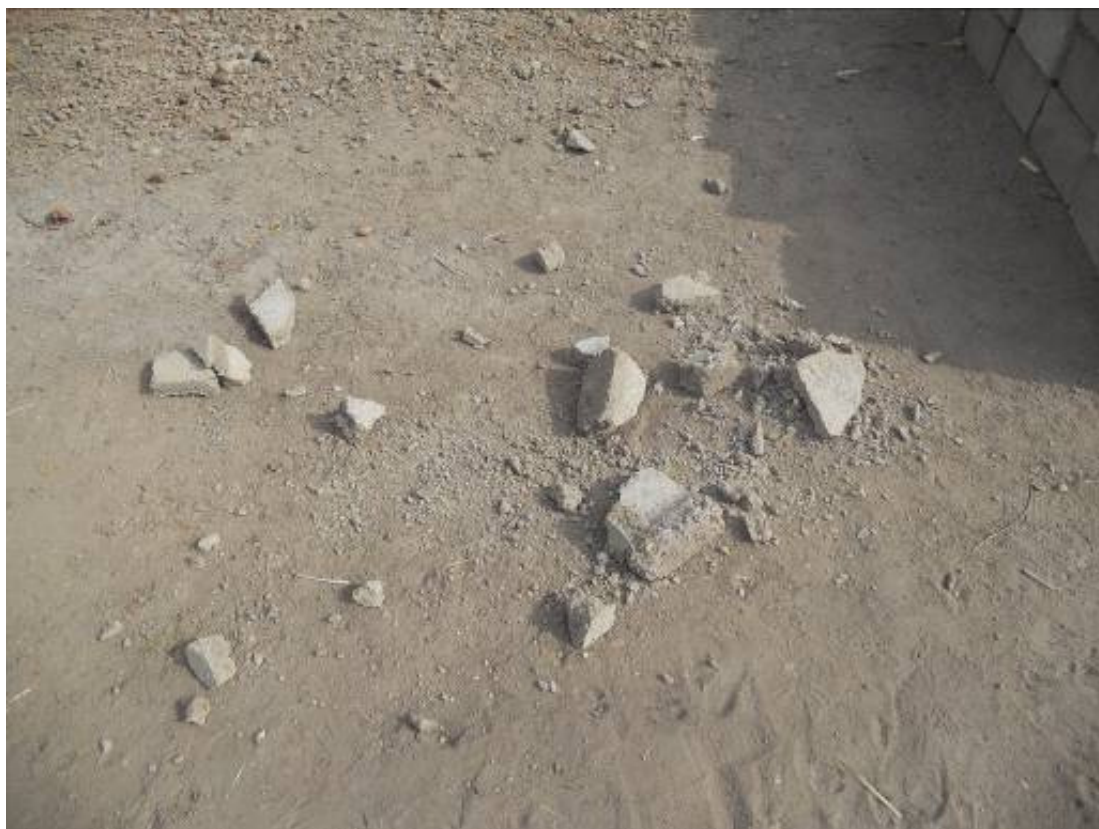
Plate 3 The result of inadequate curing; very poor quality blocks

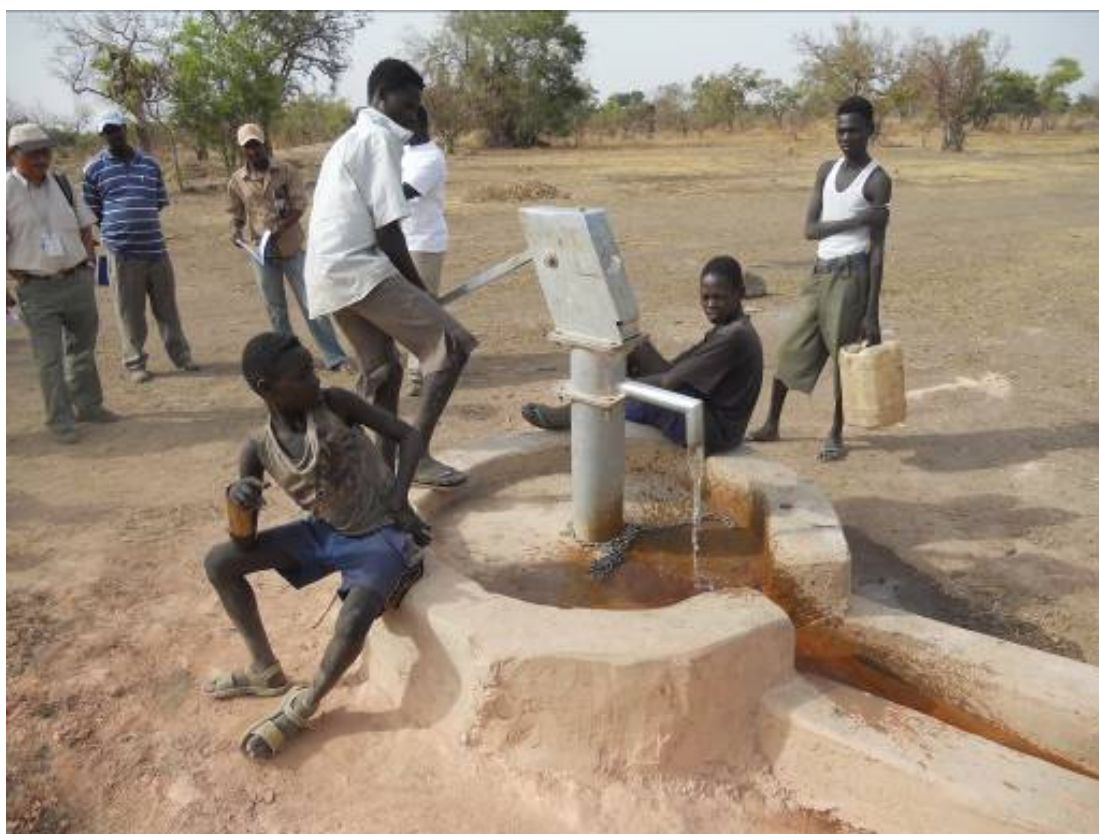
Plate 4 Borehole and pump complete and in action

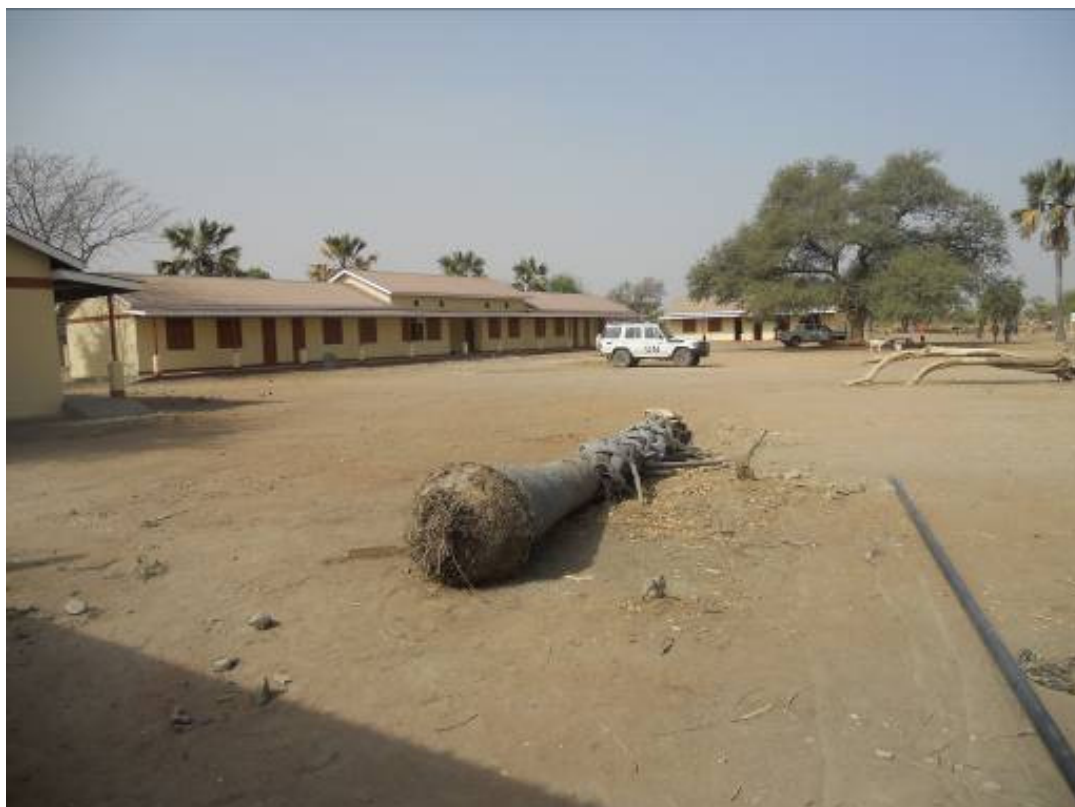
Issues: there were a number of design and construction issues. The general design issues are dealt with elsewhere in this report but it was noted that the administration building is oriented to face north/south but the classroom buildings are oriented to face east/west and will therefore be hot in the mornings and particularly hot in the afternoons.

Plate 5 General view of site showing classrooms facing east/west and good finishes to buildings

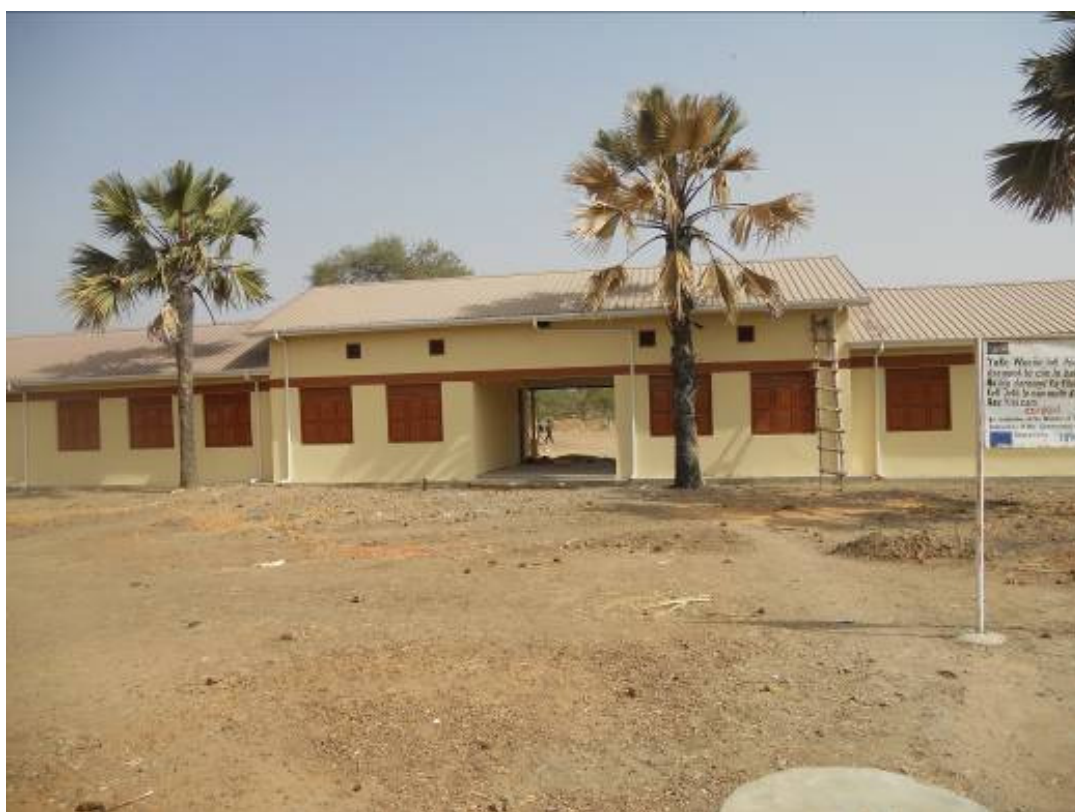
Plate 6 View of administration/classroom building showing raised central section of roof and good finish to building

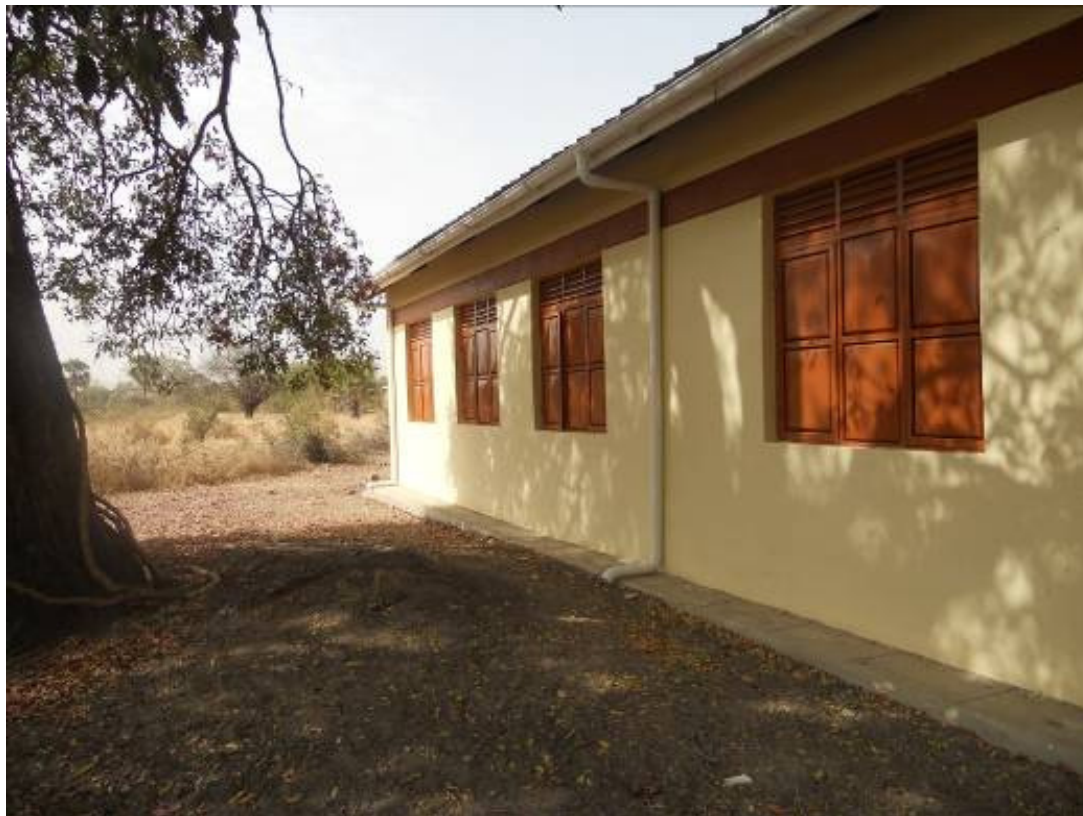
- Some buildings have been constructed very close to trees. If the crowns of the trees overhang the buildings this is likely to mean that the roots will be under the building (or will grow back if they have been cut off). UNOPS stated that the roots did not extend under the buildings but it is never a good idea to retain such large trees so close to buildings as even if the roots do not damage the buildings, leaves will collect on the roofs and can eventually rot the roof sheets. No trees should be allowed closer than 4 metres from any building and this distance should be greater for large trees.

Plate 7 View of classroom building showing tree very close to building; very small roof overhang and PVC gutter and downpipe

Recommendations: it is recommended that the water storage tanks and all of the gutters and downpipes are omitted. This is because: the amount of water that could be stored in the tanks is negligible given the length of the dry season and the tanks will be a breeding ground for mosquitoes; PVC gutters and downpipes rapidly go rigid in the tropics due to UV from the sun and are then easily damaged; the gutters will soon block up with leaves and dust and will also provide a breeding ground for mosquitoes. This again will provide significant cost savings and should also reduce the incidence of malaria around the schools.

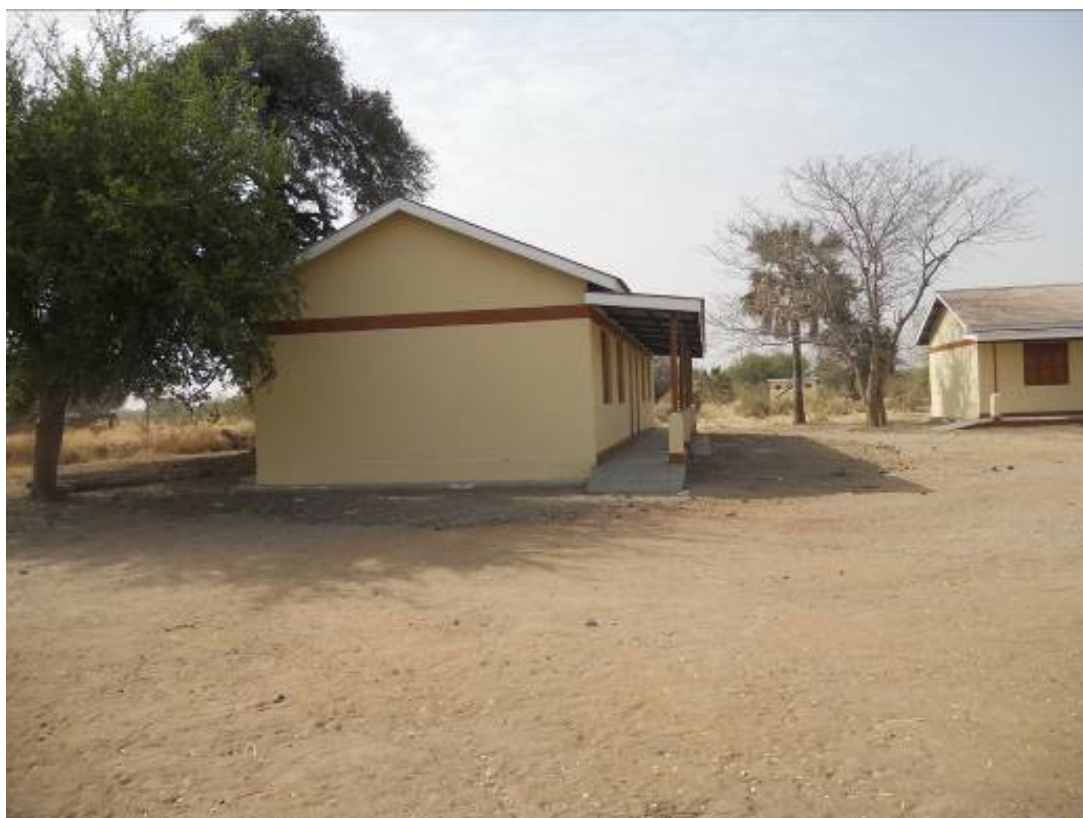
Plate 8 View of classroom building showing separate veranda roof and tree very close to building

Recommendations: The design of the veranda roof should be revised. The top members of the roof trusses (and the rafters at end and cross walls; see below) should be extended to support the veranda roofs and the ends of these members should be supported on the steel columns (the timber beam between columns should be omitted). The roof sheets should be supported on 50 x 100mm timber purlins spanning between the top members and rafters. This will greatly simplify construction and reduce costs and the roof sheets will no longer be in contact with the walls. The screed to the veranda floor should be omitted and the slab should be finished with a steel float. Expansion joints must be provided in the veranda slabs and ramps should be provided at the ends of the verandas with a maximum slope of 1 in 10.

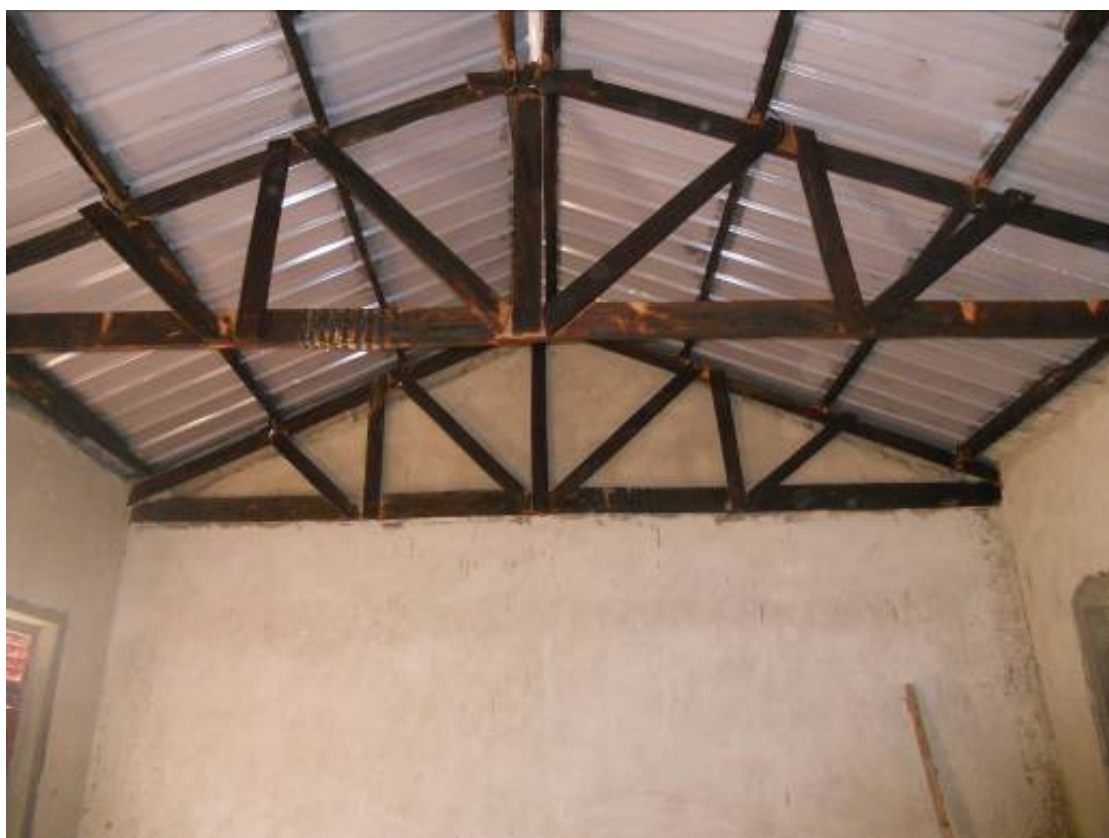
Plate 9 Poorly constructed and inadequately treated roof trusses

Recommendations: the sizes of the truss members should be reduced to 50 x 100mm and 50 x 150mm. The numbers of trusses in the secondary school classrooms should be reduced to 3No at 3.06 metre centres and in the primary

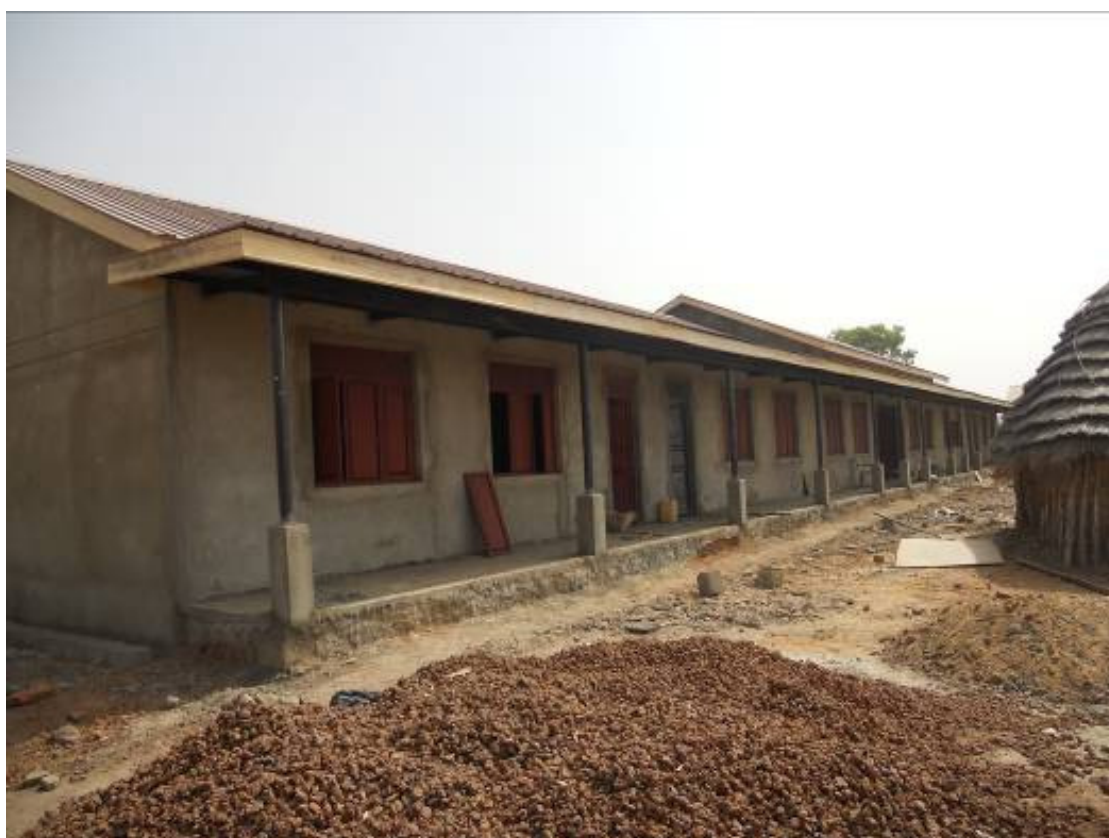
Plate 10 View of administration/classroom building showing almost flat veranda roof

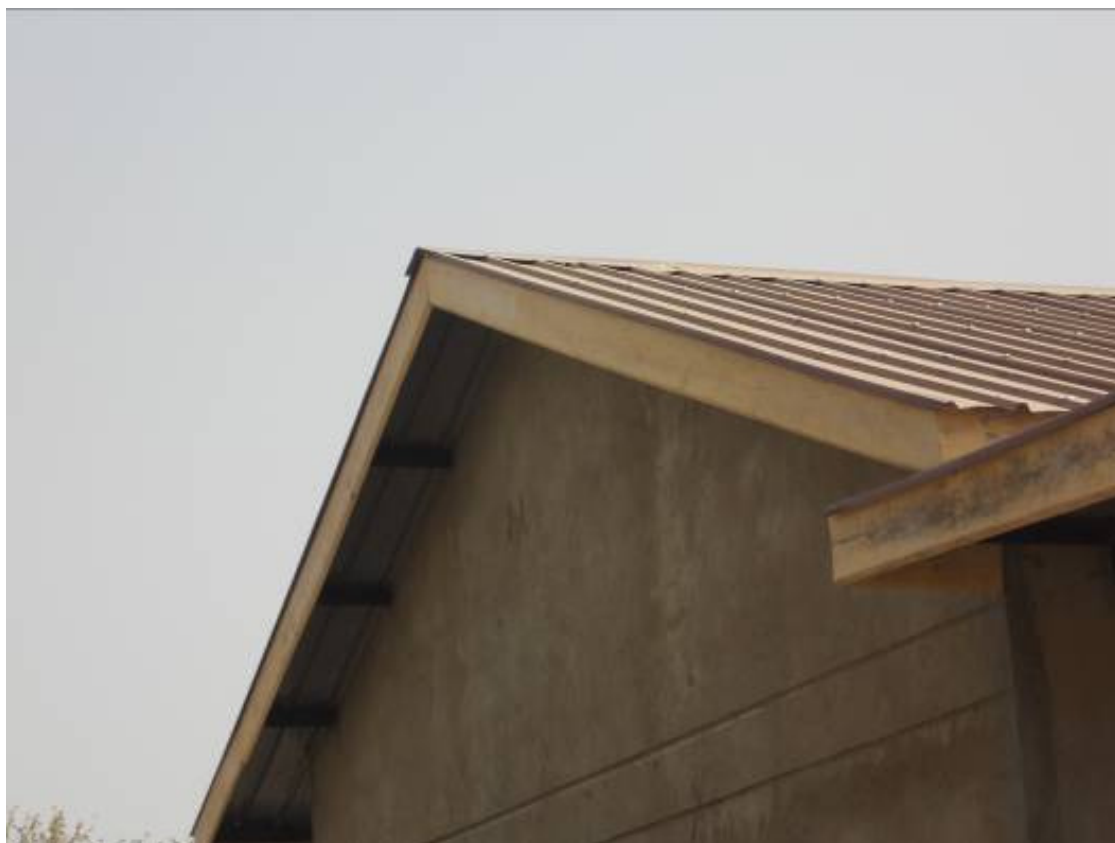
- The fixings to the end corrugations of the roof sheets were inadequate. The sheets had been nailed into the verge board which was only 25mm thick. The ends of the roofs are very exposed to winds on these exposed plains and the sheets should be securely fixed. The verge boards should be 50mm thick and the roof sheets should be fixed through the last corrugation into the verge board with roofing screws not ordinary nails.

Plate 11 Roof verge showing inadequate fixings to last corrugation of roof sheets

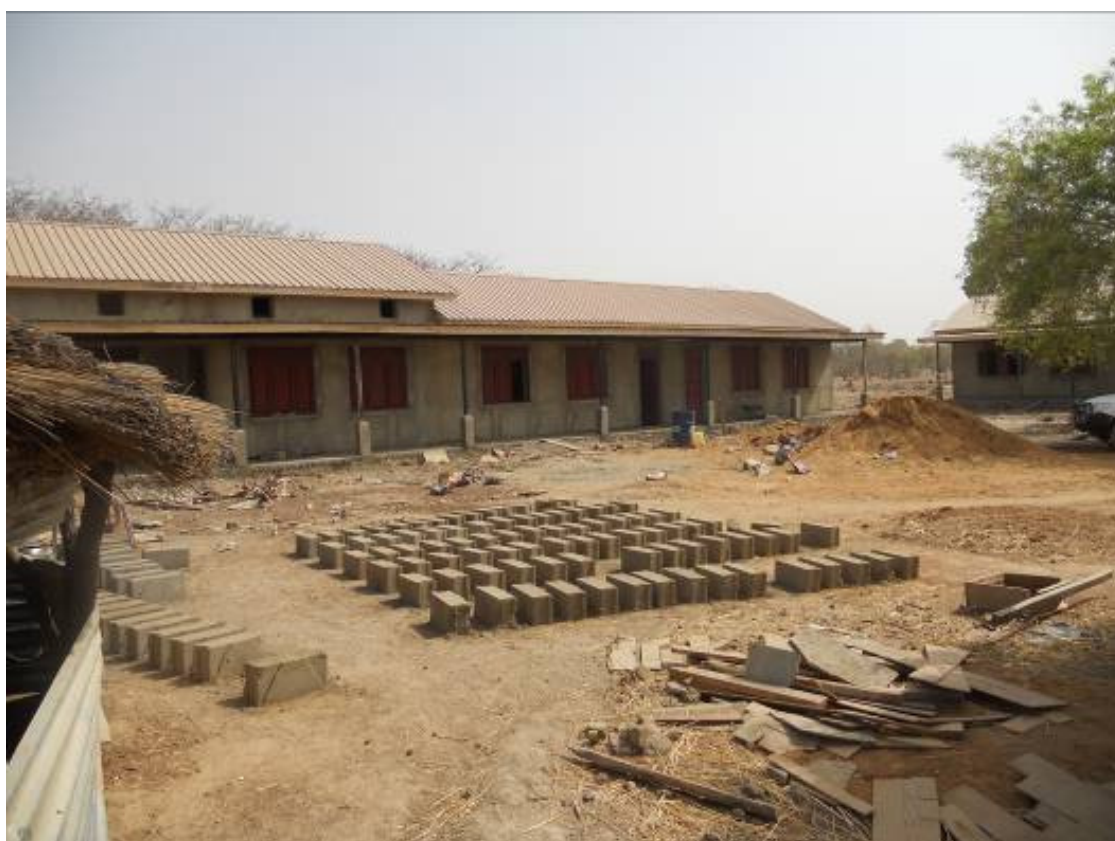
Plate 12 More blocks drying too quickly under the sun

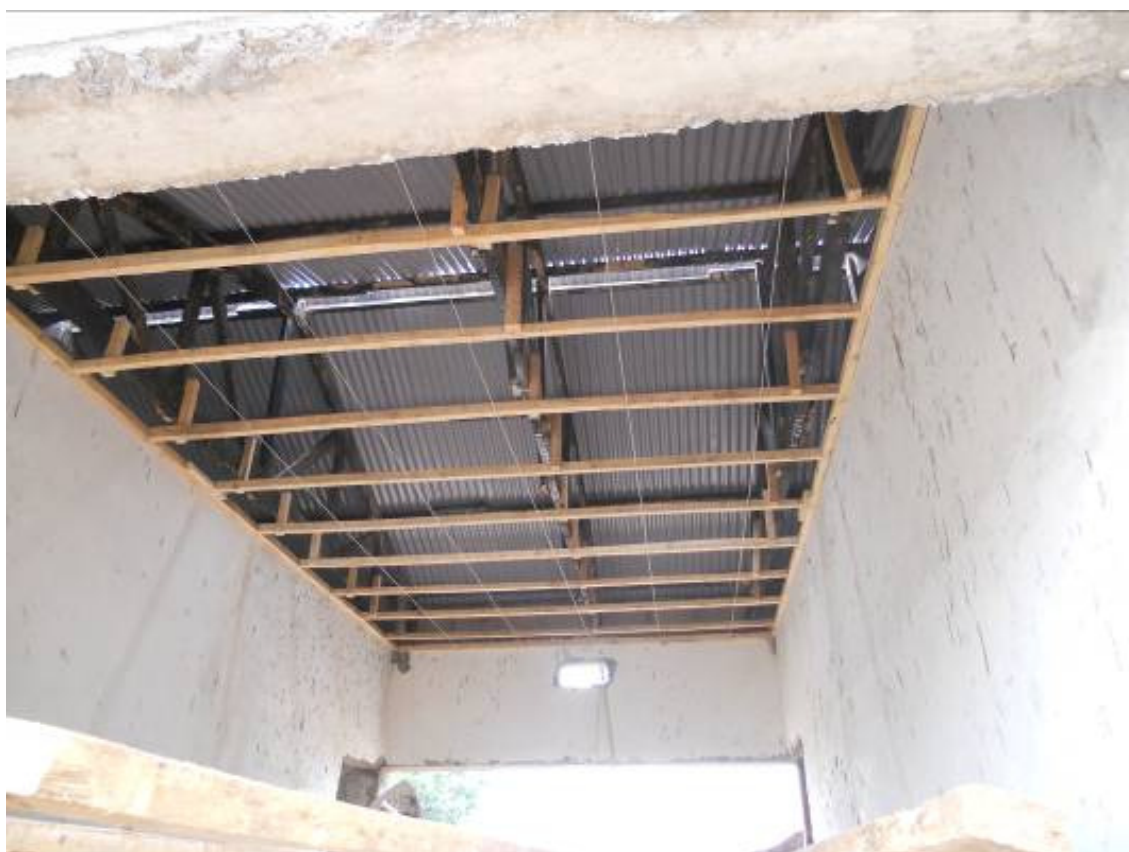
Plate 13 View of untreated ceiling framing under inadequately treated roof trusses

Recommendations: it will be more cost-effective to fix the ceilings directly to the roof purlins to form sloping ceilings. This will reduce the amount of timber required in the ceiling framing; it will increase the volume of the rooms and make them more comfortable and it will also allow the height of the outside walls to be reduced by one block all round. All these measures will provide significant cost savings.

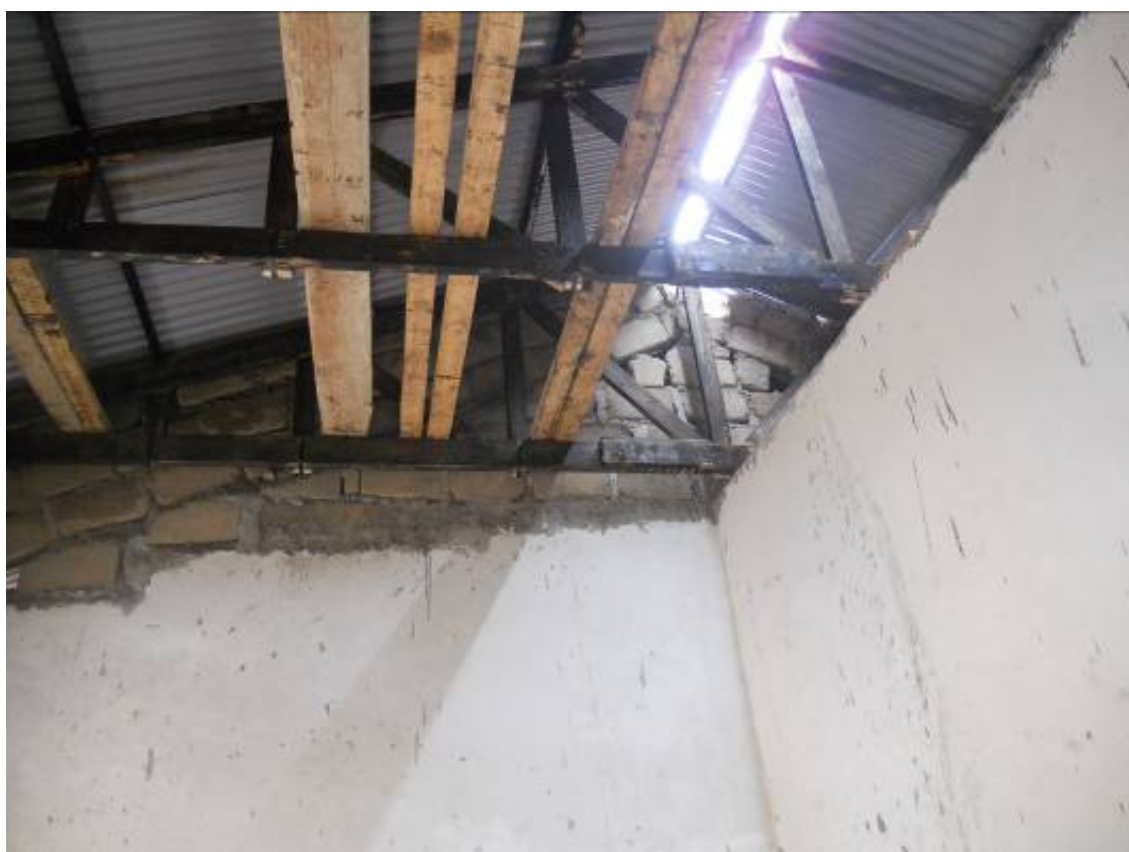
- The fixings to the end corrugations of the roof sheets were again inadequate and the comments under the above school again apply.
- Roof trusses have been fixed against end and cross walls in all buildings where they are not required. The joints to the bottom members of the trusses have been fixed with flat steel tape nailed to the members. These joints would be stronger if they had been fixed with timber battens to both sides as the tape will probably stretch.

Plate 14 Badly built cross walls and inadequately treated roof timbers
