DFID South Sudan Education Programme Construction & Rehabilitation of Education Facilities

Construction Review

Nigel Wakeham, Consultant Architect

March 2012

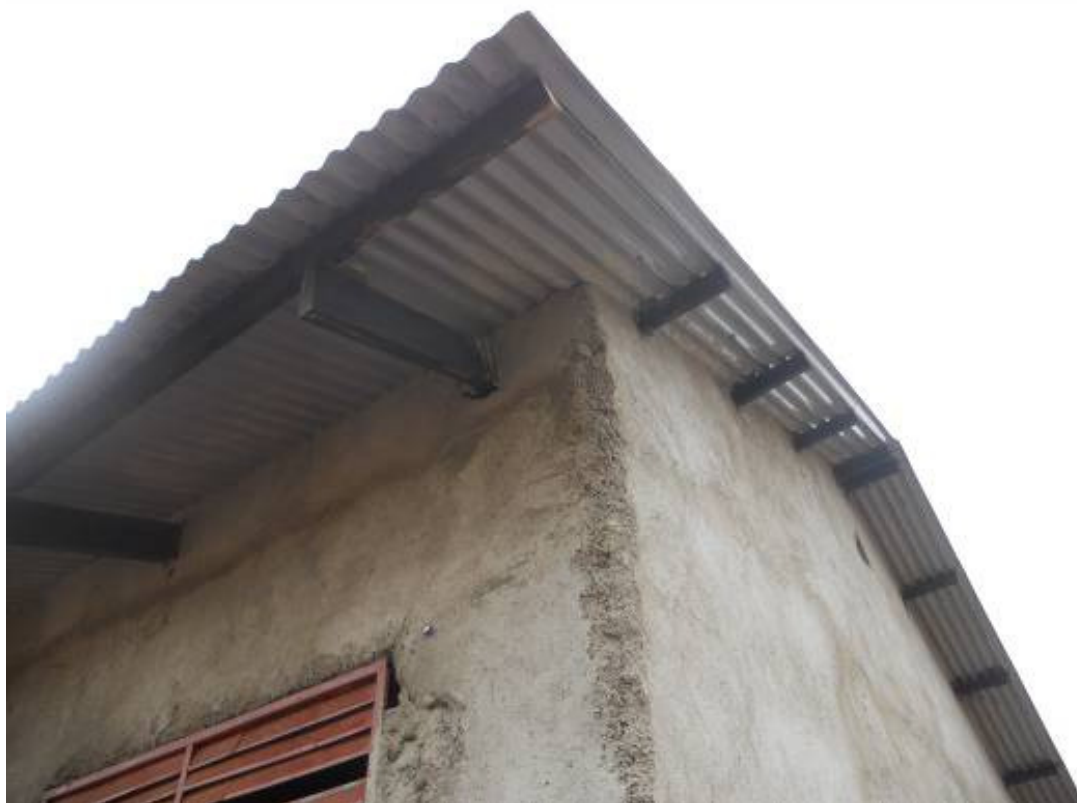
- The roof sheets along all sides of the buildings are in contact with the render to the walls. This is a very poor detail as the cement in the render will when damp attack the roof sheets and eventually rot them. Cement: sand render must always be kept from coming into contact with roof sheets. The same comment applies to all of the schools.

- There were no fixings to the end corrugations of the roof sheets but if the standard verge boards which are only 25mm thick are fixed then the fixings will again be inadequate.

Plate 15 View of roof sheets showing render in contact with sheets and problems with fixing last corrugation of end roof sheets

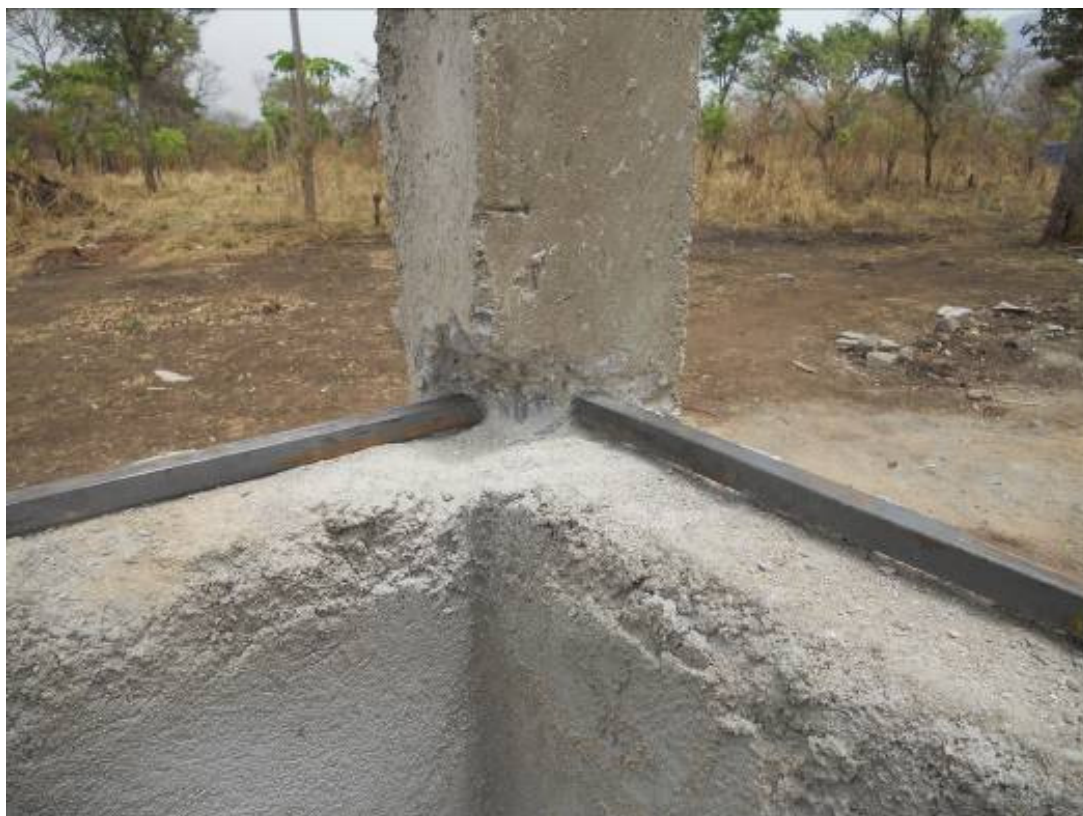
Plate 16 Columns to kitchen cut into at base for steel frames
