**MINISTRY OF PUBLIC WORKS AND TRANSPORT**

**PERFORMANCE MONITORING  
OF  
THE NEC-ADB PACKAGE I  
TRIAL AND GRAVEL ROADS**

**SEACAP 17.02**

**FINAL REPORT  
JUNE 2009**

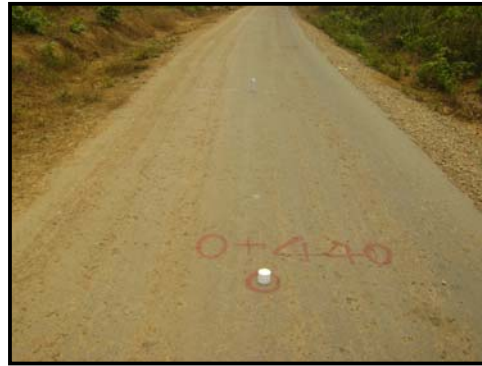
Figure 4.1 Defects in Otta Seal – possibly construction related

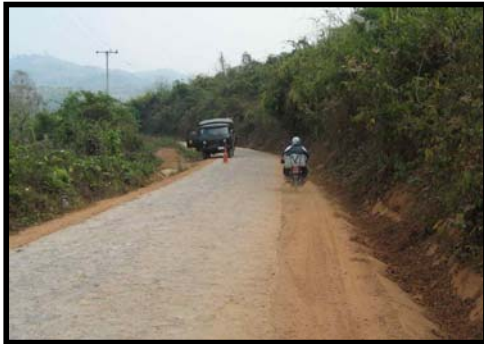
4. It was evident that because of the roughness of these options the local two-wheeled traffic was using the gravel shoulder rather than the carriageway. The result is a significant deterioration of the shoulder and an undercutting of the carriageway edge. Figure 4.4

Figure 4.4 Traffic using shoulder rather than rough carriageway

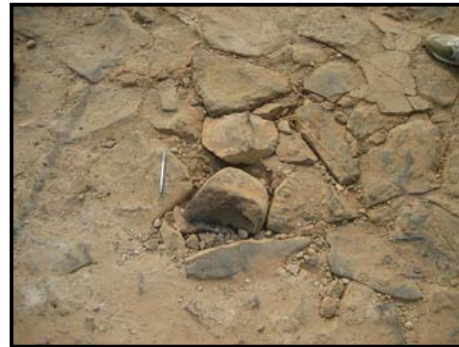
1. The visual appearance of both these option is poor and the evident roughness of surface is reflected in the high IRI figures. In the case of the non-mortared option the surface has evidently deteriorated significantly since construction. Figure 4.3

2. The non-mortared option shows a significant DCI of 40% surface condition with stone and inter-stone matrix conditions between 20-30% DCI.
3. The mortared option shows a similar figure for surface condition and matrix but a much better figure for stone condition (10% DCI), which may either reflect better selection of stone or that the mortared matrix is giving better support to the larger stones.

Figure 4.3 Rough stone surface

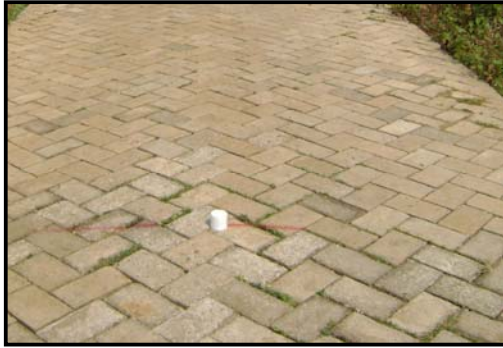
1. The principal deterioration issue is erosion of the unsealed sand joints - with an individual DCI of 30%, Figures 4.7 and 4.8
2. There is however a surprisingly high figure for cracked or broken blocks (DCI 15-20%). This is high in comparison with similar pavements in Vietnam which would suggest that the Bokeo concrete blocks could be below specification as regards strength.
3. The decrease in roughness probably reflects a bedding-down effect on the blocks in the sand bedding layer.

Figure 4.7 Grass growing within joints may loosen blocks

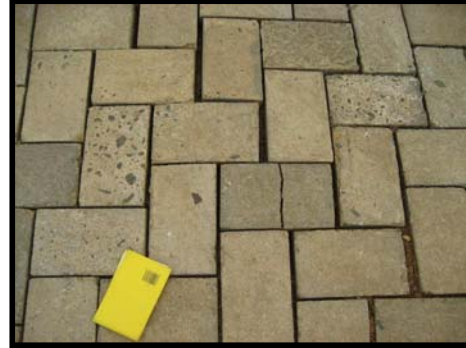
Figure 4.6 Eroded badly spaced joints. One cracked block

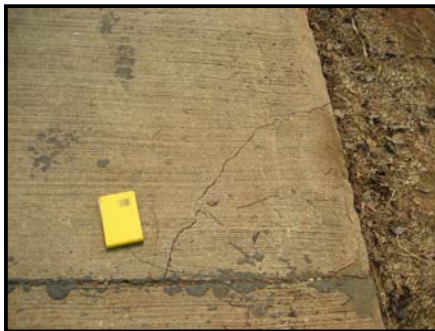
1. The pavement blocks are performing satisfactorily with only isolated cracks – typically at the edge of blocks. Experience from elsewhere indicates that erosion or soaking of the gravel sub-base can sometimes lead to cracking under load. Figure 4.8
2. The inter-block seal condition is shown separately as a significant deterioration factor that should be dealt with easily by routine maintenance.

Figure 4.8 Typical corner edge crack in concrete slab

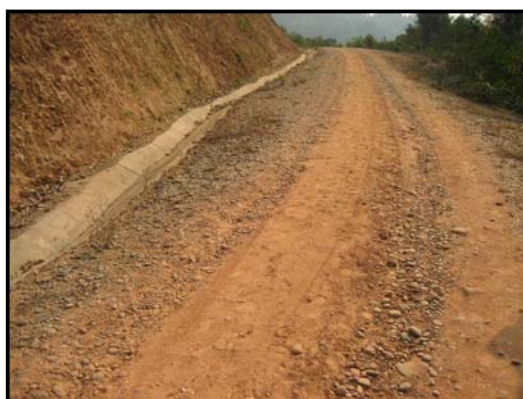
1. On the assumption that the roads were constructed to the specified 6-7% camber, then after just under 2 years all road sections are now below the required shape requirements.
2. On high gradients 30% of the NEC roads are significantly below shape, Figure 5.3
3. 75% of the non-NEC road sites were recorded as having a cross sectional shape incapable of effectively shedding surface water. The implication is that there is no effective maintenance procedure in place to maintain shape

Figure 5.3 Eroded gravel on steep section of NEC package II road 201. Shape prevents run-off into well constructed drain
