MCTPC - SEACAP 21/003 - DFID

**MAINSTREAMING SLOPE STABILITY MANAGEMENT INTO
THE NATIONAL UNIVERSITY OF LAO COURSES AND THE MPWT**

TERMINAL REPORT

January 2009

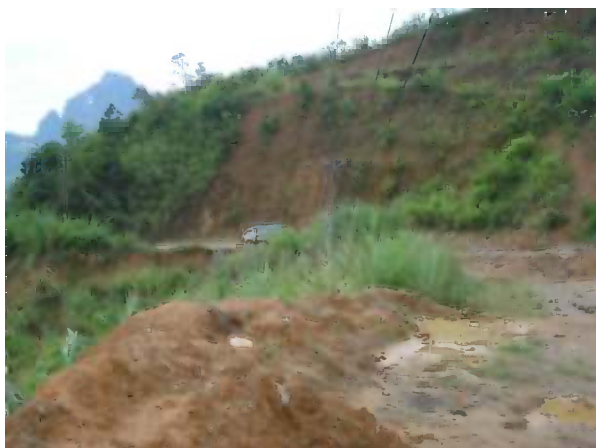
Landslide site at km 239.3

This is a pre-existing landslide with a toe in the stream channel below and a current head at original road level. It is likely that the failure was originally precipitated or aggravated by the placement of fill on the slope as a result of original road construction and, more lately, spoil disposal.

The present failure occurred during the 2008 wet season and appears to have regressed from the lower slope headwards, ultimately removing all support to the road over a distance of 60m or more.

Field observations indicate that failure at the top of the slope above the stream channel is active, probably even in the dry season. From the limited ground investigations undertaken it appears that most of the slope comprises a thickness of gravelly clay (fill material) and possible previous landslide debris overlying a silt/clay material, which is interpreted to be derived from in situ weathering of the underlying rock.

The earlier engineering response to this landslide has been to realign the road progressively into the hillside. The recommended measures are to construct a mortared masonry retaining wall on the outside edge of the road, founded on intact material beneath the failure surface. The horizontal alignment for the road should be as 'tight' to the existing cut slope as possible. It is anticipated that the depth of this wall should be up to 6m below original (pre-current earthworks) ground level, to as little as 2m – 3m in the vicinity of the trial pit locations. Removal of soil and fill from the landslide head should lead to an overall improvement in the stability of the slope below. It is recommended that visual monitoring of the alignment is carried out immediately up (239+430) and down chainage (239+250) as the movements below the road extend into these areas as well. It will be important to ensure close geotechnical supervision during construction in order to derive final designs and founding depths.

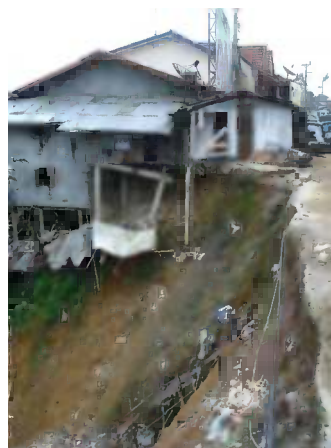
Landslide site at km 257.1

This failure occurred during the 2008 wet season in the centre of Phou Khoun. The road edge was previously retained by a masonry wall, which has collapsed into the gully below. There is a culvert outlet at this location and it is anticipated that scour beneath this outlet originally led to loss of support to the wall and its eventual failure. There is also a water supply pipe that runs across the slope, and it is understood that leakage from this also contributed to the problem. Failure of the wall has led to exposure of the road edge over a distance of approximately 15m.

Early considerations here were for a reinforced concrete cantilevered road retaining wall. Depending upon materials ultimately exposed this wall would require an exposed height of up to 7m, plus foundation, though it is likely that the required height could be significantly less than this. If this option is taken up then it will be necessary to carry out in situ testing of the ground for bearing capacity confirmation.

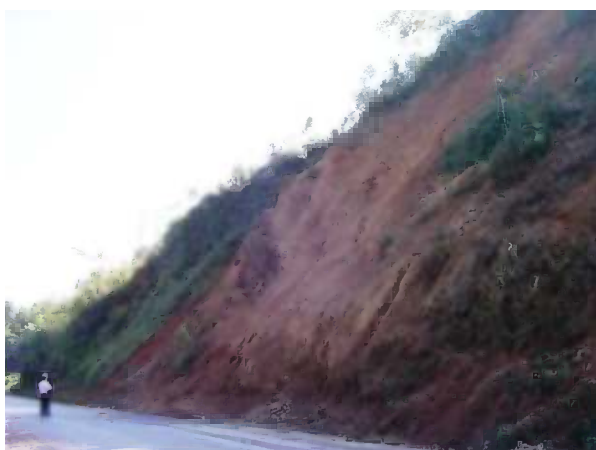
Landslide site at km 257.9

This is a cut slope failure in weathered and closely jointed phyllite. The failure depth is shallow and the slope is steep (up to 1:1 in places). The lower part of the slope is covered in slide material from above, and appeared damp during the 21/003 site inspection. There is therefore likely to be a significant source of water which will aggravate instability. Above the cut slope there is a break in slope. Inspection of this slope revealed evidence for additional instability, possibly ultimately related to the cut slope failure below. Given the uncertainty, however, it is recommended that efforts are focussed on the cut slope only. It is recommended that this comprises a 3m high, 40m long composite masonry revetment. Debris clearing and trimming from the slope in general should take place prior to constructing this wall and bio-engineering applied to the final slope.

km 257.9	108031/DWG/301 108031/DWG/302	Clear existing debris within the failed area and trim back any back or side scarps to a smooth profile. Construct 3m high, 40m long composite

masonry revetment at the toe of the slope. Plant three lines of brush layering immediately above the revetment. Elsewhere within the trimmed area plant grass slips at the spacing shown on the drawings. Reconstruct the roadside drain at the base of the revetment.
km 317.9	108031/DWG/401 108031/DWG/402	Construct 60m long gabion retaining wall as close to the base of the existing cut slopes making due allowance for the road width. Wall likely to be founded up to 6m depth but could be less than this towards each end. It is very likely that good ground conditions may not exist within the central section of the wall, but a greater depth of wall is not recommended unless it is certain that better stable conditions are no more than 1 - 2m lower. The wall dimensions should be as those given in the Slope Maintenance Manual, drawing SMM/DWG/002. On the valley side of the new wall the fill should be removed from site and disposed of at a safe stable location. It must be emphasised that the wall only provides a temporary solution, and that in the long term, wall movements can be expected to occur.

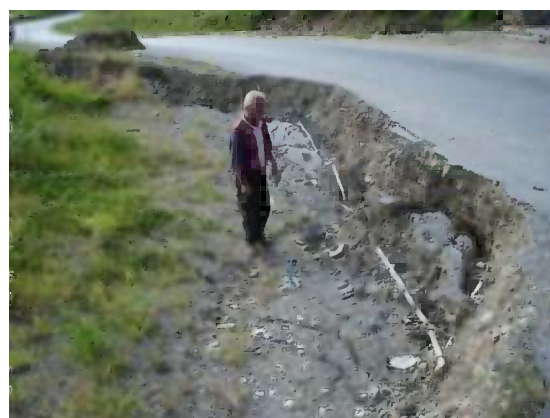
Landslide site at km 317.9

This is a large landslide that extends from the stream channel below the road to the hillside above. There is every indication that this landslide has been in existence for many years. The road had been realigned further into the hillside prior to the commencement of 21/001, but in recent years it is apparent that movements have continued and the road continues to fail. In 21/001 the extent of this movement was recognised and some surface improvement works and monitoring was carried out. The ground movements have continued and some of these works have been damaged as a result.

During 21/001 three boreholes were put down. These found landslide and fill material but were inconclusive in terms of identifying the failure plane. A makeshift inclinometer was installed in one of these holes and readings implied shallow movement at a depth of approximately 2.4m below ground level. This is interpreted to be movement on a shallow surface, above the main landslide movement.

During 21/003 further field observation have been made and it is confirmed that the slopes below and above the road are continuing to fail. Movements on the slopes above the stream channel below the road are particularly active.

The driving force for this movement is anticipated to be toe erosion (at least in terms of precipitating the original failure), slope steepness on the lower slope, weak material on the sliding surface (as yet unconfirmed) and groundwater, given the large catchment area above. The placement of fill and spoil on the slope may have aggravated the instability.

The recommendation at this site is to construct a gabion retaining wall to a depth of up to 5m. This should retain the road against shallow failure but cannot be founded beneath the ultimate failure surface that might be of the order of 10m based on field observations (ref drawing 108031/DWG/401). Consequently, the wall will provide some temporary support to the road but may ultimately fail. It will be important to ensure close geotechnical supervision during construction in order to derive final designs and founding depths.

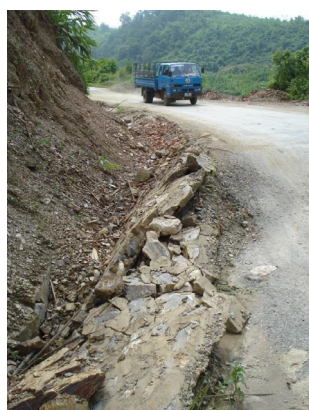
Landslide site at km 336.4

The section of road between 336+295 and 336+330 has been undergoing deep seated movement since before SEACAP 21/001 began in October 2006. Boreholes were put down on the outside edge of the road but these were inconclusive in terms of failure depth and materials. The interpretation at the time of 21/001 was that the failure had been precipitated as a result of the steepness of slope, the extremely disturbed nature of the underlying rock (as exposed in the cut slope) and possibly, originally, toe erosion in the river below. The rock appears to be particularly weak and tectonically disturbed. The conclusion of 21/001 was that a solution at this location would be expensive and would probably comprise the extension of the existing culvert at 336+220 downstream to a point where it would have enabled a fill slope to be constructed above it, thus providing support to the slope above. Such a solution would need careful investigation and design were the funds to be available. The 21/001 works were only therefore aimed at carrying out monitoring and superficial slope improvement and drainage works.

During 21/003 fieldwork it has become apparent that the extent of slope instability has increased significantly. This increased instability comprises a slow failure of the entire cut slope between 336+230 and 336+330. It is apparent that this failure has daylighted in the toe of the cut slope because the side drain is pushed forward in many places. The road between 336+230 and 336+295

is not yet showing any signs of disturbance, which supports this interpretation. The hillsides above the road are also failing in association with the cut slope instability described above. The majority of this movement appears to be fresh, i.e. indicative of first-time movement, though there is evidence of weathered scarp slopes indicative of previous movement.

Given that the only permanent solution would be to realign the road away from the cut slope into the valley on the top of a substantial culverted fill slope, and in view of the significant cost of carrying out such works, the recommendation here is to accept that movements of the road will continue to occur and to make adequate provision for maintenance that might include regular reinstatement of the road surface and the roadside drain, as well as minor cut slope trimming.

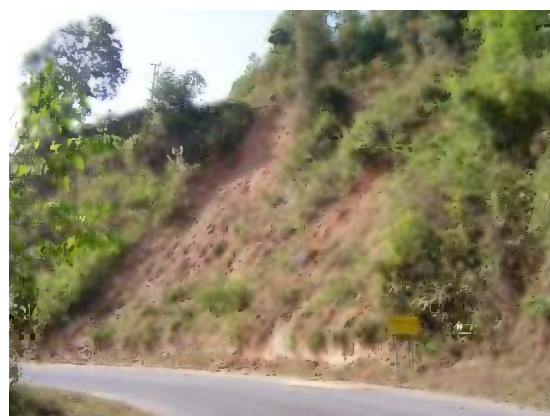
Landslide site at km 341.2

This is a slope located between two sections of road joined by a hairpin bend. Shallow instability (probably 1-2m deep) has occurred over large parts of the slope over a road distance of approximately 50m. The instability has taken place predominantly in the upper slope and this has extended back to the edge of the side drain to the upper road in two main locations. The scars associated with these features are approximately 8m and 5m width respectively. If this process is allowed to continue then the edge of the road itself will itself fail. The debris from these failures has overtopped the revetment wall to the road below and material is in the side drain.

The side drain to the upper road section on the outside edge is surplus to drainage requirements and it is recommended that it is filled in. This would allow walls to be constructed in masonry to the edge of the road on the upper section. These walls should be constructed in masonry and founded on in situ rock beneath the fill that currently comprises the upper slope. Once this is done and the material has been trimmed, the resultant slope below the walls should be protected with hand-applied shotcrete down to the level of the steep break in slope below. This should be sufficient to protect the upper section of road. For the section below, it is recommended that all loose material be cleared and the slope protected with bio-engineering. If, in this process loose intact rock is exposed in places, then this can be protected with either hand-applied shotcrete or masonry revetment.

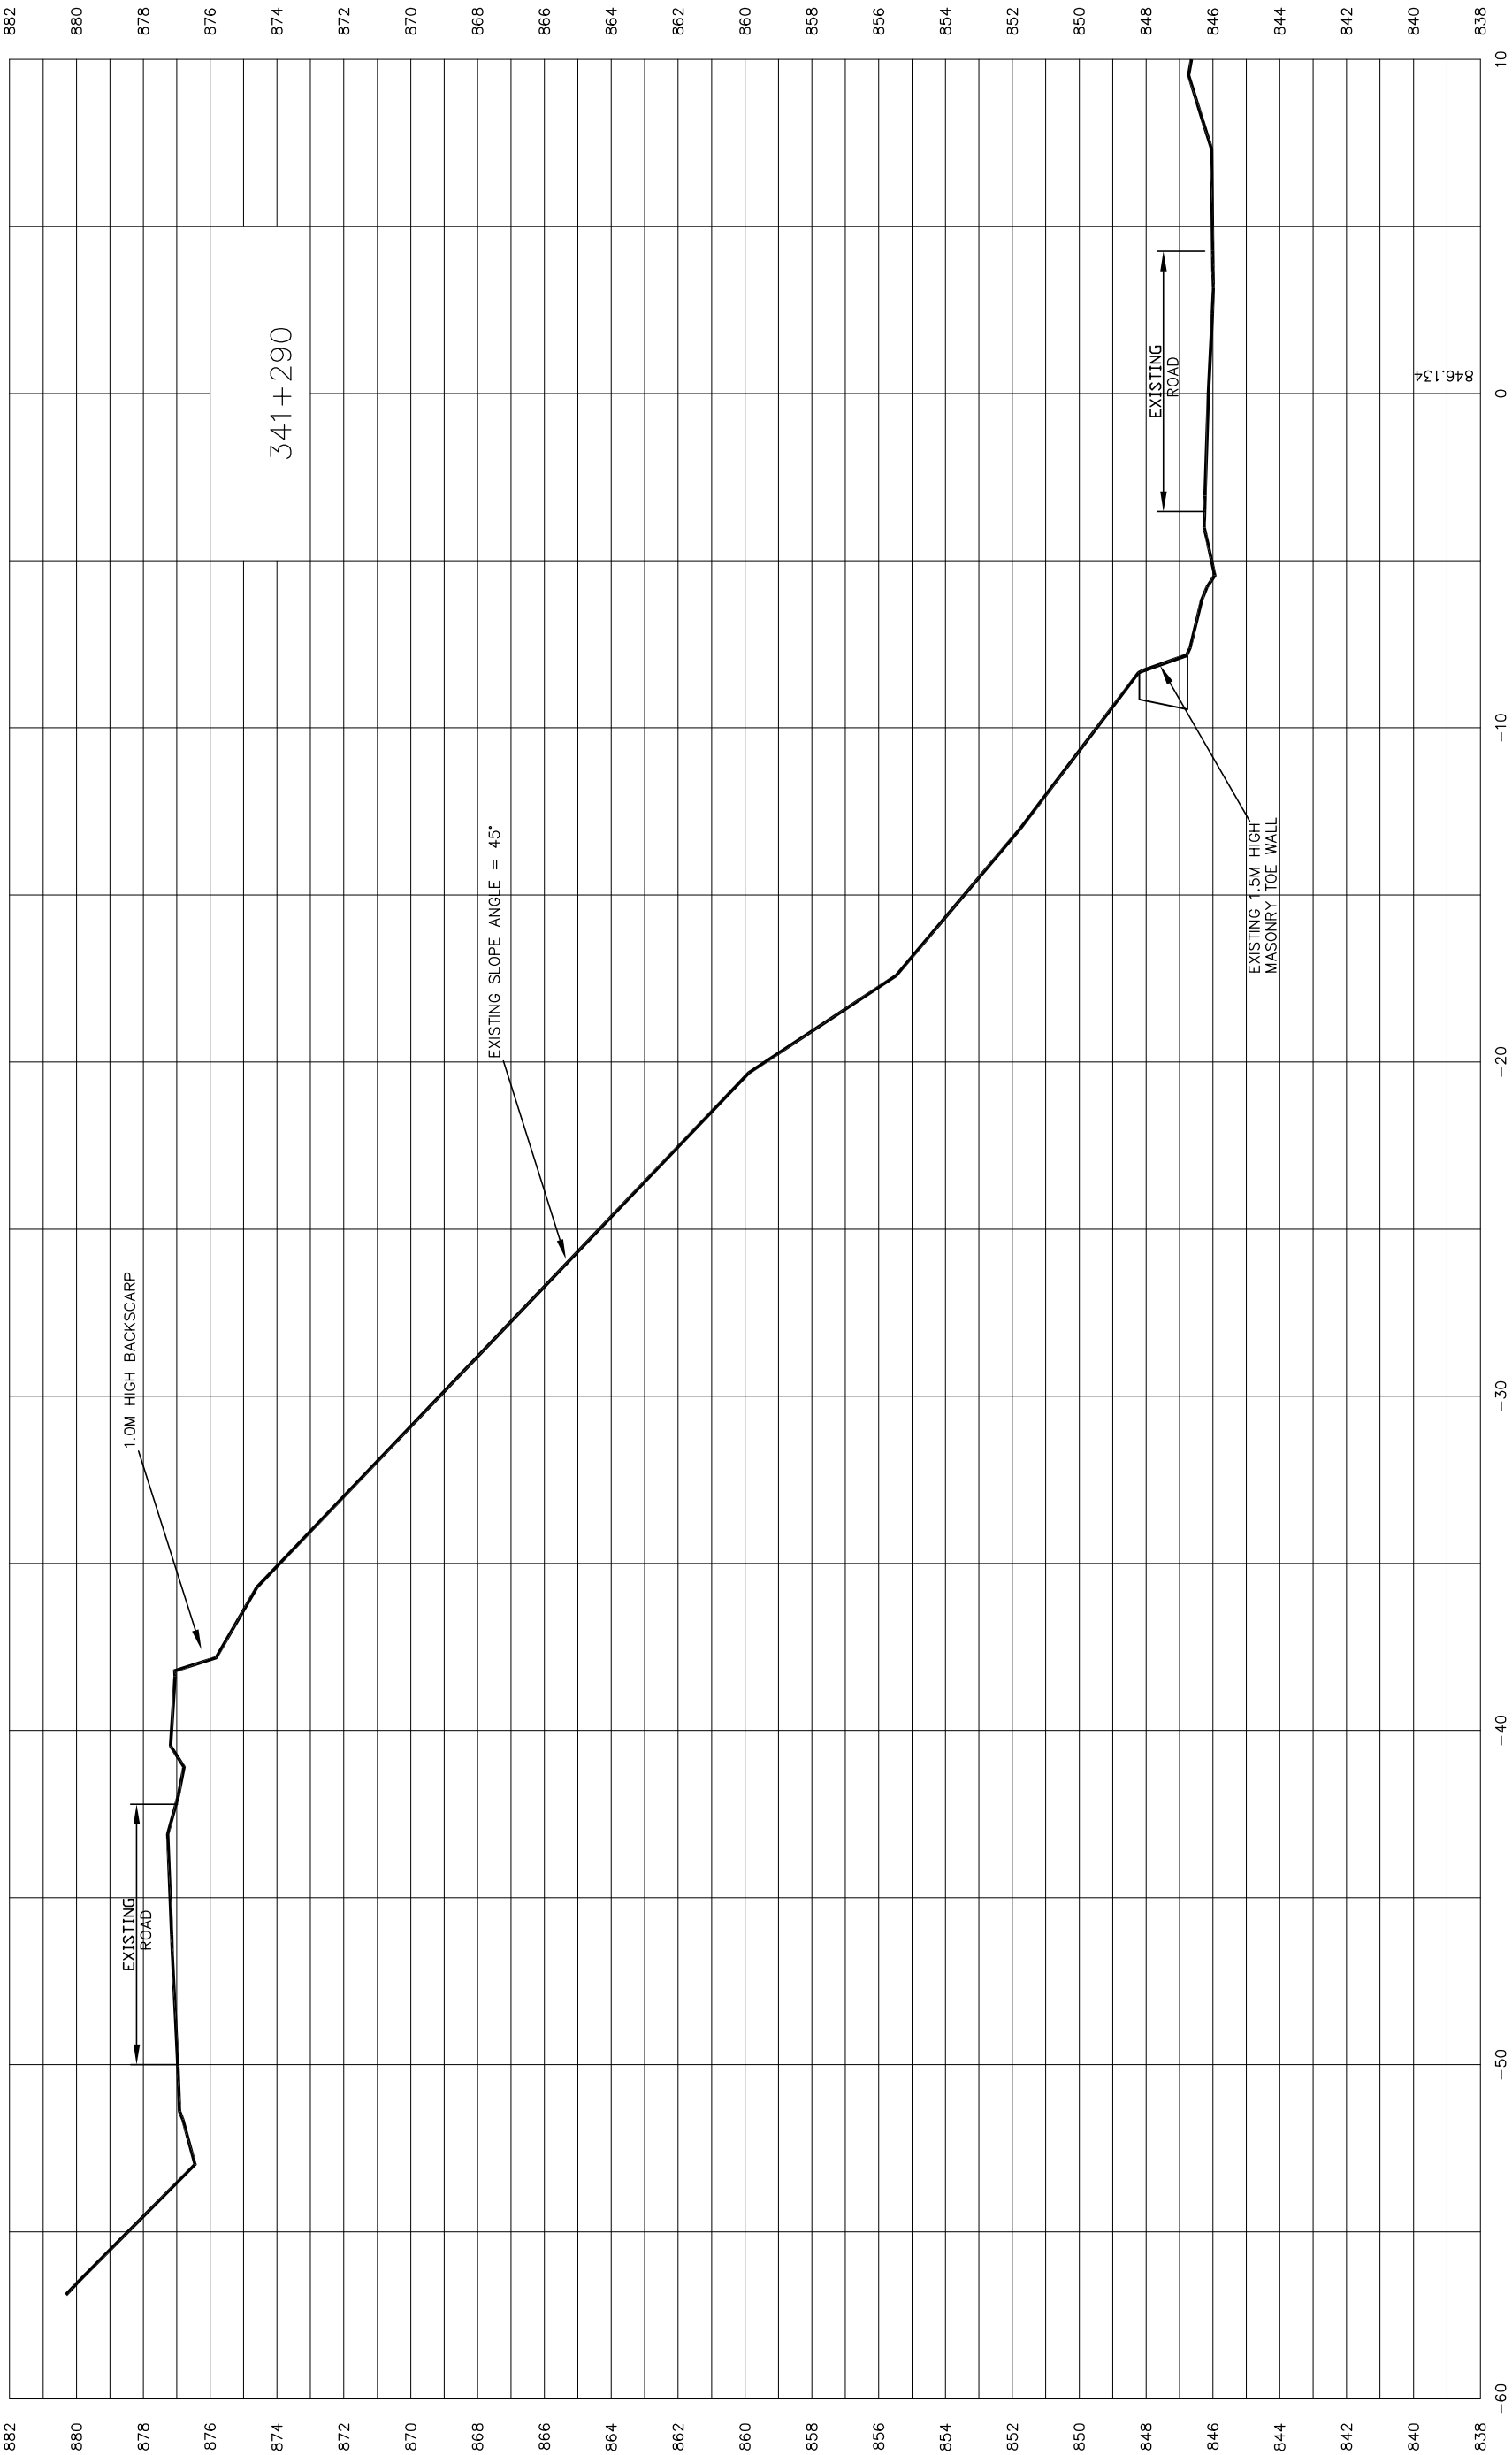
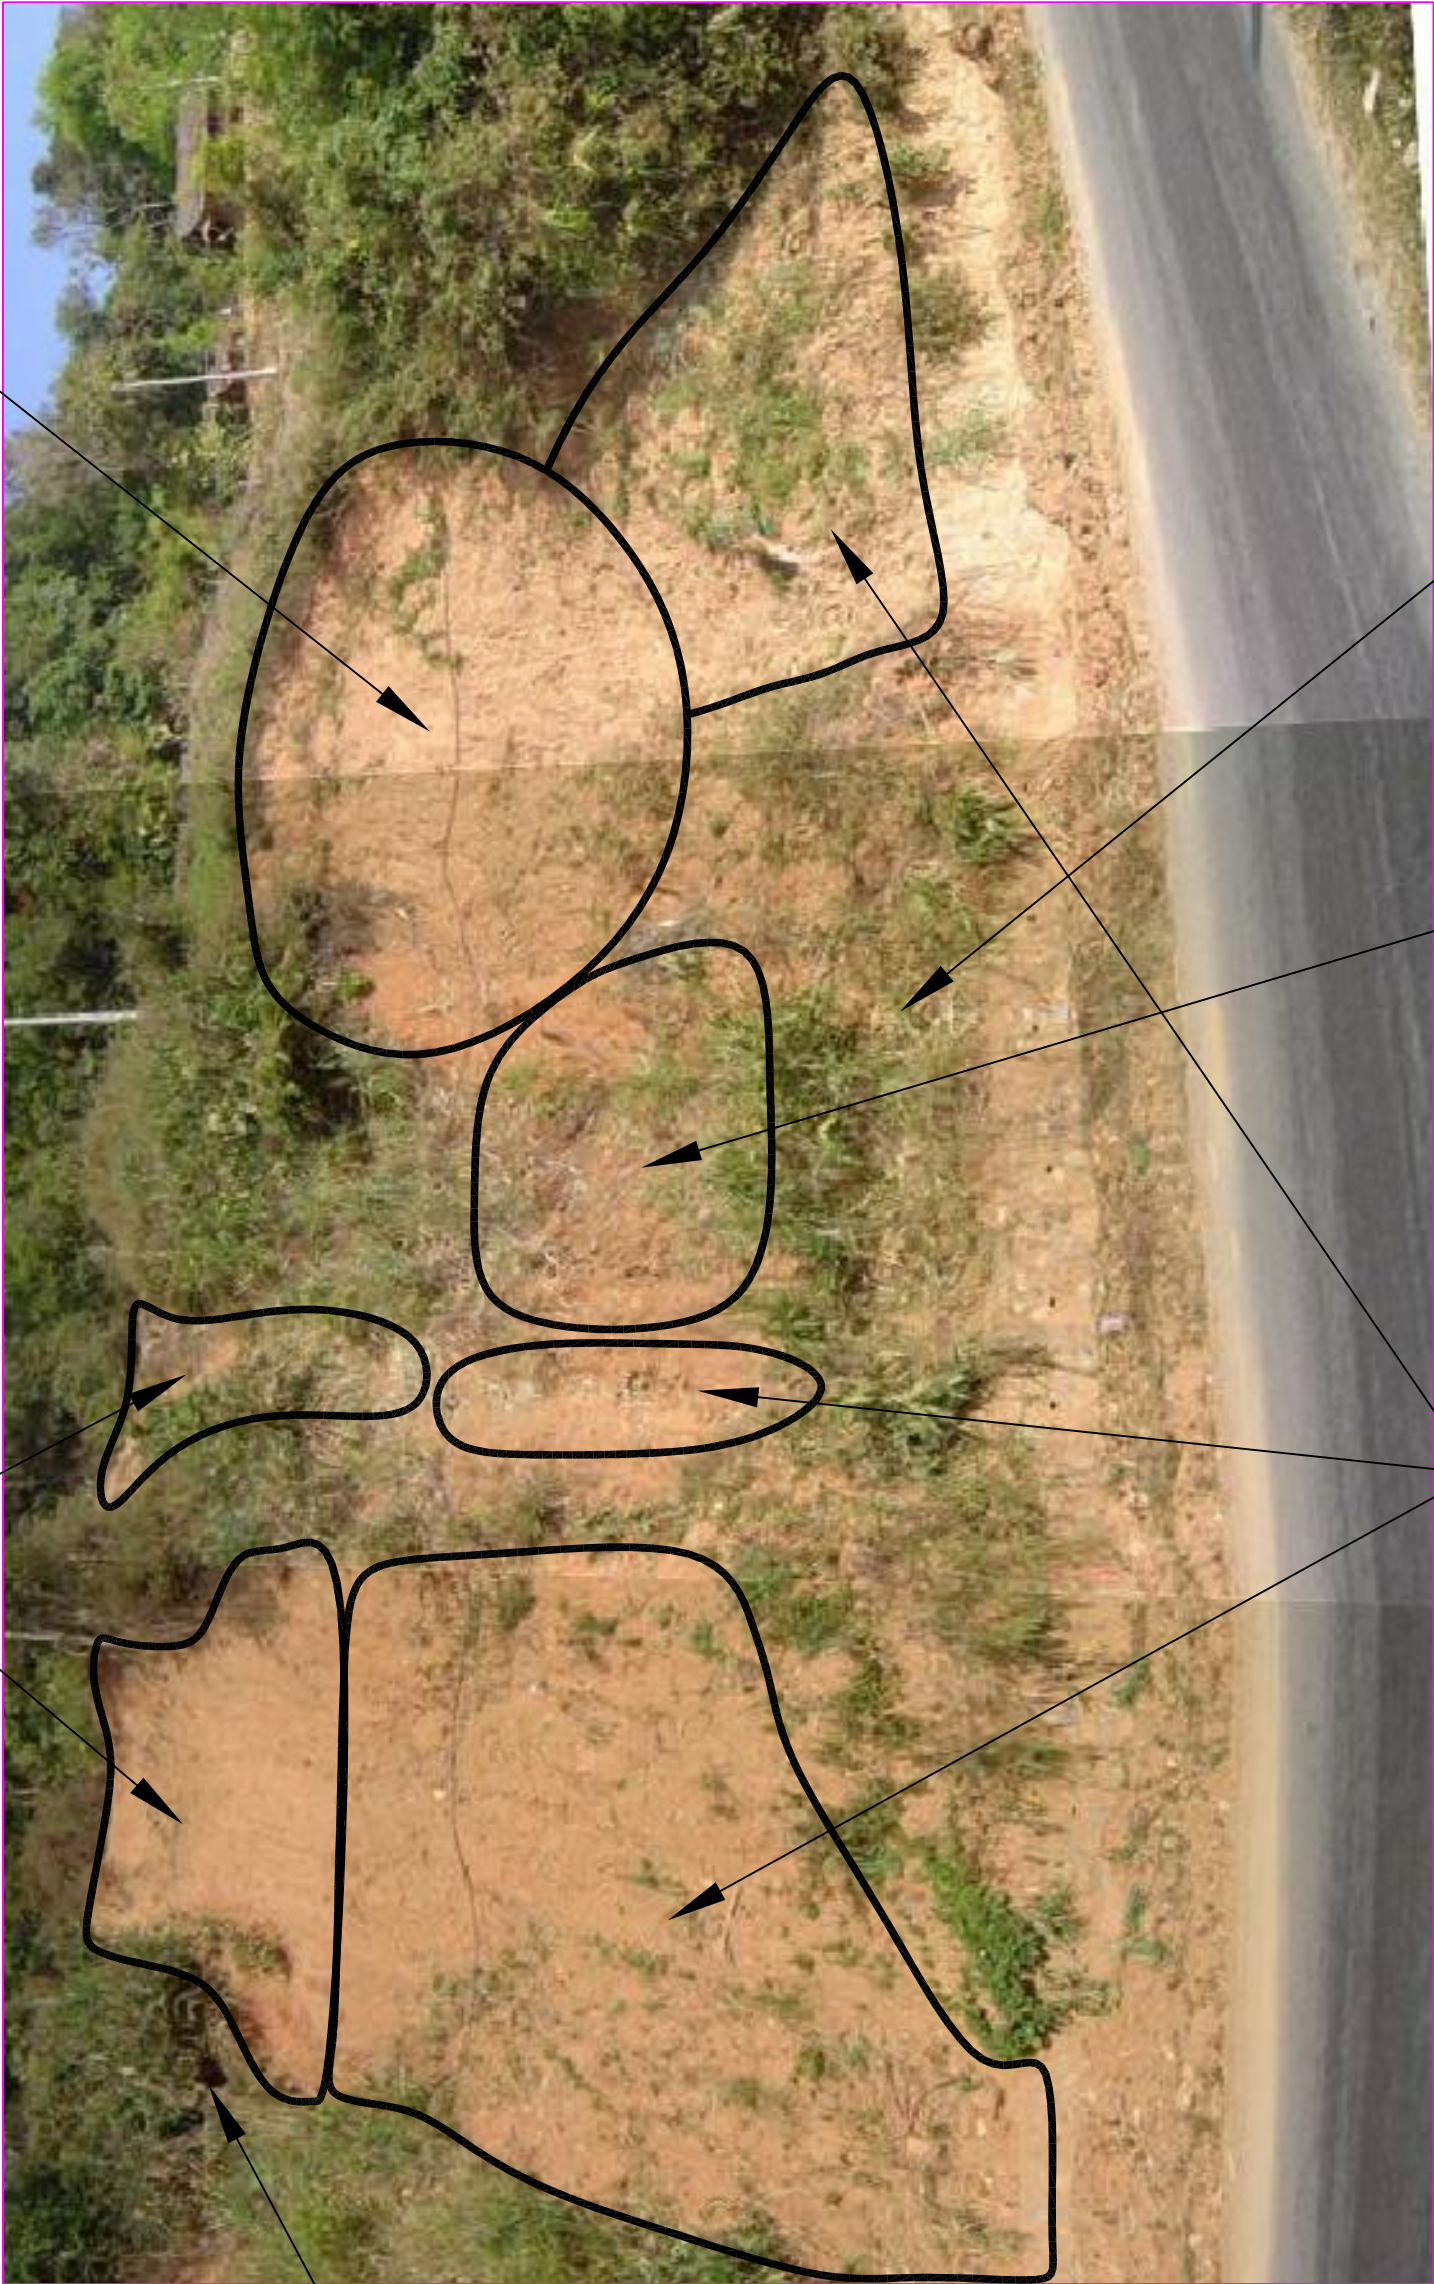
ROAD 13 N - KM 341.2
RECOMMENDED REMEDIAL WORKS

POSSIBLE RE-ACTIVATION
OF REVEGETATED FAILURE:
OBSERVE IN 2009 WET SEASON

CONCRETE 50MM HAND-APPLIED
REINFORCED SURFACING BELOW
NEW RETAINING WALLS

REPAIR DAMAGED VEGETATION
WITH GRASS PLANTING AS NECESSARY
WHEN TRIMMING OF DEBRIS IS COMPLETE
