# **A CASE STUDY OF THE PREMATURE FAILURE OF A TRIAL ROAD IN DAK LAK PROVINCE, VIETNAM**

*Dr Jasper Cook, OtB Engineering Ltd, UK*

*Dr John Rolt, TRL Ltd, UK*

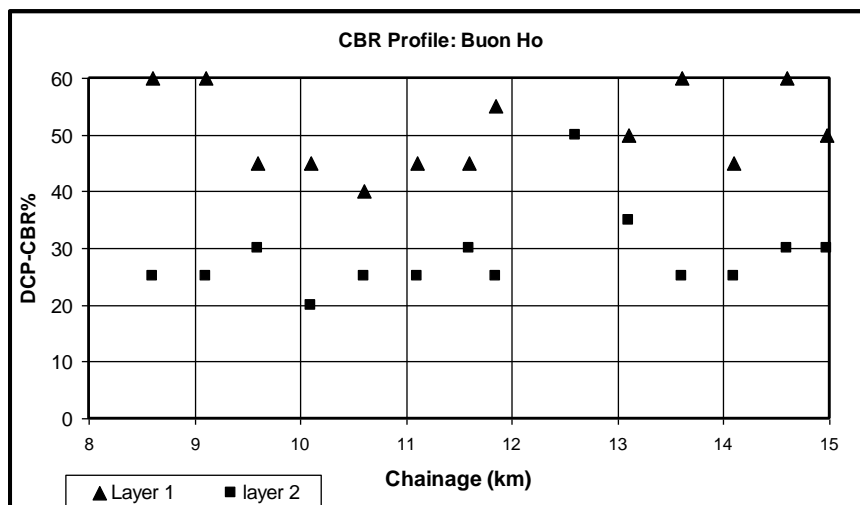
**Figure 2 In Situ Strength of Existing Pre-Trial Road**

Prior to the trials programme the Buon Ho road was primarily of unsealed gravel construction with some sections of Penetration Macadam. The existing surface was in poor condition and composed of sub-standard quality gravely silty clay, Figure 2.

The original designs are shown in Table 2. Estimates of the likely ‘subgrade’ strength were made by using DCP measurements in the original old road (Figure 2). Analysing the available data using the AASHTO design method it is apparent that even if the road had been constructed as designed, none of the sections would have survived for more than a year or two with the traffic that was being carried after construction (Table 8). However, this conclusion depends on the actual subgrade strength that may differ from the value assumed in the design.

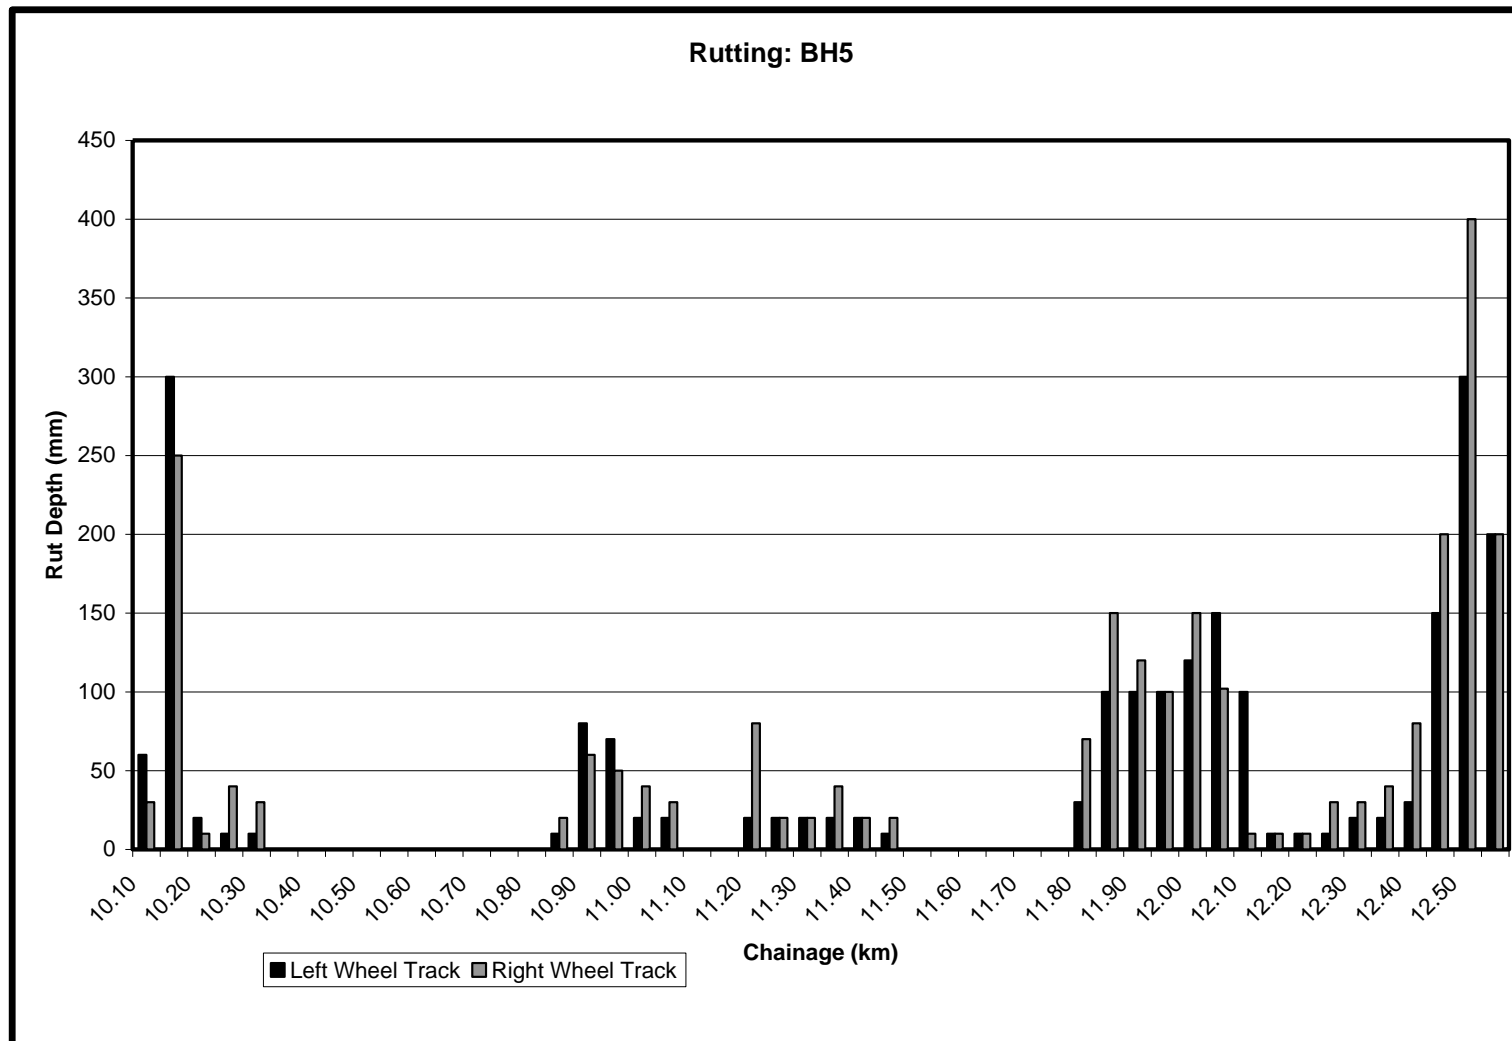
Figure 3. Rut Depths for Section BH 5

A visual condition survey was undertaken of the whole of the Buon Ho trial road using an assessment 'block' length 25m. Figure 3 presents a typical wheel-track rut depths plot measured as part of the visual survey procedure. Visual descriptions were grouped into 5 general levels of condition as defined below and presented in Figure 4, which also includes test pit locations, pavement design references and contractor boundaries.

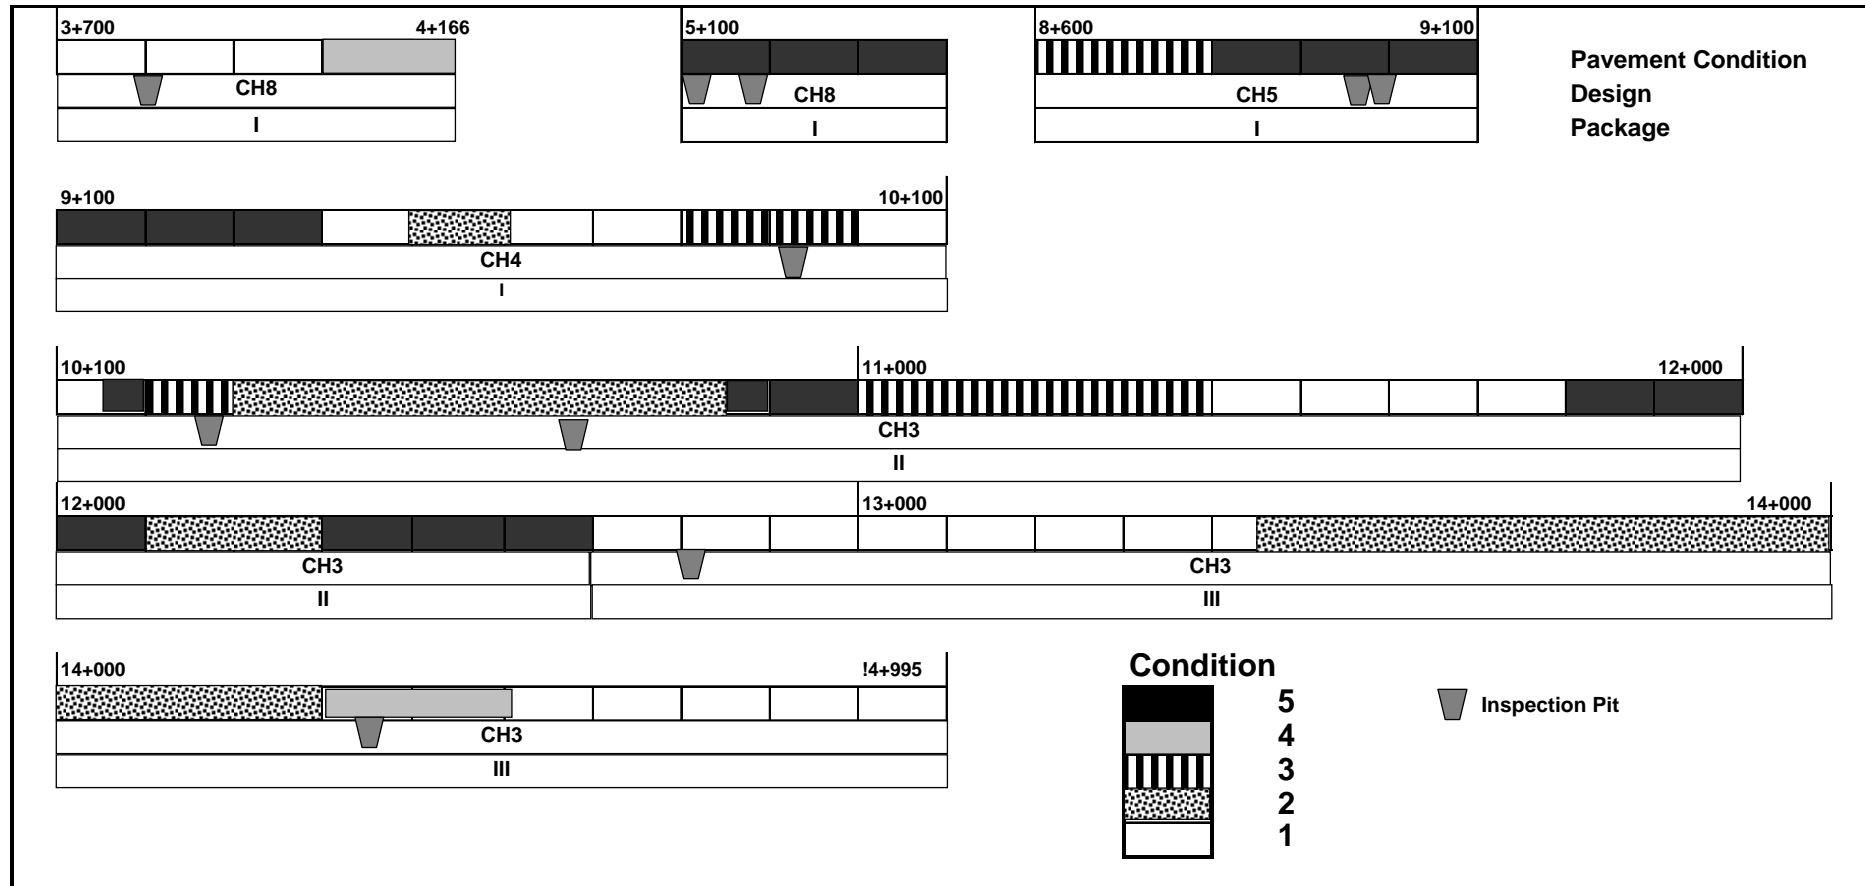
Figure 4. Buon Ho Pavement Condition Summary

The pavement condition groups were:

1. Pavement in **good** condition, with only occasional isolated cracking and occasional minor ruts <20mm
2. Pavement in **fair** condition, with some slight stripping of seals leading to occasional shallow potholes; occasional rutting up to 20mm, occasional interconnected or crocodile cracking
3. Pavement in **moderately poor** condition, with significant crocodile cracking and scattered potholes, rutting may be up to 70-80mm
4. Pavement in **bad** condition, extensive crocodile cracking and potholes with rutting up to 200mm
5. Pavement in **very bad** condition – essentially pavement has lost seal and lost integrity with severe ruts and loosening of base material.
