**CASE STUDY OF DAK LAK RRST PAVEMENT AND
SURFACE DETERIORATION**

BUON HO ROAD

SEACAP 24

June 2008

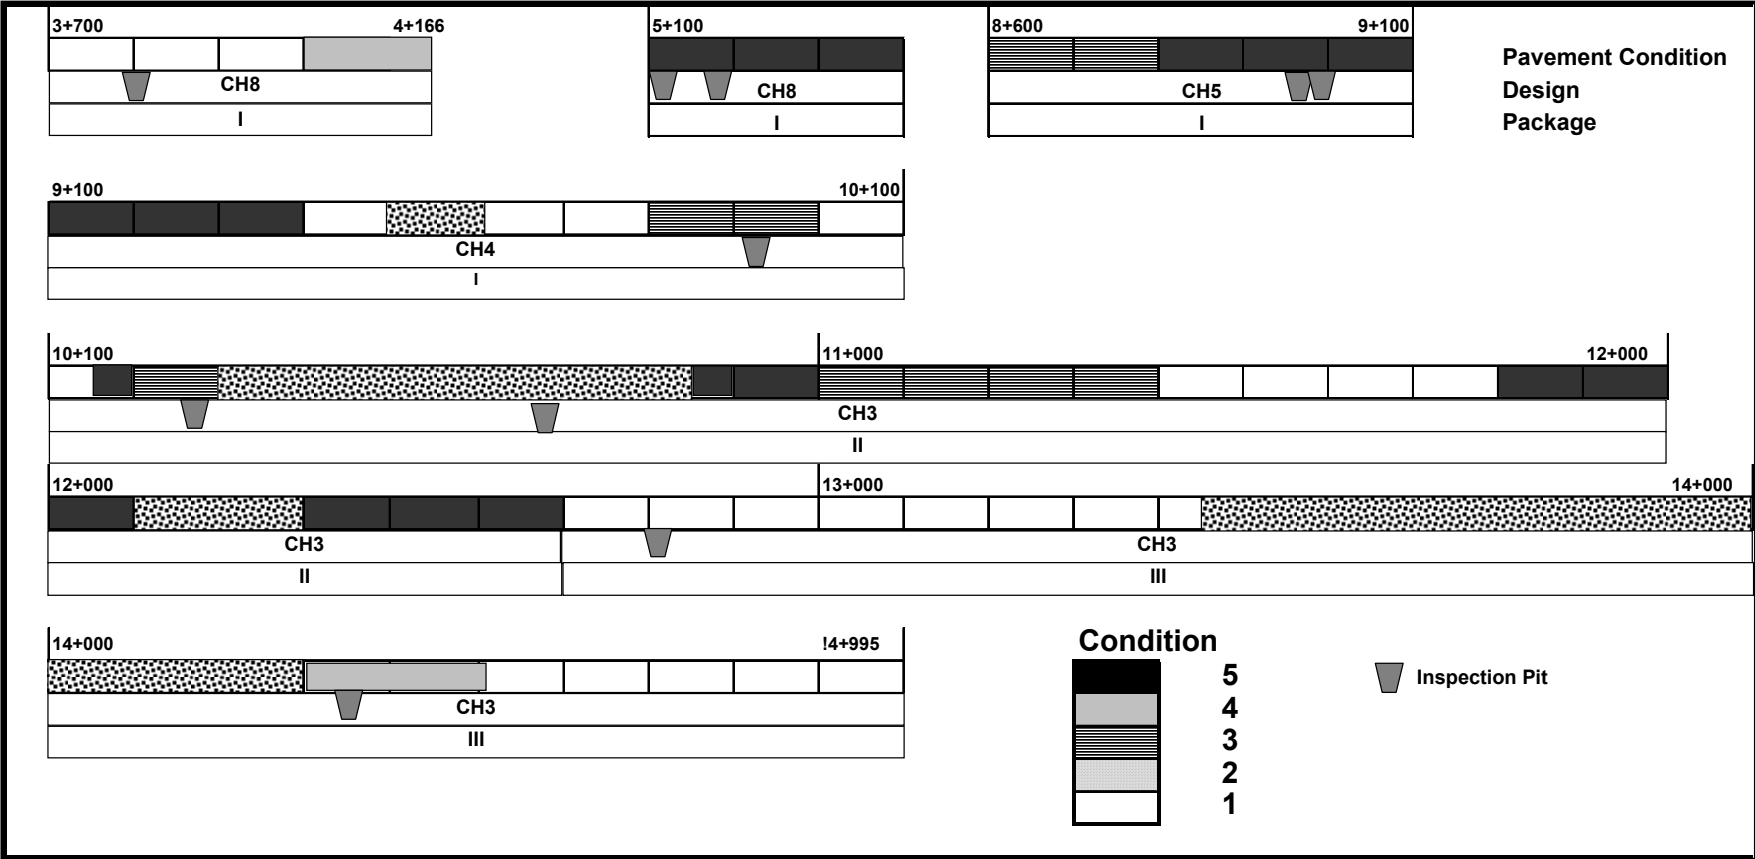
Figure 9. Buon Ho Pavement Condition Summary

Descriptions are grouped into 5 general levels of condition as defined below and presented in Figure 9, which also includes test pit locations, pavement design references and contractor boundaries.

1. Pavement in **good** condition, with only occasional isolated cracking and occasional minor ruts <20mm
2. Pavement in **fair** condition, with some slight stripping of seals leading to occasional shallow potholes; occasional rutting up to 20mm, occasional interconnected or crocodile cracking
3. Pavement in **moderately poor** condition, with significant crocodile cracking and scattered potholes, rutting may be up to 70-80mm
4. Pavement in **bad** condition, extensive crocodile cracking and potholes with rutting up to 200mm
5. Pavement in **very bad** condition – essentially pavement has lost seal and lost integrity with severe ruts and loosening of base material.

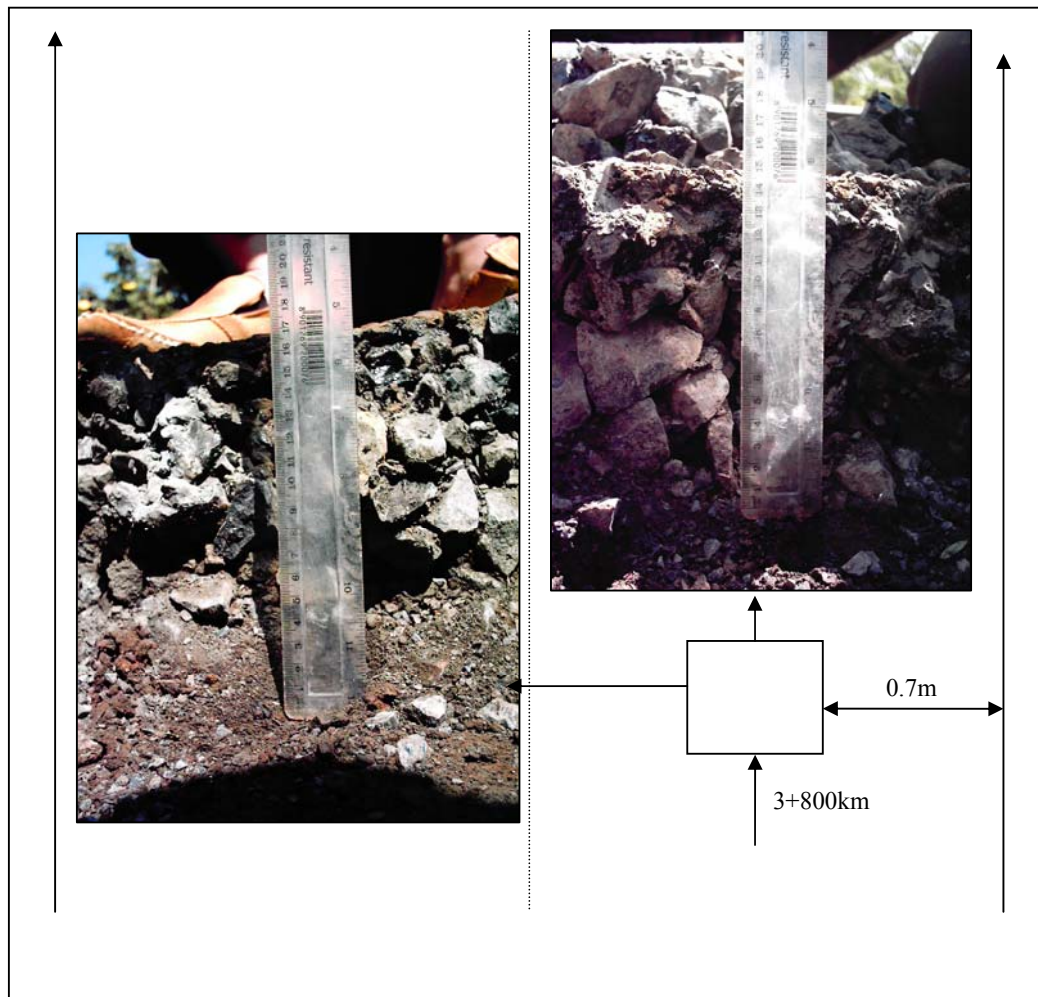
BH1.01 Chainage 3+800km; right side	
Description	Layer
60mm penetration macadam, angular clean gravel-cobble, some as large as 80mm	Surface-Base
100mm thick as per design, angular aggregate, well graded WBM, with largest dimension up to 100mm.	Sub-Base
Dark brown stiff clay with some organic material.	Sub-Grade

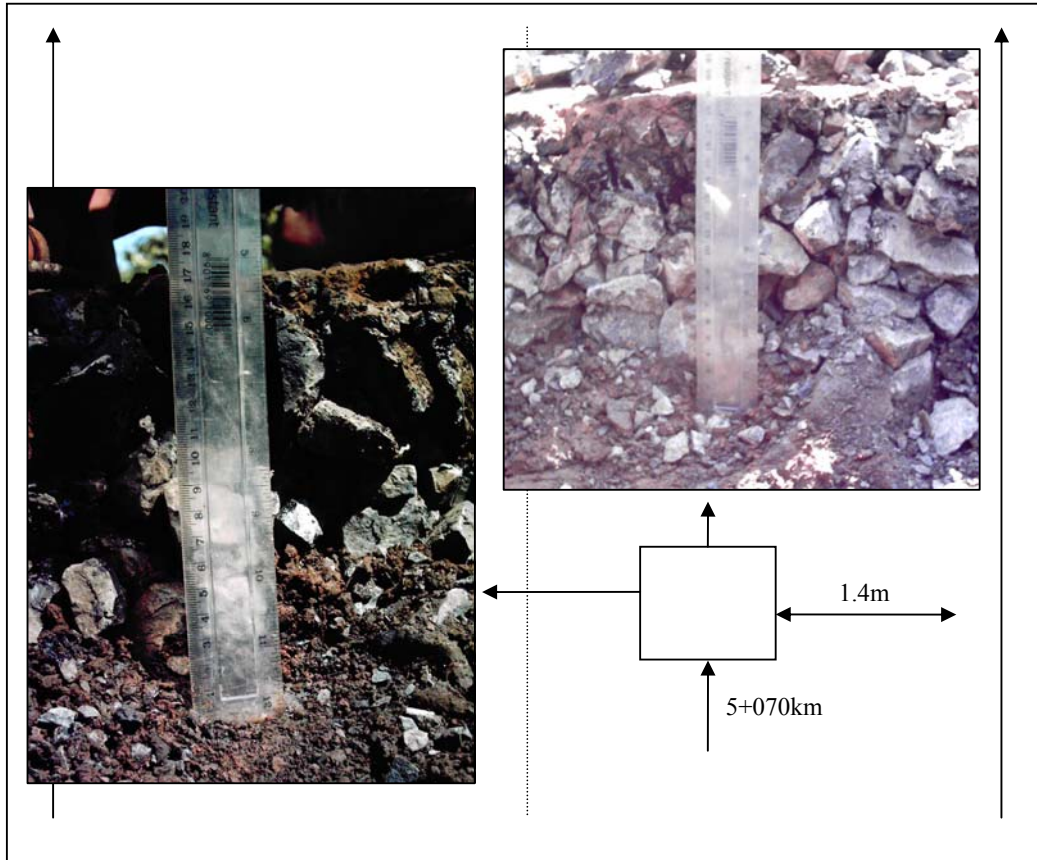
Buon Ho Test Pit 2

BH 2.01 Chainage 5+070 km; right side	
Description	Layer
60mm penetration macadam angular clean gravel sized aggregate	Surface/Base
100-120mm, angular aggregate, well graded WBM, largest dimension up to 90-100mm.	Sub-Base
Mottled dark brown and orange stiff clay, some fine gravel. No depression in sub-grade	Sub-Grade

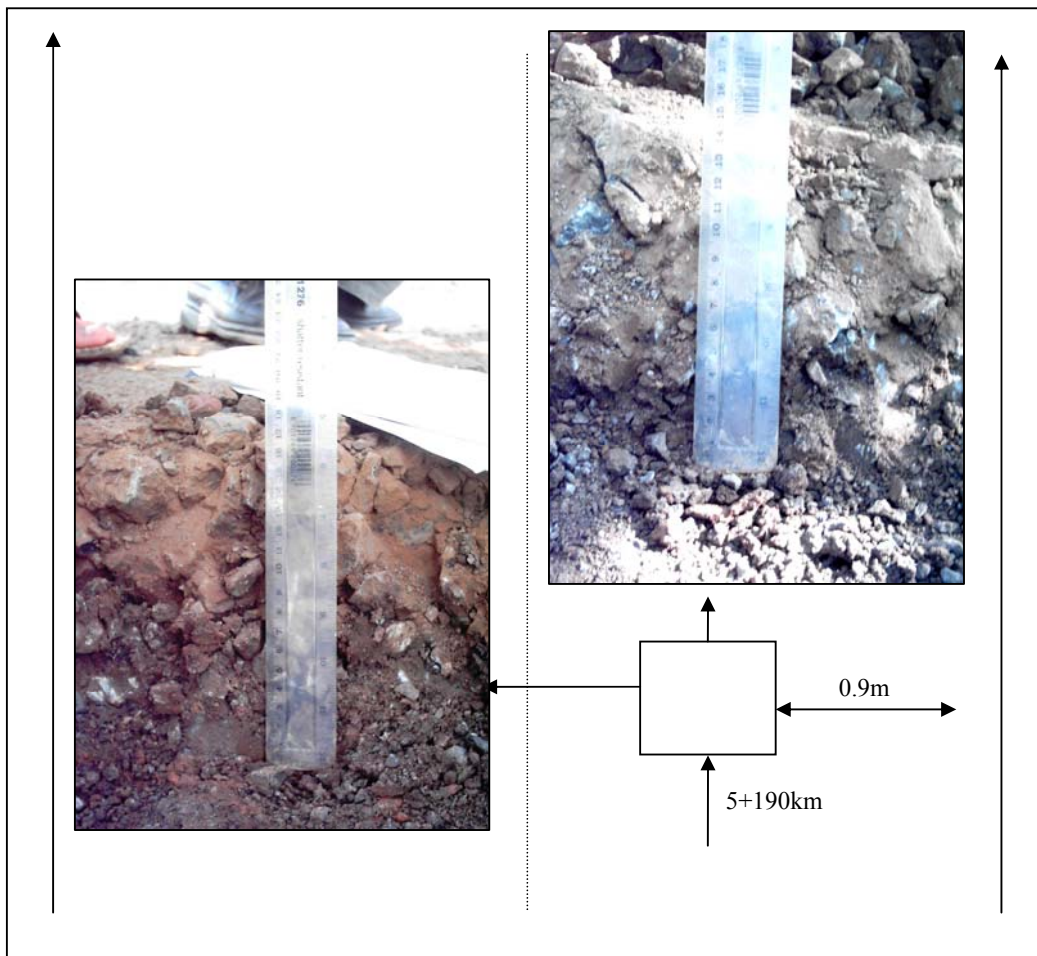
Buon Ho Test Pit 3

BH 2 02 Chainage 5+190 KM	
Description	Layer
60mm penetration macadam, angular aggregate though some clay adhered to particles.	Surface/Base
100mm angular aggregate, well graded WBM, largest dimension less than 100mm. Has clay adhered to particles.	Sub-Base
Dark brown firm clay, uneven interface with sub-base with coarse aggregate punched into top layer.	Sub-Grade

Pit was sunk in a heavily rutted section, the base material contained significantly more clay than the previous trial pit.

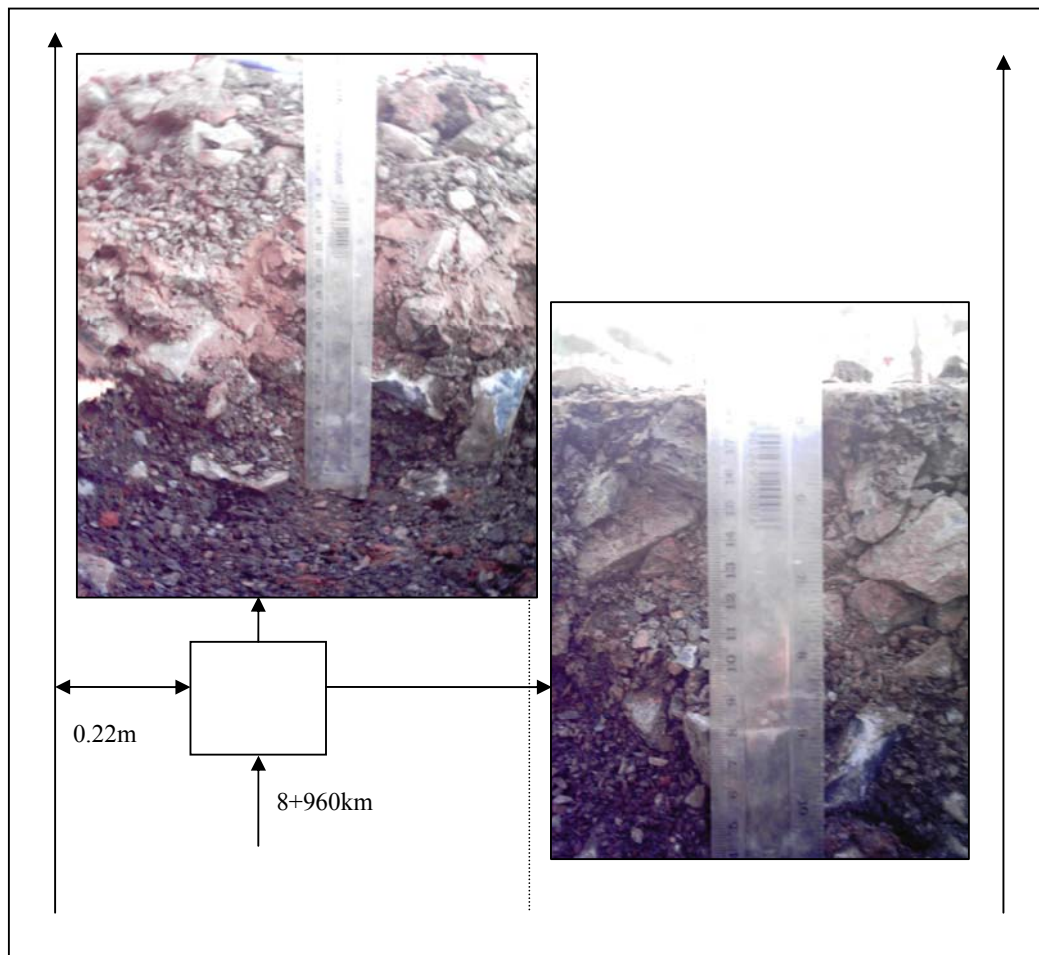
Buon Ho Test Pit 4

BH 3.01 Chainage 8+960 km, Left hand side	
Description	Layer
10-20mm surfacing good. 100mm base contains clay adhered to aggregate. Aggregate largest dimension up to 70mm. Distinct thin 5mm chip between layers.	Surface/Base
100mm layer of angular intact aggregate no bigger than 60-70mm	Sub-Base
Red brown clay soil	Sub-Grade

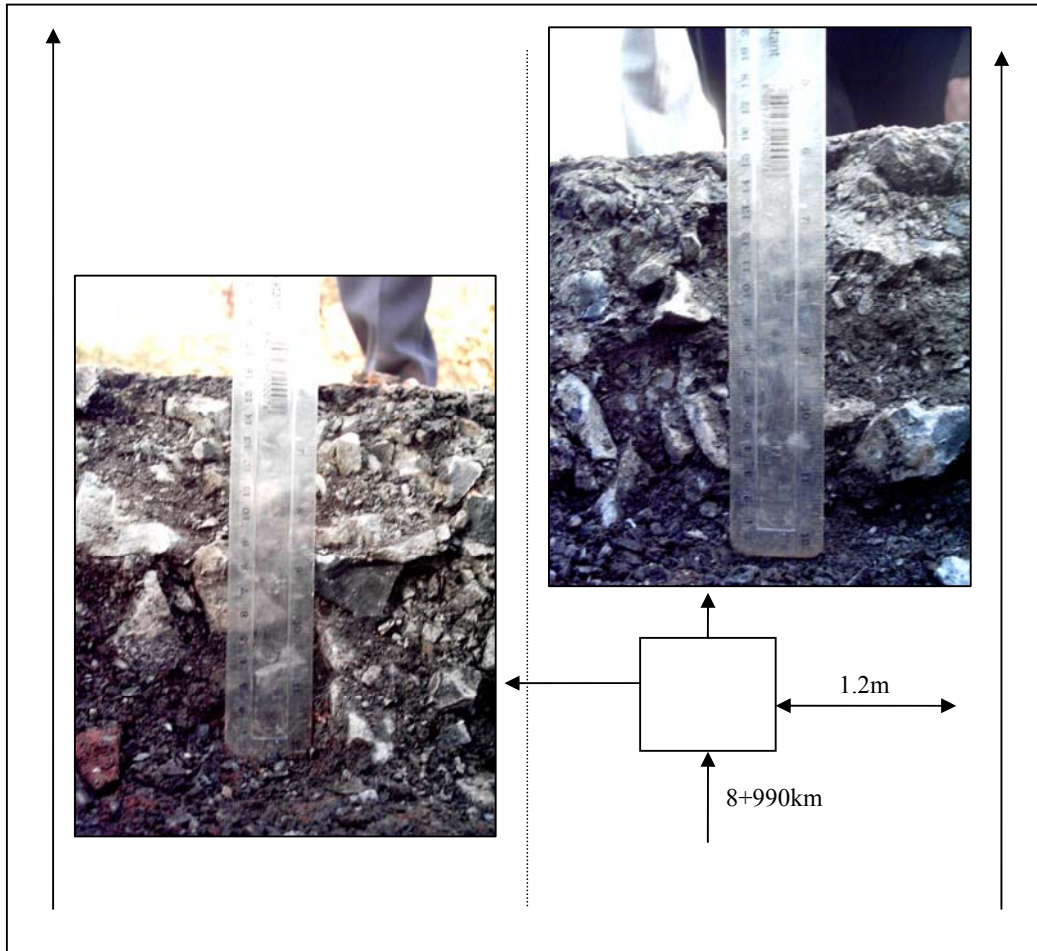
Buon Ho Test Pit 5

BH 3.02 Chainage 8+990km Right hand side	
Description	Layer
10mm surfacing, base 80-90mm good intact angular aggregate on average 60-70mm, overlying then fine chipping layer	Surface/Base
80-90mm clean angular aggregate, 60-70mm, not punched into sub-grade.	Sub-Base
Red brown clay firm, some fine gravel 2-3mm.	Sub-Grade

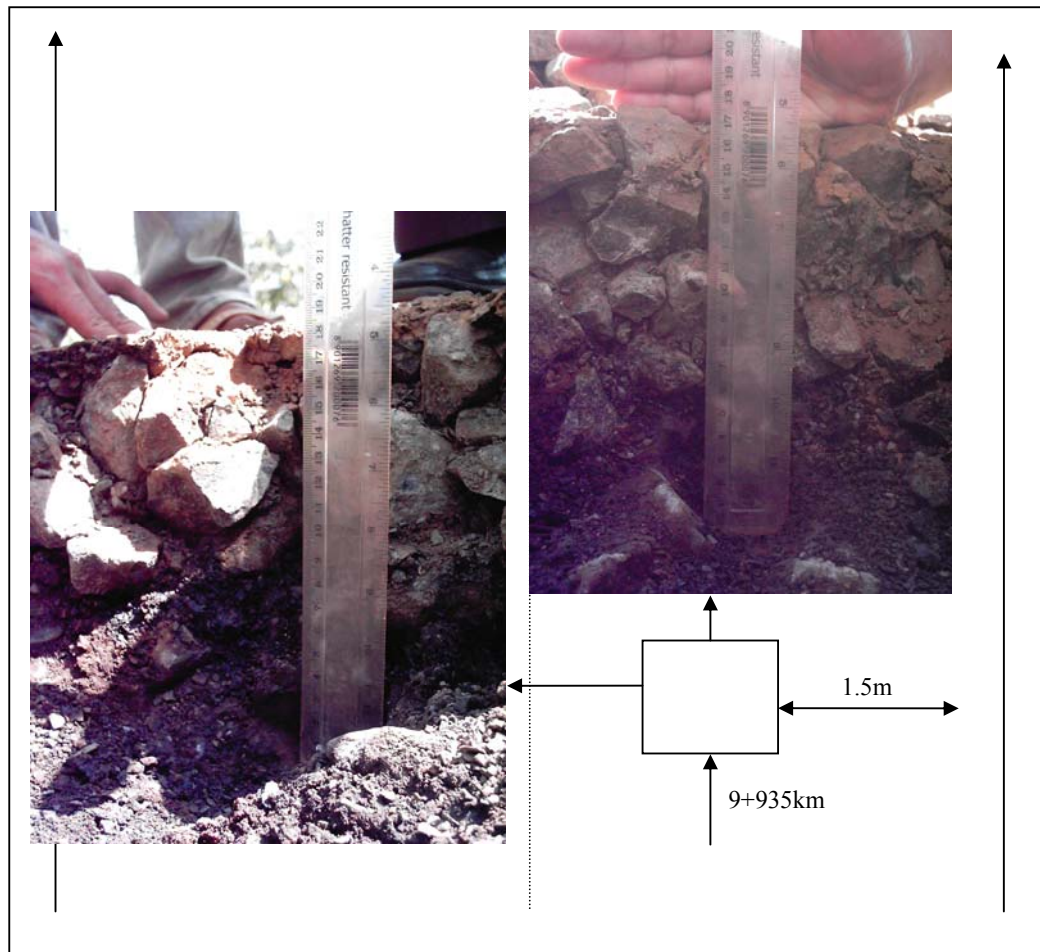
Buon Ho Test Pit 6

BH 4.01 Chainage 9+935km; Right hand side	
Description	Layer
5-10mm surfacing. 100mm base angular intact aggregate average 50-60mm, largest dimension less than 80mm. Slight clay content. Fine chippings layer at bottom.	Surface/Base
100mm of 40-60mm intact aggregate layer, slightly damp,	Sub-Base
Dark brown clay sub grade punctured by sub base approx 40-60mm.	Sub-Grade)

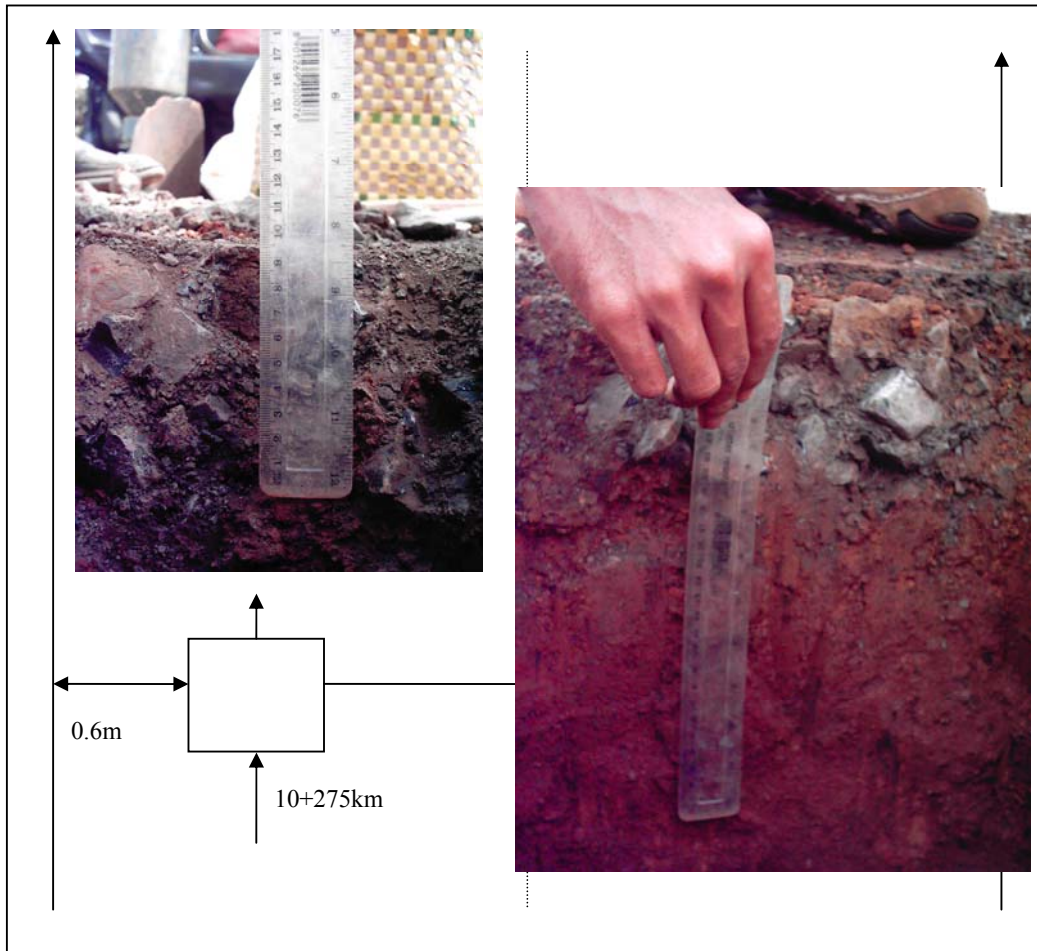
Buon Ho Test Pit 7

BH 5.01 Chainage 10+275km; Left hand side	
Description	Layer
5-10mm surface seal 100mm clean intact aggregate average 50-60mm, uneven interface with sub-base.	Surface/Base
200mm of light brown slightly gravelly clay with discernable layer break at 100mm. Very similar to underlying sub-grade, no clear interface.	Sub-Base
Light brown clay with fine gravel (5mm), appears the same material as above.	Sub-Grade

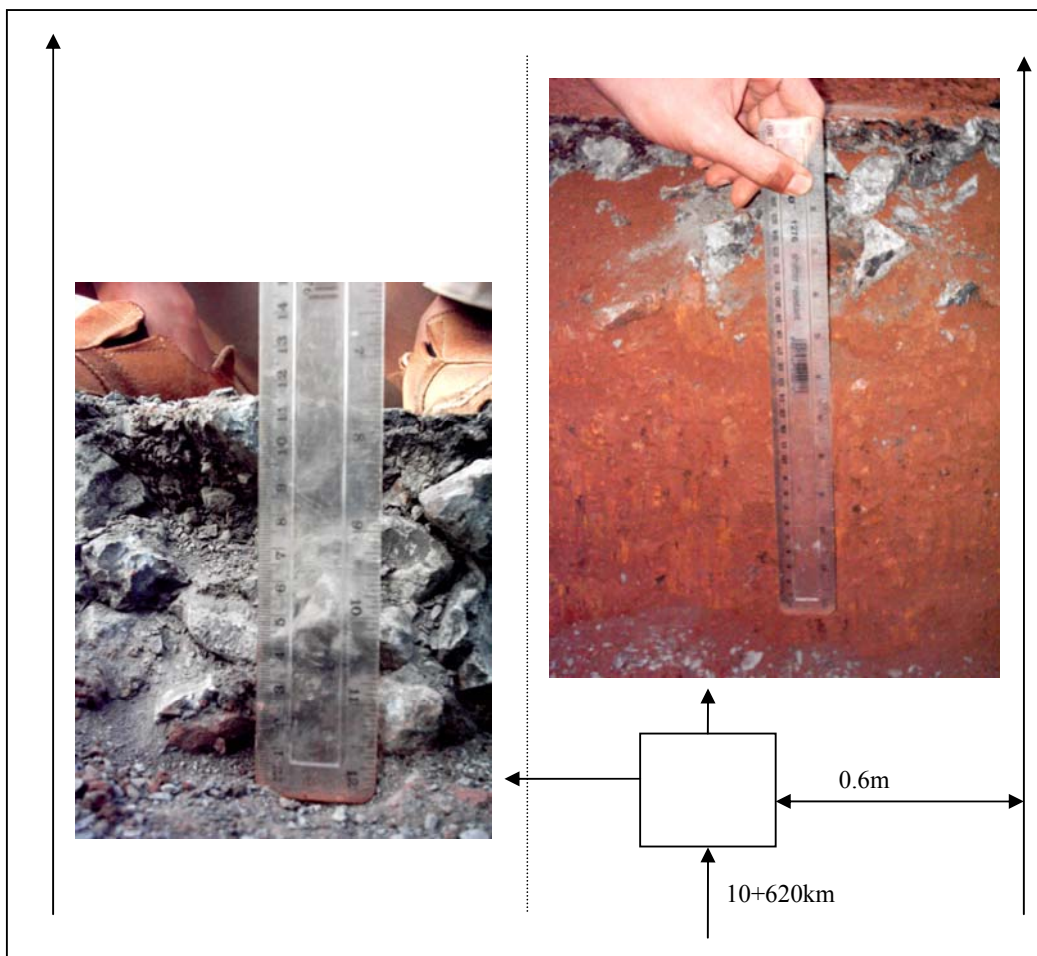
Buon Ho Test Pit 8

BH 5.02 Chainage 10+620km; Right hand side	
Description	Layer
10mm strong surfacing, breaks in large pieces. 100mm good angular clean aggregate, no bigger than 70mm and 50-70mm on average. Followed by thin layer of 5mm fine chippings.	Surface/Base
200mm Brown clay with fine gravel (5mm); no layering at 100mm and no apparent change to sub-grade	Sub-Base
Brown clay with some yellow flecks, no small gravel	Sub-Grade

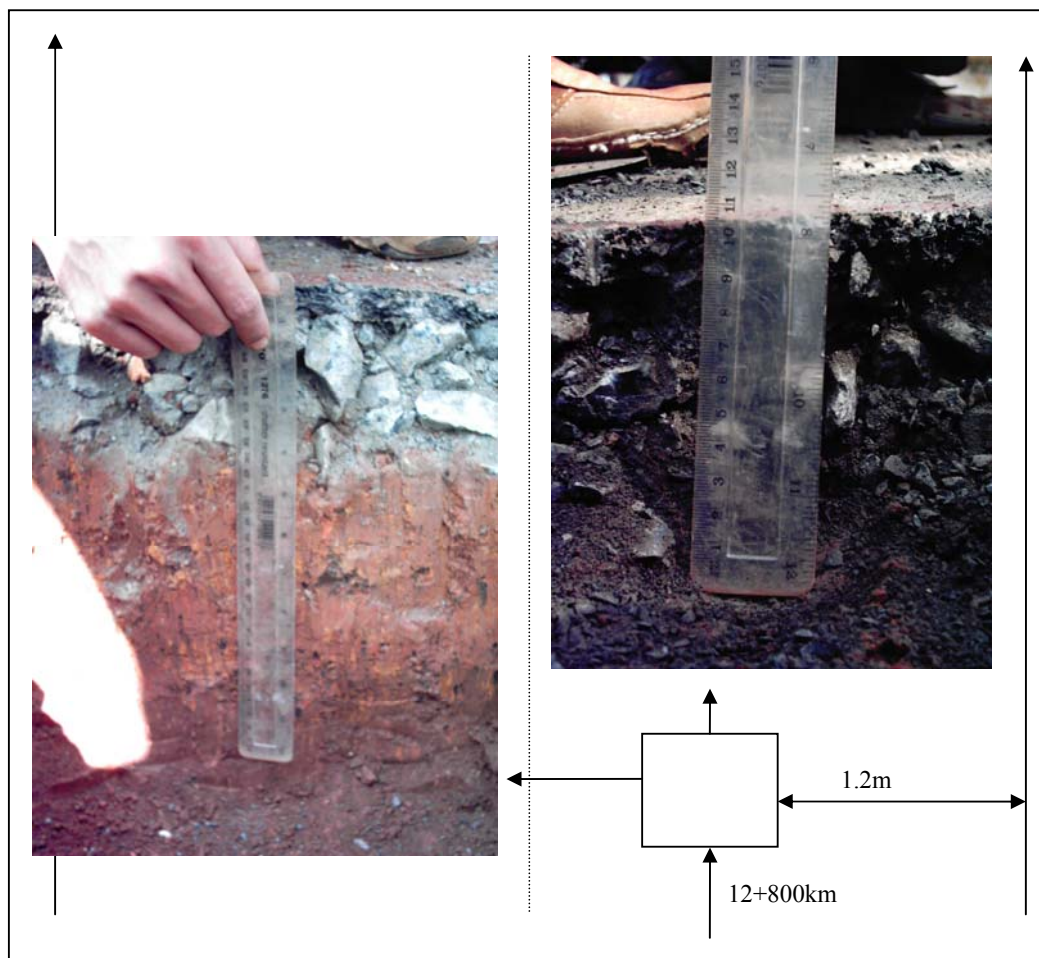
Buon Ho Test Pit 9

BH 6.01 Chainage 12+800km; Right hand side	
Description	Layer
10-15m dense stone surface seal, hard to break with crow-bar. 100mm- well graded angular intact aggregate; average 50-80mm	Surface/Base
200mm mottled orange-brown clay, firm-stiff with layer of gravel-cobble approximately 90-100mm at the bottom. Layer change not discernable	Sub-Base
Layer of black aggregate then brown firm clay with fine gravel.	Sub-Grade

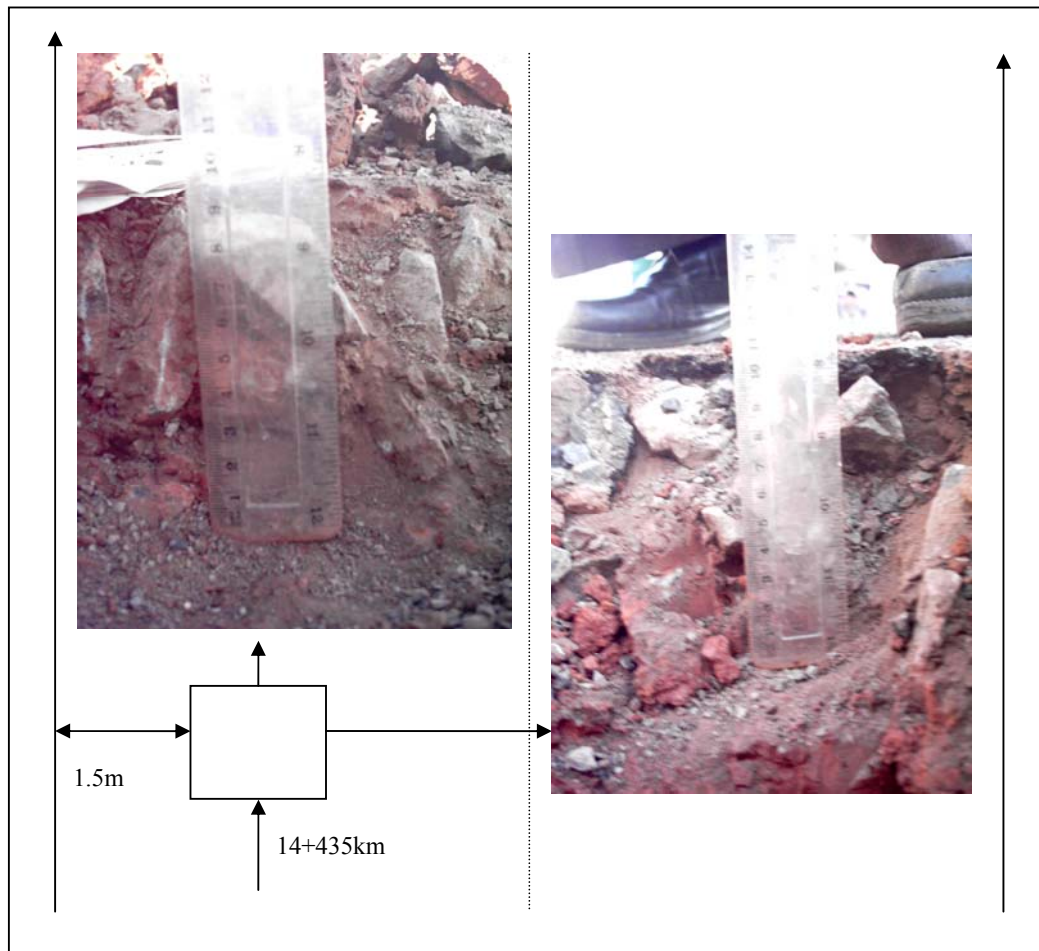
Buon Ho Test Pit 10

BH 6 02 Chainage 14+435km; Left hand side	
Description	Layer
5 to 10 mm surfacing, poor quality, thin in places. 50 to 80mm of intact clean, aggregate on average 50-60mm.	Surface/Base
200mm of brown firm clay with fine gravel (5mm). Interface not deformed. Layers not discernable	Sub-Base
Brown firm clay with fine gravel (5mm), same as sub base, No discernable change to sub base.	Sub-Grade
