**SOUTH EAST ASIA COMMUNITY ACCESS
PROGRAMME**

**CASE STUDY OF DAK LAK RRST PAVEMENT AND
SURFACE DETERIORATION**

EA SOUP ROAD

SEACAP 24

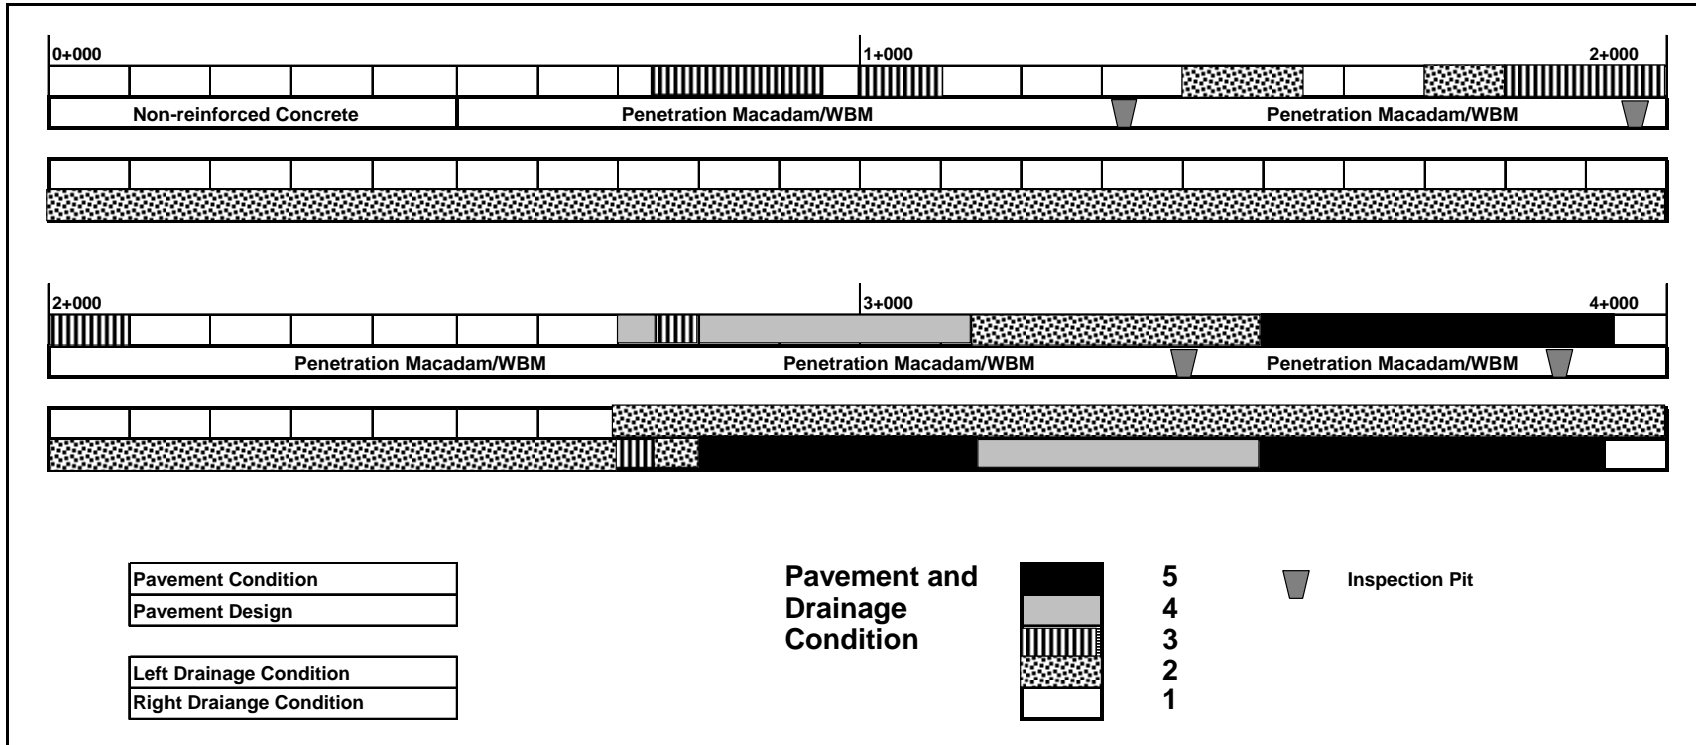
Figure 4. Ea Soup Pavement Condition Summary

1. Ea Soup road has suffered significant deterioration in the section km 2.7 to km 3.8; although less severe deterioration is evident in other in places.

7. An elevated irrigation ditch now exists to the left hand side of the carriageway between km 2.8 to km 3.9. This had been heightened subsequent to the trial road being completed. Local information indicated that this irrigation ditch both overtopped and leaked.
8. The road section on embankment above and adjacent to a deep irrigation channel suffered only isolated pavement deterioration, Figure 4.

There are other smaller areas of pavement along the road, as shown on Figure 4, that should also be repaired.

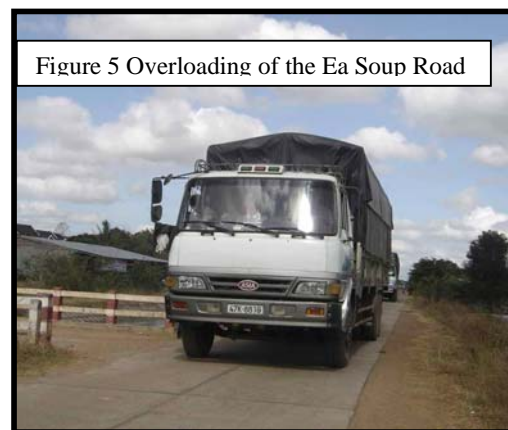
The very low percentage of trucks within the overall ADT³ indicates an equivalent standard axle (esa) total of between 50,000 and 75,000 for a 10-year design life. The pavement was designed to comply with Commune Class A Standards and as such has a 6t axle load limit. There is anecdotal evidence however of at least some overloading by large trucks and during the investigation heavily laden trucks were noted as using the road on an intermittent basis (Figure 5).

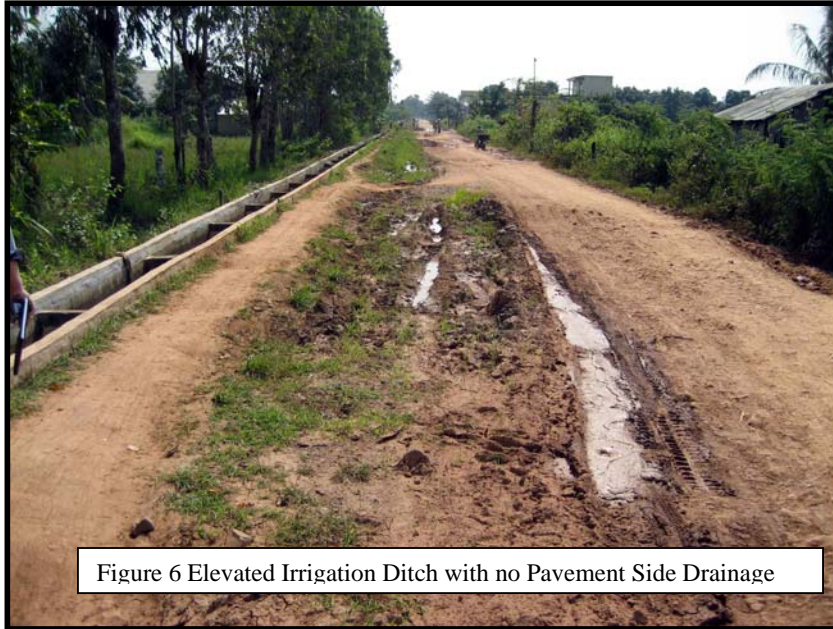
The investigation has shown that no side drainage was constructed and hence the combination of this with the leaking irrigation ditch constituted a significant risk to adequate pavement performance by providing what is in effect a reservoir of water to keep the pavement in a saturated condition between km 2.7 and km 3.9, (Figure 6).

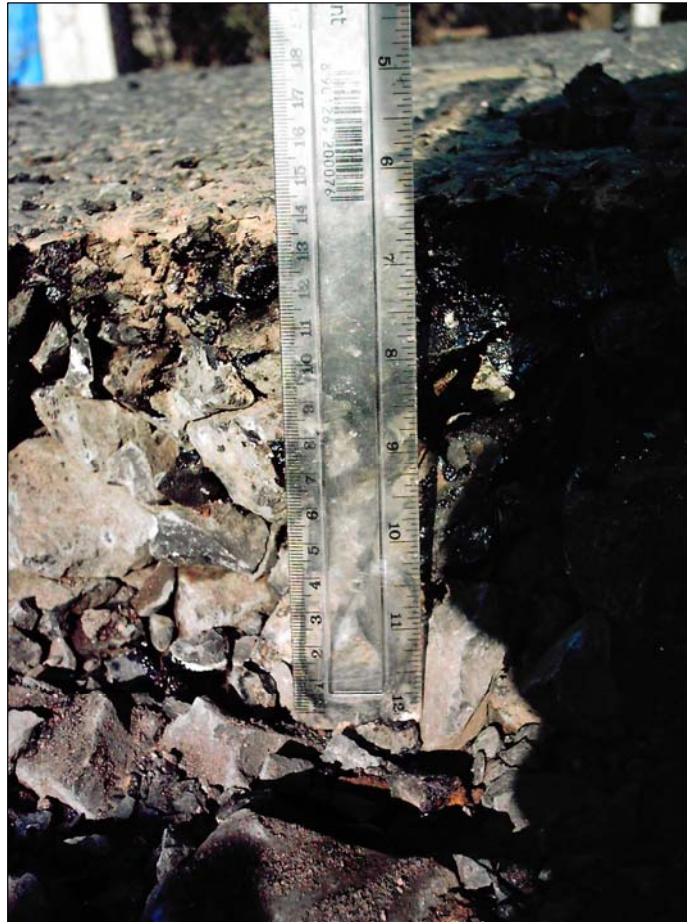
Ea Soup Pit No 1

ES 2.01 Chainage 1+325km	
Description	Layer
60mm Penetration macadam surface Materials size is close to standard. Penmac in fair condition. Bitumen content looks sufficient	Surface/Base
100-120mm of WBM sub-base; 50% of material is oversize, with largest dimension 100 to 200mm	Sub-Base
Natural gravel. Brown sandy clay with gravel. Particle size distribution is fairly good. Strong subgrade	Subgrade

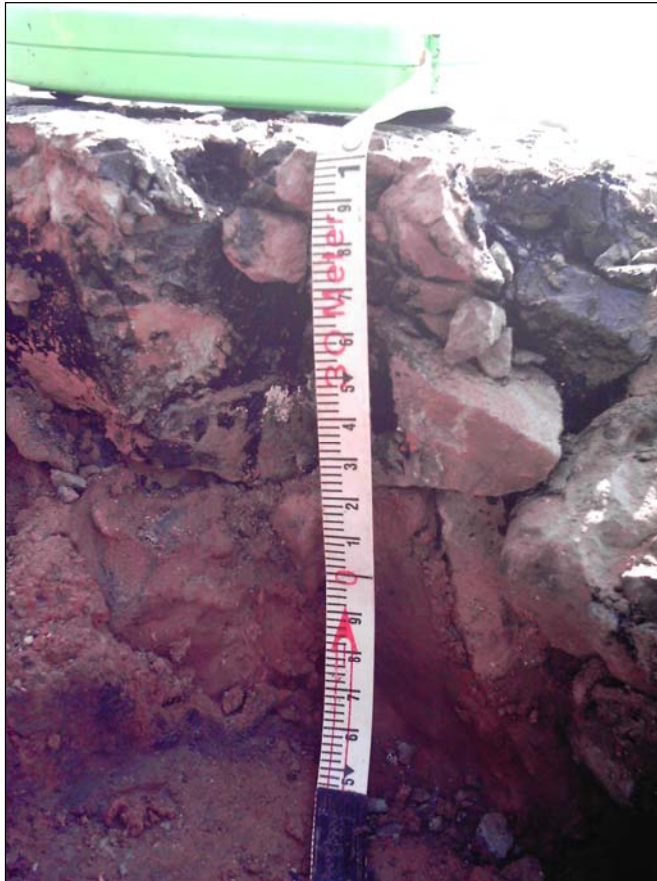
Ea Soup Pit No 2

ES 2 02 Chainage 1+980km	
Description	Layer
60mm of Penetration macadam surface Materials size is close to standard. Penmac in fair condition. Bitumen content looks sufficient	Surface/Base
100mm WBM with significant percentage of oversize materials. Also large amount of clay material present in sub base. Oversize particles from 100 to 200mm.	Sub-Base
Hill gravel. Brown sandy clay with a little gravel. Low subgrade strength	Subgrade

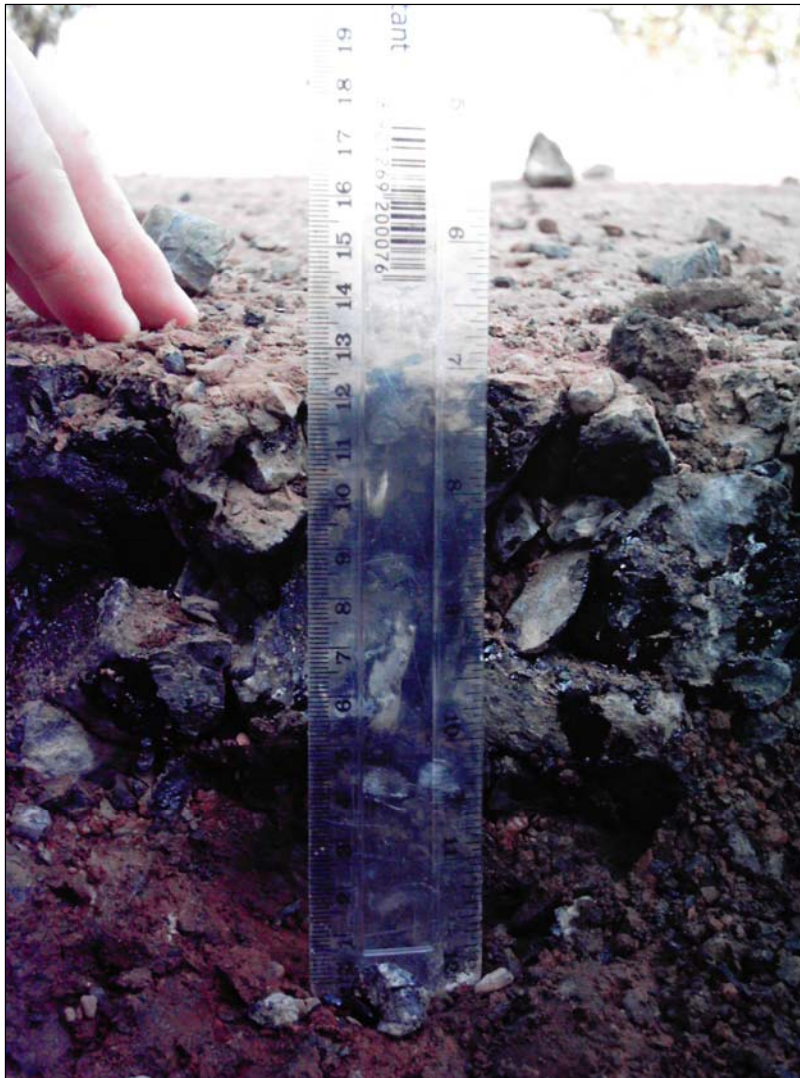
Ea Soup Pit No 3

ES 3 01 Chainage 3+400km	
Description	Layer
60mm Penetration macadam. Materials size is close to standard and in fair condition. Bitumen content looks adequate.	Surface/Base
70-80mm WBM. Materials size is close to standard.	Sub-Base
Grey brown sandy clay, wet. High subgrade strength.	Subgrade

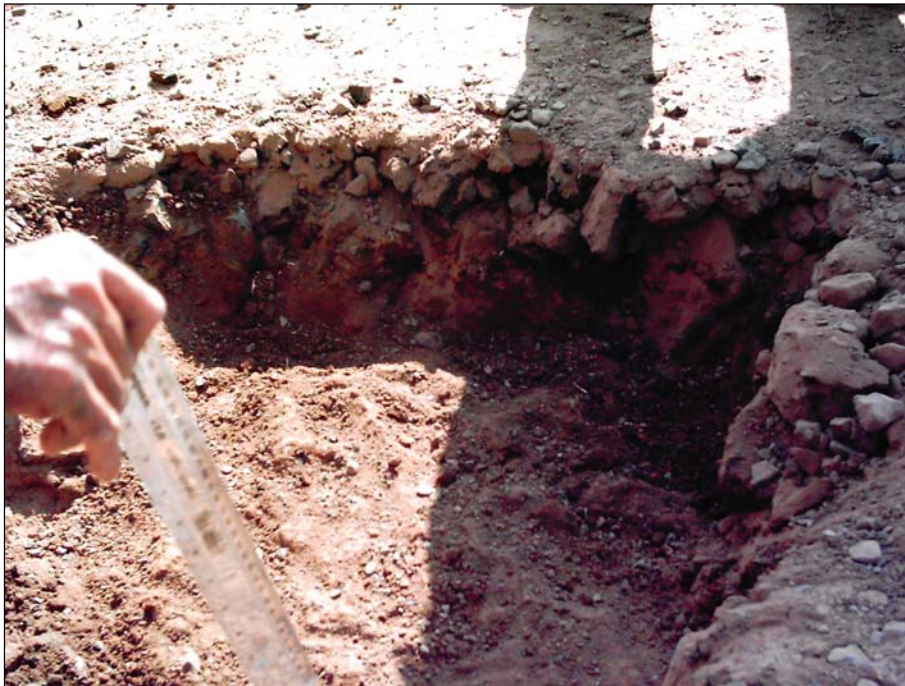
Ea Soup Pit No 4

ES 3.02 Chainage 3+875km	
Description	Layer
60mm Penetration macadam surface. Materials size is close to standard. Layer in bad condition. Bitumen content looks insufficient.	Surface/Base
100mm WBM, with a lot of oversize materials. Oversize materials from 100mm to 200mm.	Sub-Base
Grey sandy clay with a little gravel, wet condition. Subgrade strength is poor.	Subgrade
