# Evidence of soil instability and erosion along paths and roads in five villages in Central Ghana

CRES/QA/EROSION/1/0401/1.1

Sub-component of DFID project R7575:  
Action research to evaluate the impact on livelihoods of a set of post-harvest interventions in Ghana's off-road settlements: focus on IMTs  
(Dr Gina Porter, University of Durham, UK)

## Report on visit 4-9 February 2001

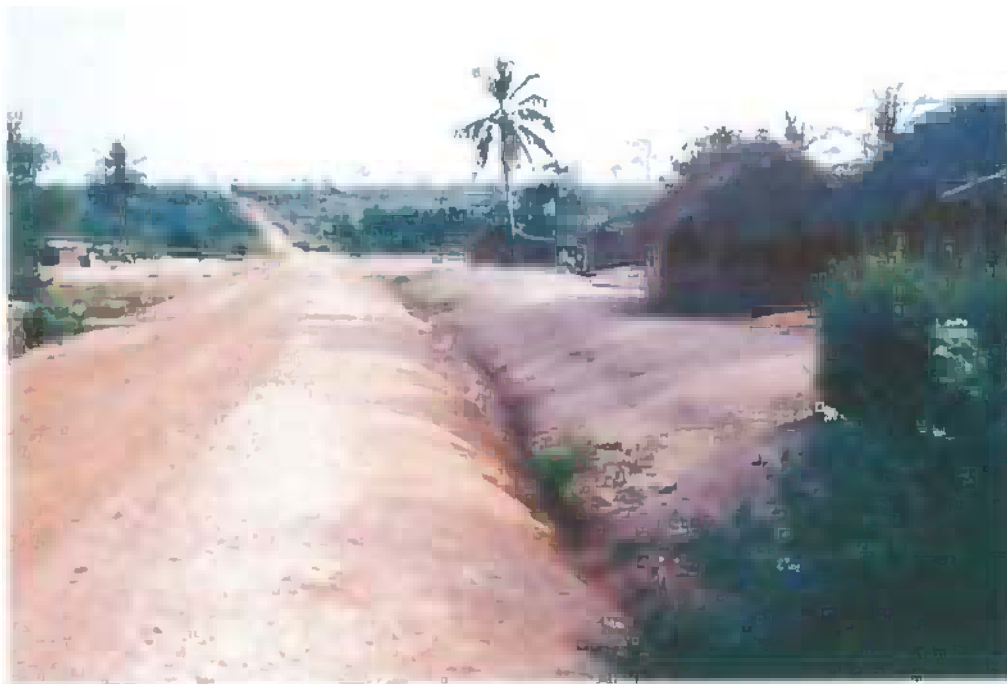
The road to the market in Awutu Bereku is 7.4 km in length, and was re-graded in November-December 1999 (Kathrin Blaufuss / Frank Owusu Acheampong, pers comm.). The sand-gravel surface (saproelite) of the road appears to have a silty matrix. This made-surface is at least 0.3 m in depth in places. There is evidence of granite cobbles in the road foundation. The road surface has good camber for drainage, and cut channels for drainage on either side. There is no evidence of breakout or extensive downcutting of these channels, except at a few localised places. Notable exceptions are the road-side channels within the Abora village itself (Figure 5). There is evidence that these channels were recently active. On the Eastern side of the village, there is evidence that field drainage coalesces into small gullies that drain into the road-side channels. To the South of the village (towards Awutu Bereku), the road passes through a valley and then rises steeply up the other side (Figure 5). A shallow, but long gully has developed within this steep road section (Figure 6), and appears to be feeding sediment directly to a pond in the valley, on the upstream side of the road (Figure 7). This pond, one of the water-supplies for Abora village (Blaufuss, pers. comm.), is very turbid. Other steep (>20°) sections of the 7.4 km road to Awutu Bereku have similar shallow gullies developed on their surfaces. Note: The middle section of this road is only shown as a path on the 1:50,000 scale map (sheet 0501A4) published in 1975.

Figure 5. Road-side drain over-deepening due to surficial erosion, Adabra village looking South.

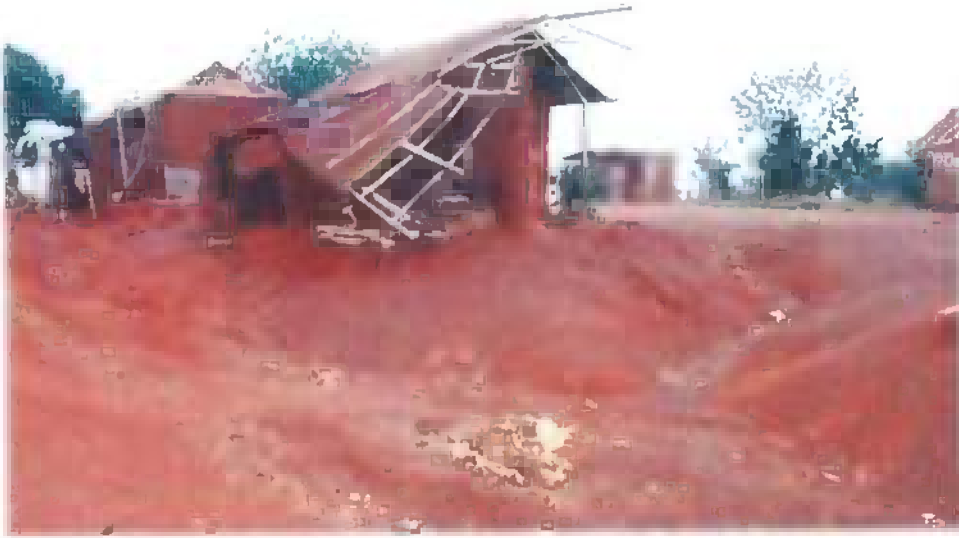
The likelihood of erosion of the road surface cannot be judged directly, as the road probably has not experienced many large storms since construction. The high rate of localised gullying of the steeper slope of the Eastern part of Abora village (Figure 12), may, however, suggest that the local soils are relatively weak, so that gullying may develop on the steep section of the Abora-Ankamu road, immediately North of Abora. The soils in the immediate vicinity of Abora are mapped as Acrisols (locally 'Bekwai-Nzima / Oda Association'; Asamoah, 1968), the dominant soil of Ghana / Ivory Coast region (Driessen and Dudal, 1991). Such soils are known to be susceptible to erosion, but not as weak as the related Alisols, which are rich in 2:1 clay minerals (Driessen and Dudal, 1991).

Figure 12. Extensive gullying on the Eastern section of Abora village

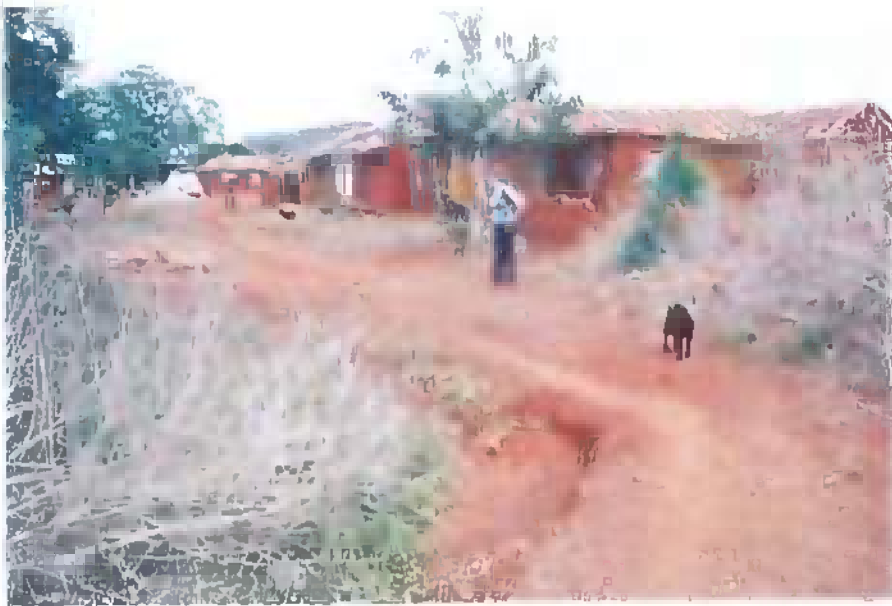
Figure 13. A gully (centre foreground) developed at the start of path 1, Abora village

This gully appears to be fed by the road-side channel East of the new Abora-Ankamu road, and by other gullies running through the Eastern half of Abora village (Figure 12). This gully, probably within Acrisol soils, is likely to offer a significant obstacle to IMT passage. The concentration of surface runoff in this area may also mean that the IMTs have a negative impact on the path surface in this area. The MOFA Village Infrastructure Project (VIP) is to make significant improvements to this footpath in the year 2001 (Thomas K Anang Siaw and Patrick A Larbi, pers. comm.; Siaw, 2000), and so is likely to remedy this local problem. Further along the path, the track lies within a small depression (0.05-0.10 m deep, 0.3 m wide) with a sandy-gravelly surface. There is flat terrain either side of the path, so widening for IMT use should not require any slope cutting. There is one small area of the path where the soil is wet, and probably relates to a small stream crossing the path. I suspect that this would be easily culverted during the VIP path improvements. At approximately 1.5 km from Abora, there is a very flat area (perhaps a shallow depression, Figure 14), with very dark brown soils, that exhibit strong cracking (Figure 15).

Local gully development and soft ground along Path 1 would probably give problems for IMT use during the wet seasons. This path is, however, to be improved in 2001 as part of the Village Infrastructure Project. The key issue, therefore, is the success of the engineered earthworks in overcoming the local soil problems. If extreme storms ( $> 100 \text{ mm d}^{-1}$ ) occur over the next 12-15 months, gullies may develop in the feeder roads close to the village due to the intrinsic weakness of the local materials. Such gullies may hinder IMT use along short sections of the Abora-Ankamu road.

Monitor the engineering works on Path 1, particularly how the surface runoff at (a) the start of the path, and (b) within the Vertisol area, is managed. Note any gullies that develop in the new feeder road.

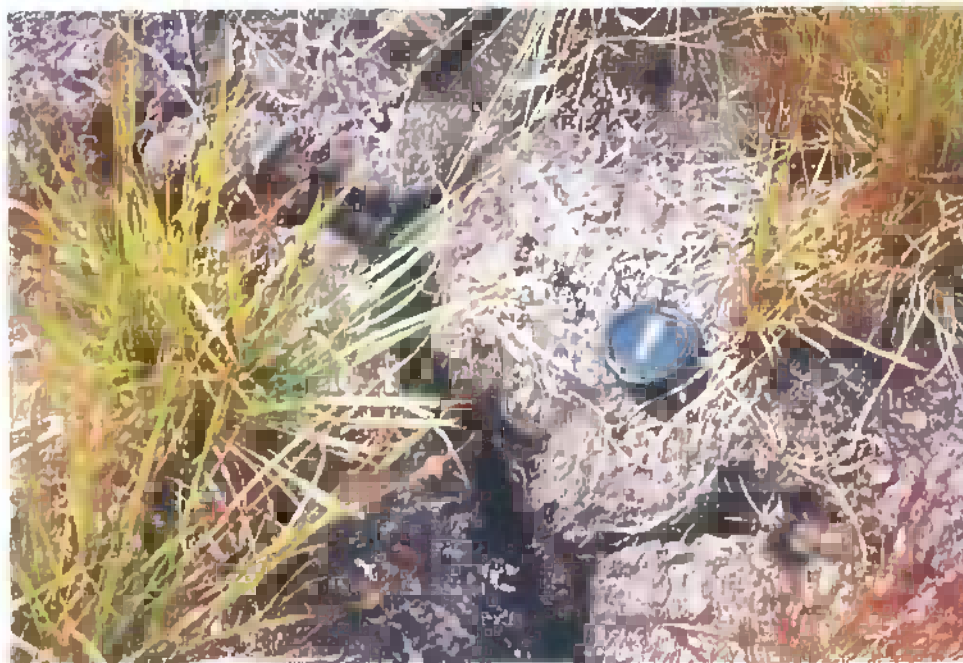
The dry-season cracking probably indicates the presence of expanding 2:1 lattice clays. These soils are mapped as Vertisol soils (locally 'Osibi-Bumbi Association'; Asamoah, 1968). While there is no evidence of old ruts associated with damage during the wet season, Vertisol soils are likely to become very slippery and waterlogged during the rainy season (once the peds have swollen with the first rains). An elevated causeway (made

Figure 15. Cracks within the Vertisol soils along Path 1, Southeast of Abora village

from soils other than Vertisols) with subsurface drainage may be necessary for successful IMT use during the wet-season. Such a causeway is planned with the VIP improvements.

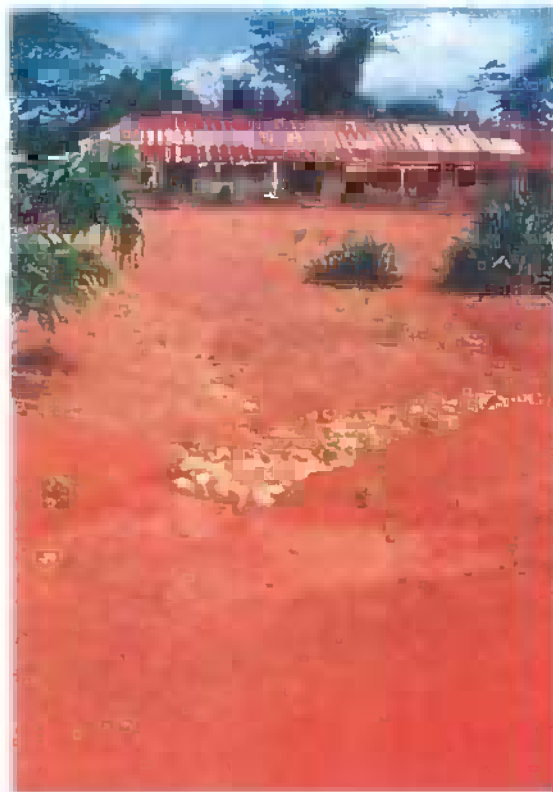
The road from Akropon to Brofo village passes through Sampa. This road is in a very good condition, probably as a result of the re-grading in May-June 1998 (Kathrin Blaufuss / Frank Owusu Acheampong, pers comm.). On the very steep section of this road immediately North of Sampa, the Western road-side drainage channel has over-deepened slightly and exposed the underlying bedrock. During extreme rainfall events (e.g., 1 in 5 year recurrence interval) of the wet-seasons, gullying is likely on such steep sections of feeder roads. Along the road to the South of Sampa, several concrete culverts (one dated 1976) were seen to be in good condition. Gully protection works were seen in the grounds of the village school. Cobbles had been placed in gullies to arrest their development (Figure 17).

Figure 17. Gully control using rock-dams, school grounds, Sampa village

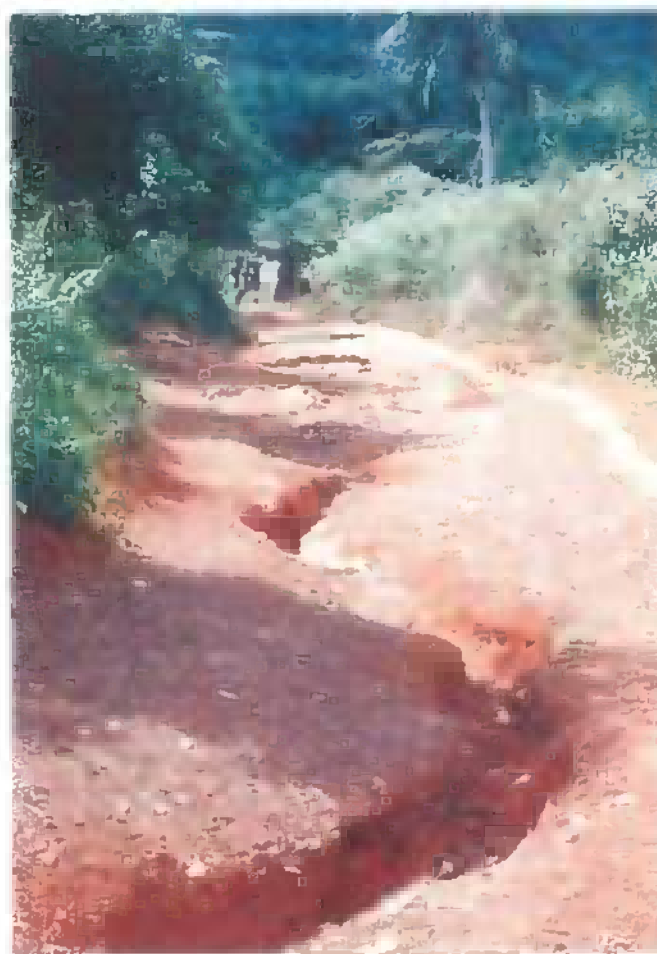
gully in excess of 100 m in length (Figure 18), and fed probably by surface flow generated in the Northwestern corner of the village. Sampa lies within the same region of relatively weak Acrisol soils as at Abora (locally 'Bekwai-Nzima / Oda Association'; Asamoah, 1968).

Figure 18. Gully development at the start of path 1, the route to the River Okye (Sampa village)

With further development, this gully would affect the passage of IMTs (see Figure 19), though I suspect that the steepness of the slope makes IMT use already hard work on this section of the Sampa-Okya River path. Below this steep section, the path has a modest gradient and is already wide enough for the use of IMTs. The soils are very dry (< 20 % moisture content by volume), with the exception of one flat area half way to the R. Okya (by the plantain plot). The wetness of the soils in this area allowed estimation of the particle texture, which appeared to be a loam. By the River Okya, the soils were, however, sandy (probably alluvial sands).

The paths seem relatively stable and capable of supporting the IMTs, with the possible exception of the very steep section of Path 1, as it leaves Sampa. Indeed, the IMTs may exacerbate the gully development if soil conservation measures are not undertaken. The feeder road in this locality appears relatively stable.

Monitor the growth of the gully at the start of Path 1, and any soil conservation measures undertaken to maintain trafficability.

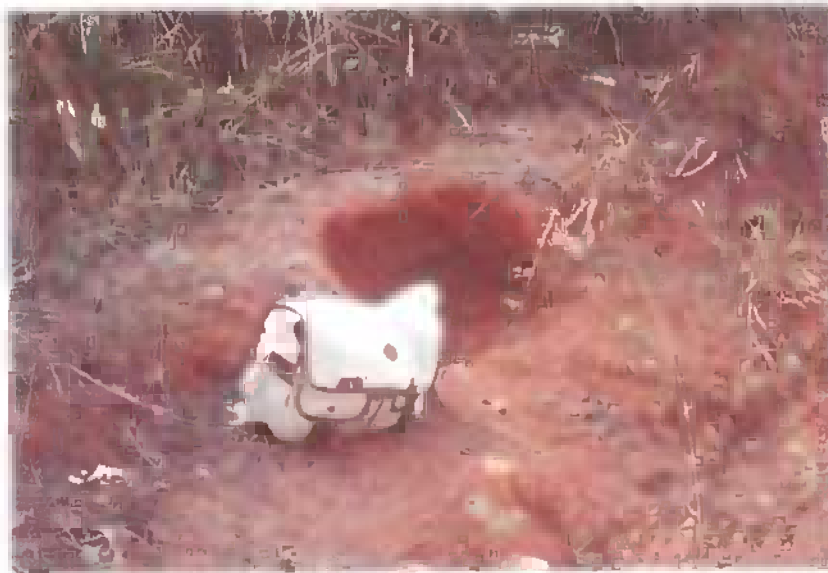
The feeder road from Lome to Dawurampon town had a very uneven surface in places, indicative of the presence of ruts and very poor trafficability during wet seasons. This road had been re-graded in November-December 1999 (Kathrin Blaufuss / Frank Owusu Acheampong, pers comm.). Close to the village, the road appeared to be in a better condition. This may have been because of the relatively modest slopes, or to small-scale repairs undertaken by the villagers themselves (Figure 21).

Figure 21. A small borrow pit (?), used to repair small road gullies, Lome village

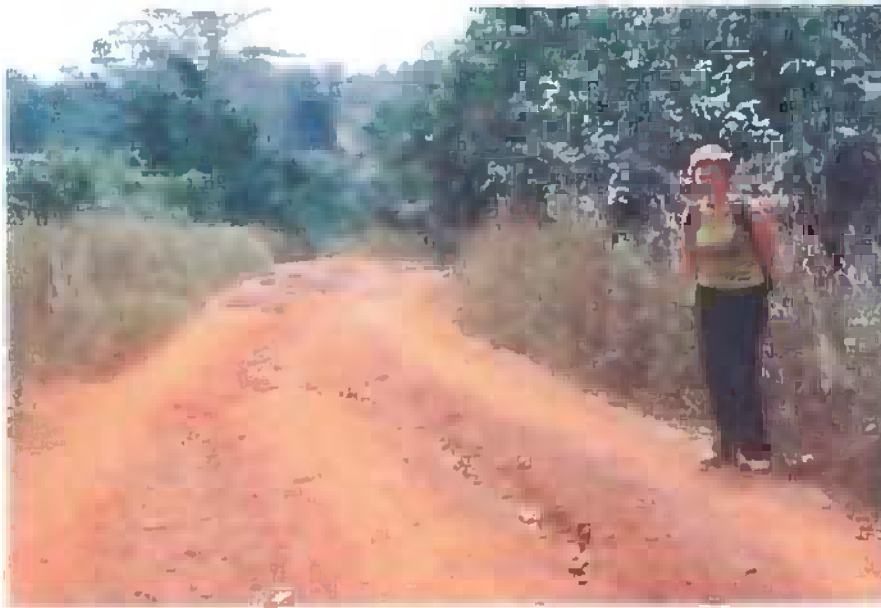
Neither the feeder roads or the village itself are shown on the 1:50,000 map (sheet 0502B2) produced in 1974/5. In places the local feeder roads have a very uneven surface indicating severe trafficability problems during wet seasons. Mud has been splashed to great heights onto the road-side vegetation, probably indicting heavy use of the road by lorries (perhaps transporting the cocoa). The road East of Awurabo (towards 'Japan Bridge') had been re-graded in June 2000 (Kathrin Blaufuss / Frank Owusu Acheampong, pers comm.). The distances from Awurabo village East to the market at Assin Akonfonde (via 'Japan Bridge') or South to the market at Assin Akropon are both in excess of 10 km, the latter feeder road being particularly gullied (Figure 24).

Figure 24. A heavily gullied section of feeder road near to Awurabo village

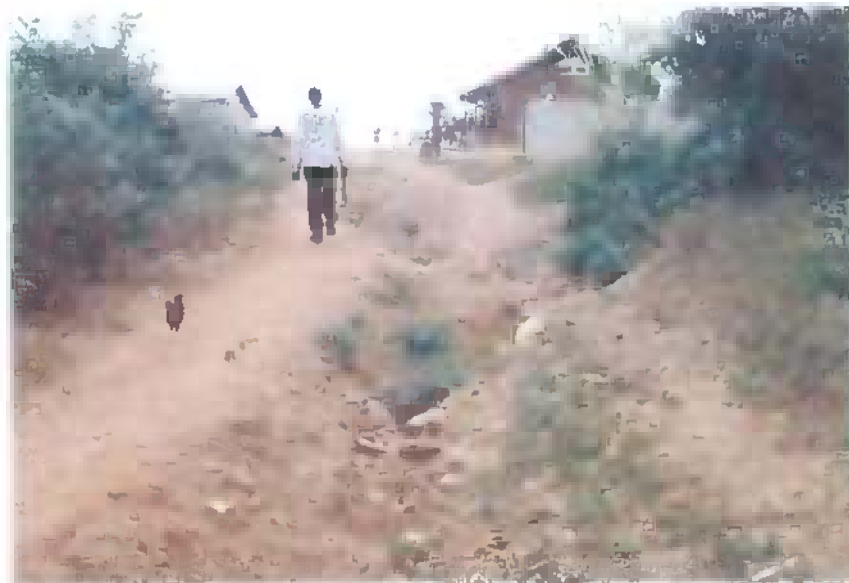
Path 1 leads from Awurabo in the Southwesterly direction towards 'Japan Bridge'. The first section of this path is gullied, and rocks have been used to attempt to check the development (Figure 25). Further along the path, there is evidence that a tracked-vehicle had been used to widen the path (undertaken during July-August 2000; Kathrin Blaufuss / Frank Owusu Acheampong, pers comm.). The undulating surface of this track indicates some local instability / erosion (Figure 24). Awurabo is within an area mapped as Acrisol (locally 'Nsaba-Swedru / Nta-Ofin Association'; Asamoah, 1968). The presence of cracking may indicate the presence of unstable clays (Figure 26) and hence the possibility that these soils may be a more erodible Acrisol-Alisol intergrade (Driessen and Dudal, 1991). The Alisol classification has only been identified since 1988; such soils were formerly classified with the more stable members of the old Acrisol group. Local cation

**Figure 25. Gully at the start of path 1, Awurabo village. Some gully control may have been undertaken with rock placement.**

Development of the gully at the start of Path 1 may make IMT use difficult, as may further deterioration of a latter section of the same path that was affected by a tracked vehicle. Path 1 may be sensitive to IMT damage during wet seasons and should be monitored. The streams and narrow bridges along Path 2 and 3 may inhibit the use of IMTs for transporting produce from distant fields.

Observe the development of the gully at the start of Path 1, and record any repairs (soil conservation measures). Observe if the tracked-vehicle damage to Path 1 further deteriorates or stabilises.

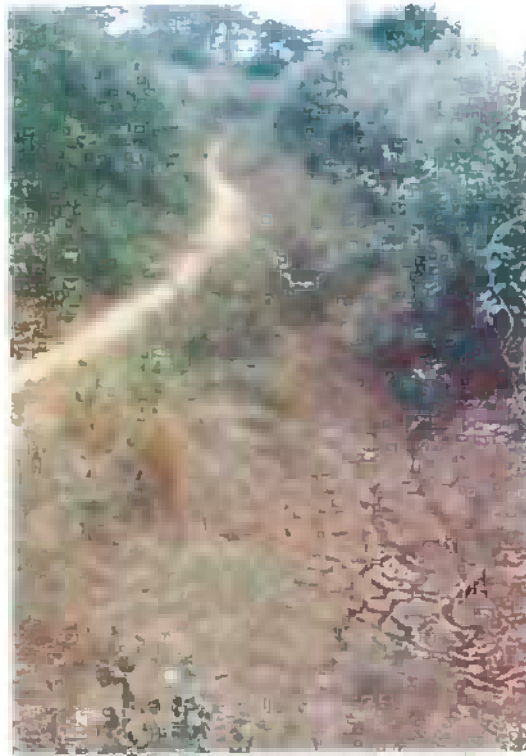
**Figure 26. A section of Path 1 (Awurabo village) widened by a tracked vehicle, showing signs of swelling clays (i.e., instability) and gulying**
