RESEARCH REPORT 381

CONCRETE PAVEMENT TRIALS IN ZIMBABWE

By J D Parry, N C Hewitt and T E Jones

Project title: PC Concrete Pavements

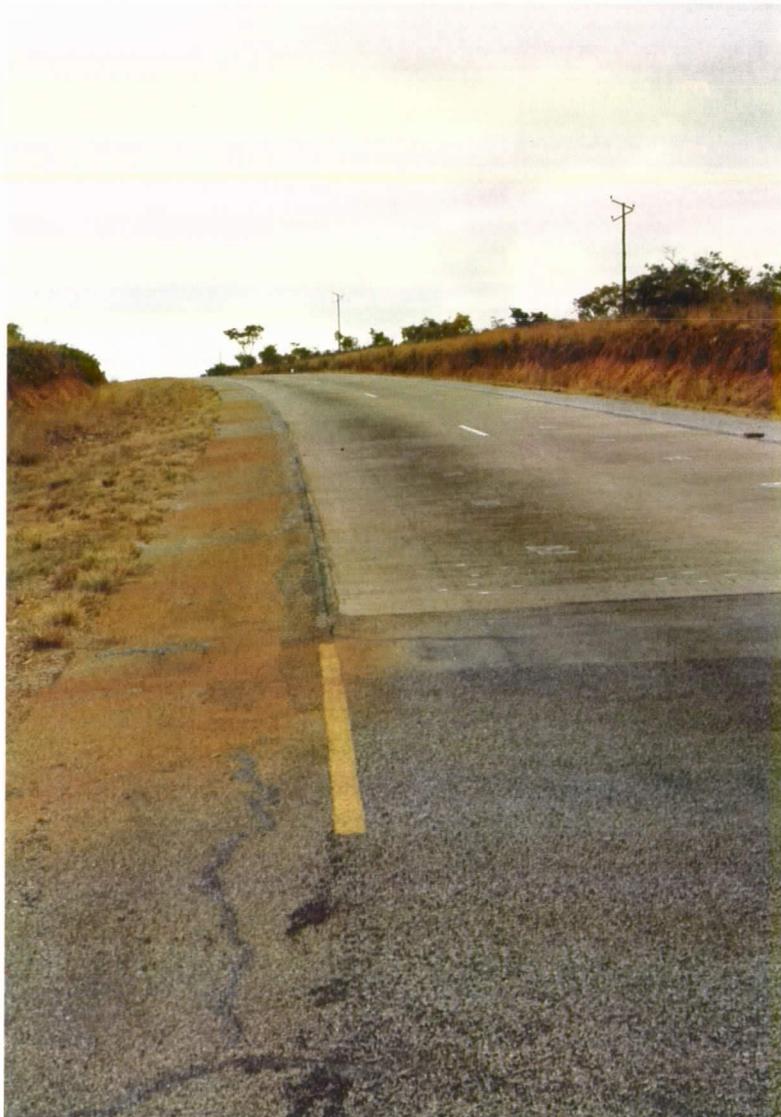
and through the gap between the shoulder and the concrete slabs. There is no apparent correlation between the amount of pumping, according to stains on the shoulders, and the magnitude of the measured deflections, but staining was more marked at the lower side of all three super-elevated sections.

Plate 1 Pumping stains on the hard shoulder of test section C4

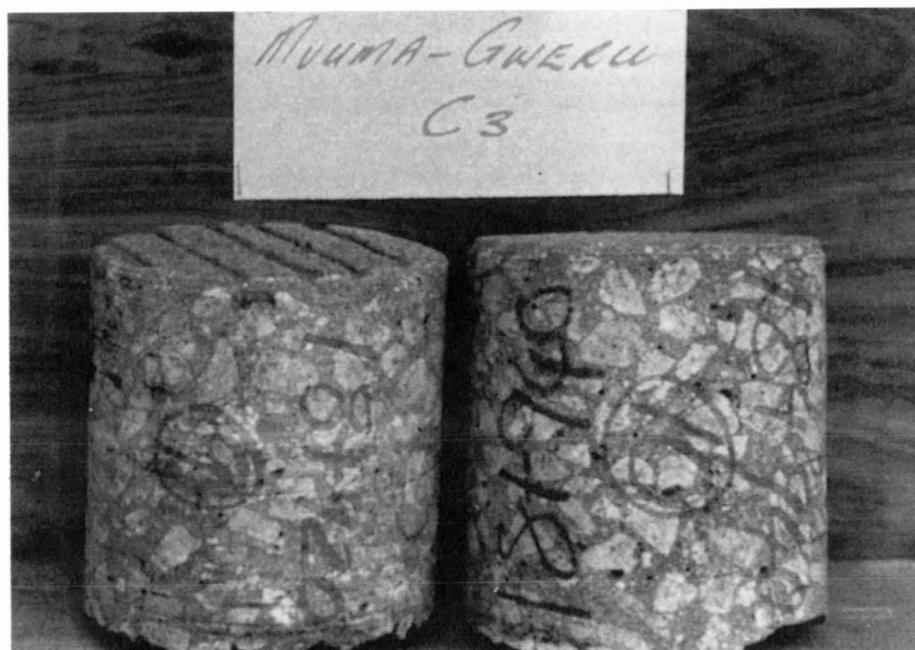
Plate 2 shows typical cores cut from section C3. Compaction is seen to be uniform and distribution of aggregates is also good. The contractor achieved the same concrete density in the pavement as in the samples made for laboratory testing.

Plate 2 Cores cut from test section C3

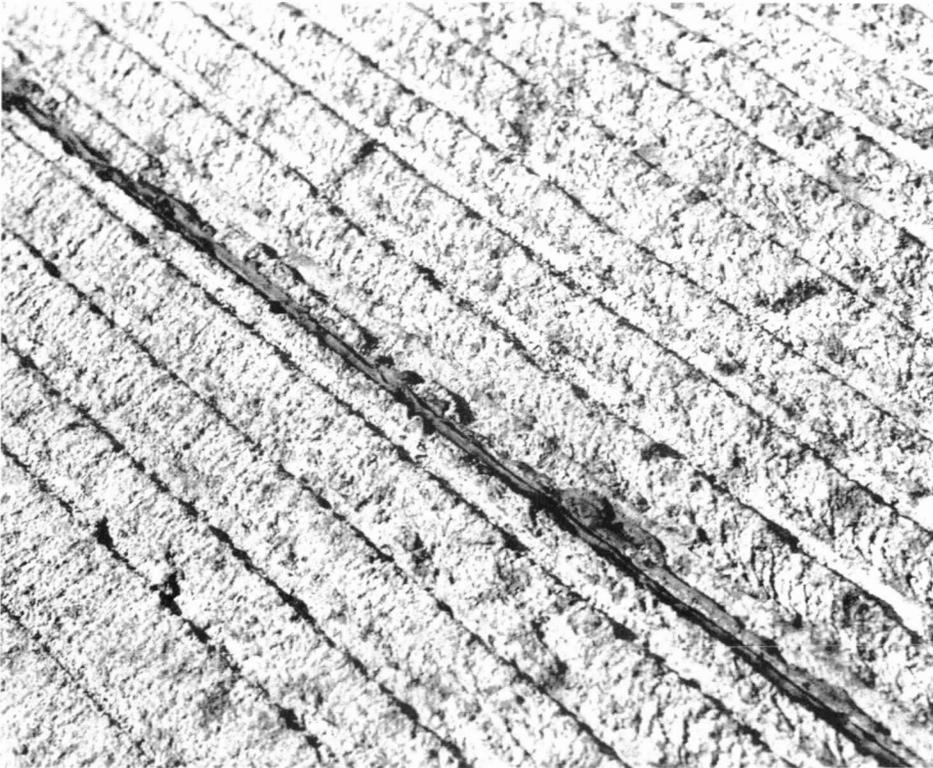
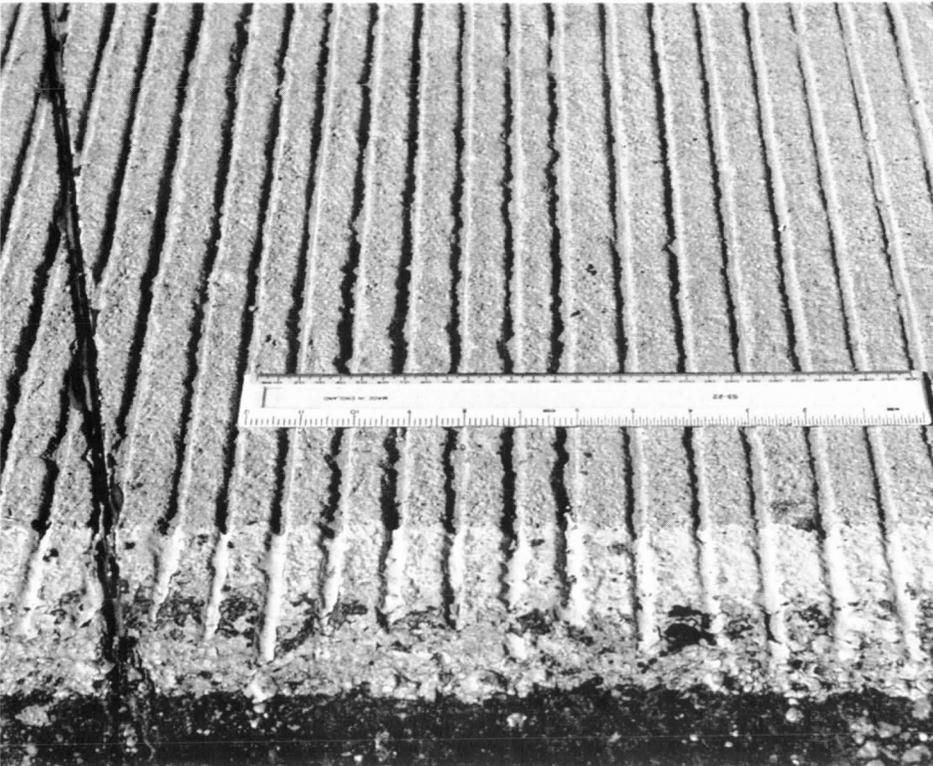
A design feature that increased the penetration of water past the damaged joint seals is the skew of the joints on test sections C1 and C4. Plate 3 shows how water running down the texture grooves is intercepted by the skewed joint and penetrates the joint far more easily than it could if the joint were cut parallel to the texture grooves. Clearly, the more water that penetrates the joint, the more likely that damage will occur to the sub-base or subgrade material.

Plate 3 Square and skew joints in relation to transverse drainage grooves

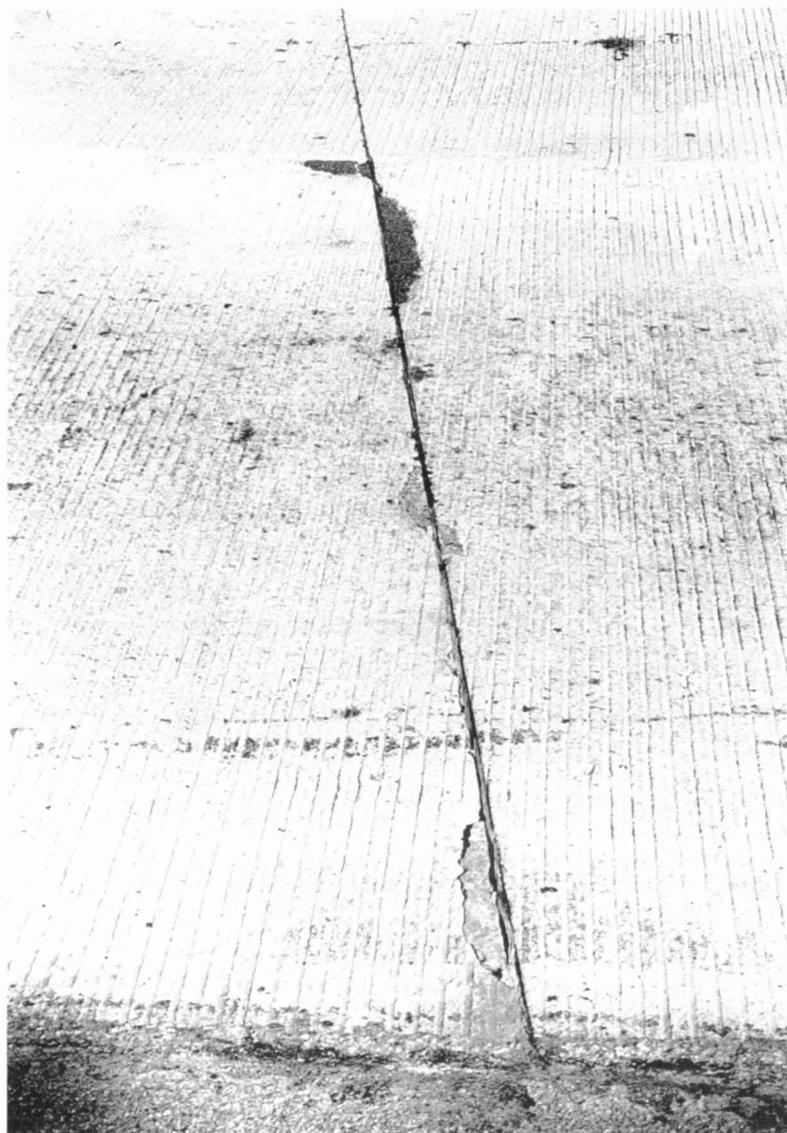
spalling and stepping, that also require attention, (Table A11). Plate 5 shows a joint with spalling problems from the time of construction. The type of repair required is referred to in the DTp advice note HA35/87 (1987) as “arris or thin bonded repair.” Where transverse cracks completely cross a slab close to the joint, full depth repairs are appropriate. Where a narrow transverse crack crosses in the central region of a slab without stepping, no repair is required.

Plate 5 Spalled joint

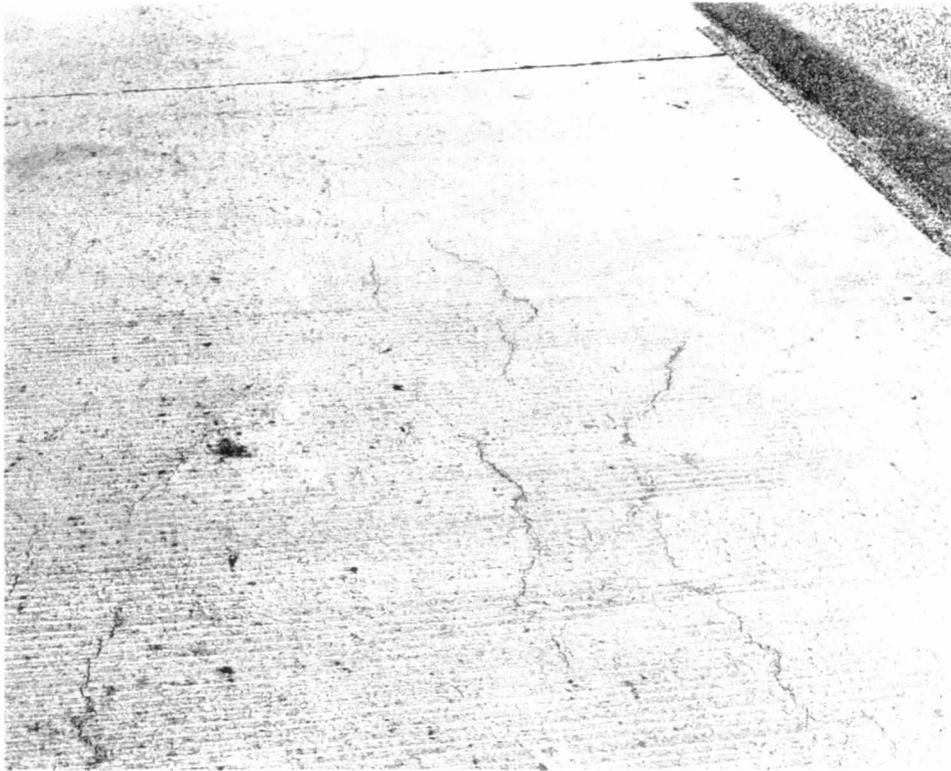
Plate 6 illustrates shallow plastic cracking caused by drying winds blowing over the wet concrete before the hessian was placed to cover it. This cracking is not structural. Plate 7 shows the small corner cracking that occurred mainly on section C3 and Plate 8 shows a typical transverse crack; this one on section C1 was caused by shrinkage before traffic loading started.

Plate 6 Plastic cracking on test section C3

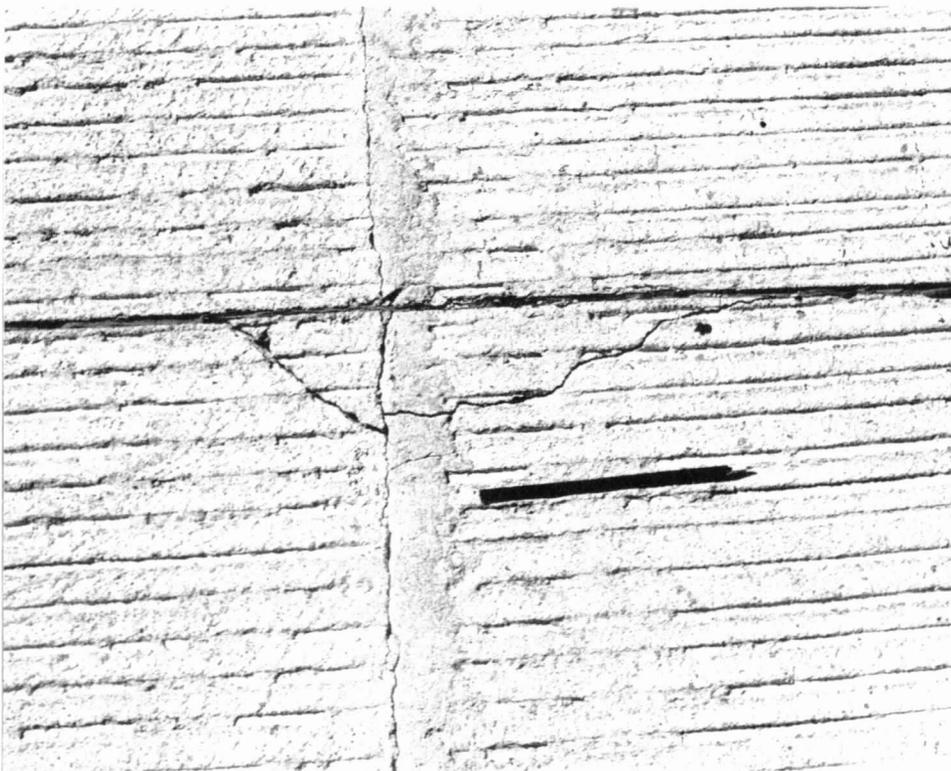
Plate 7 Corner cracking on test section C3

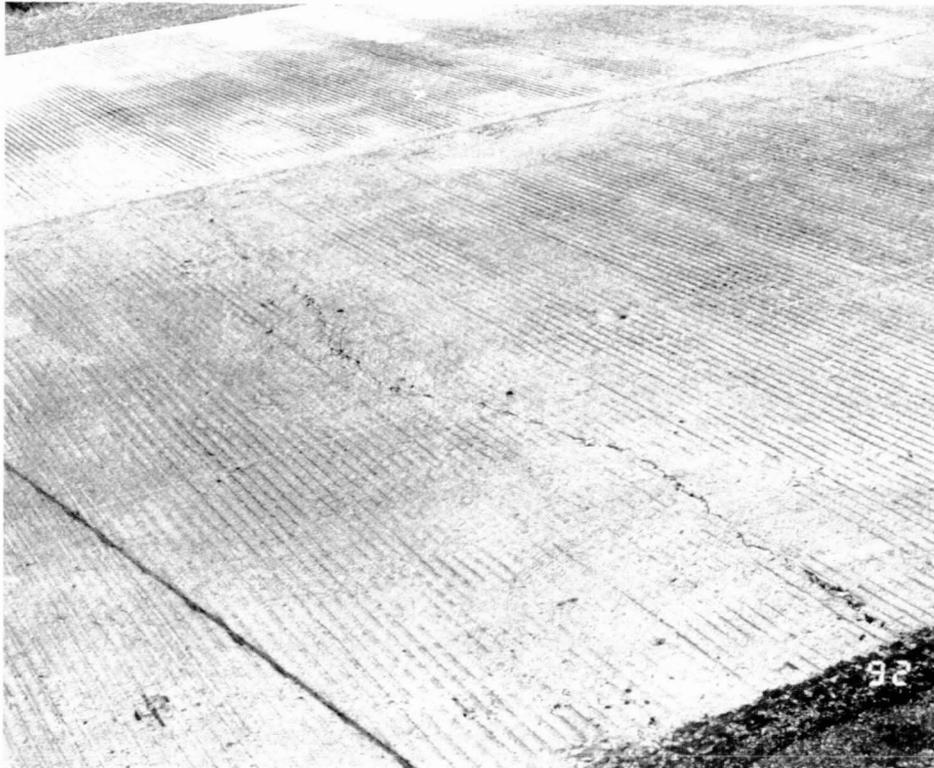
Plate 8 Transverse crack on test section C1
