Mozambique RRIP/AFCAP Back Analysis Research Project (TRL/ANE)

by Kenneth Mukura and Dr. John Rolt - TRL

ARRB LVRS Symposium, Cairns Australia - 25-27
November 2013

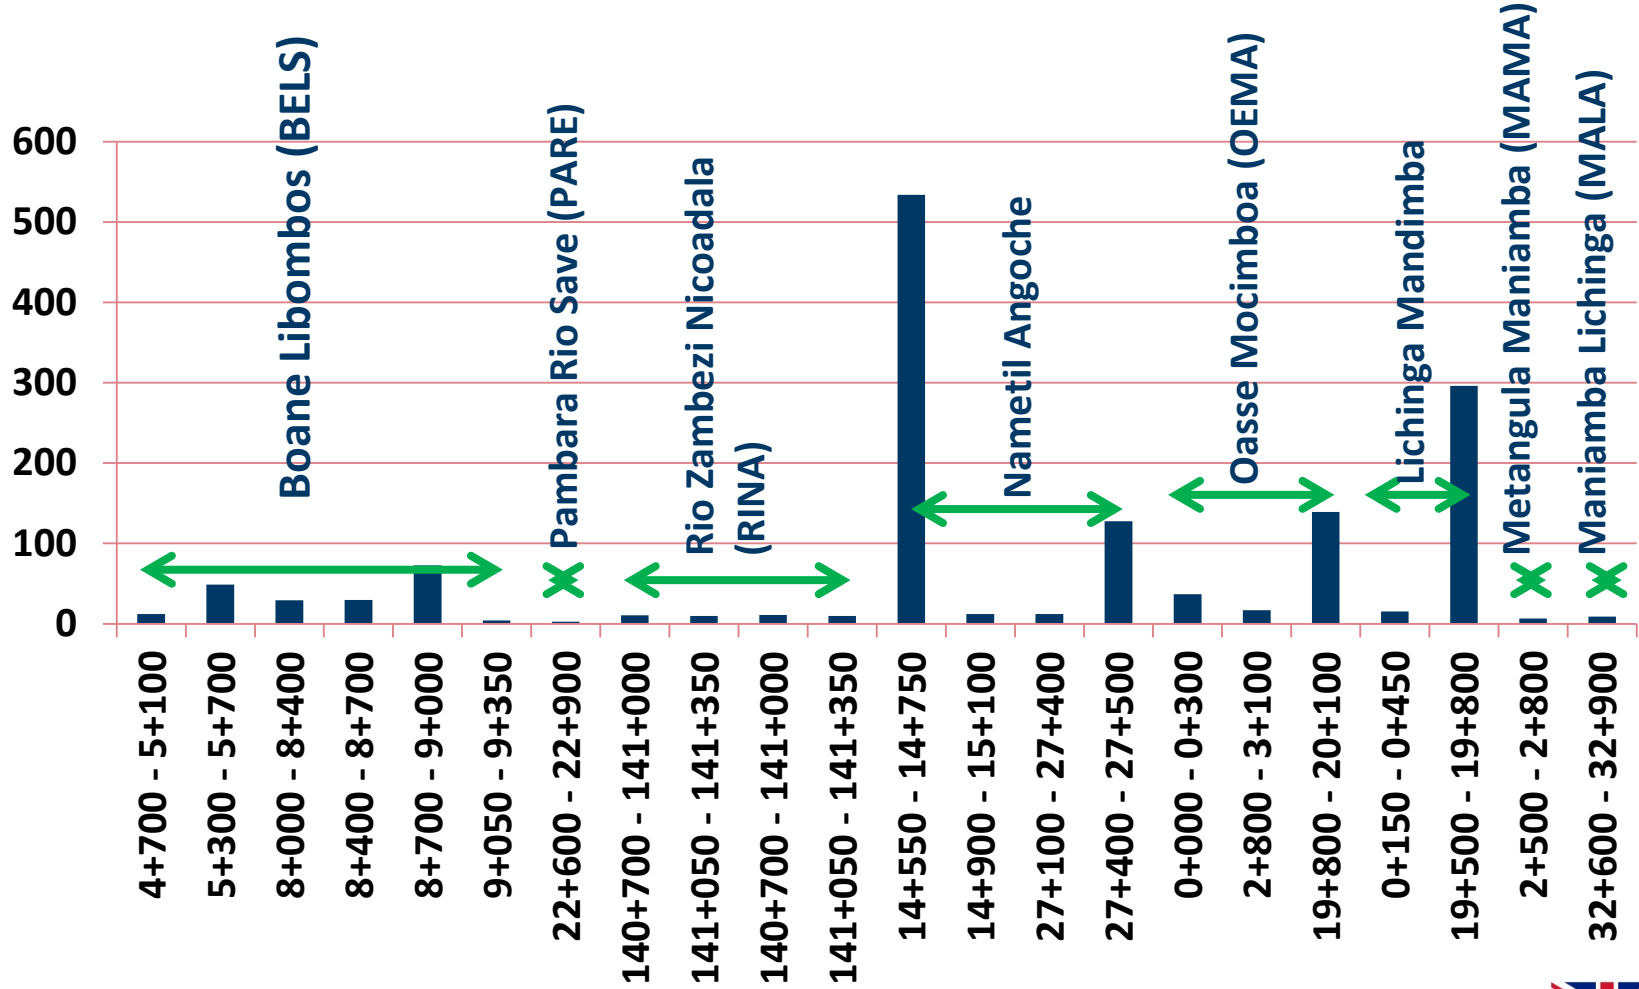
Deterioration index (DI)

- $DI \leq 40$ is indicative of a surfacing in good condition.
- $DI > 40$ not satisfactory.
- 6 sections out of 22 were considered unsatisfactory but 2 were only marginally so.
- Low values of rut depth indicate very little if any structural failures.
- Cracking, potholes (and their patching) were the main reasons for deterioration.

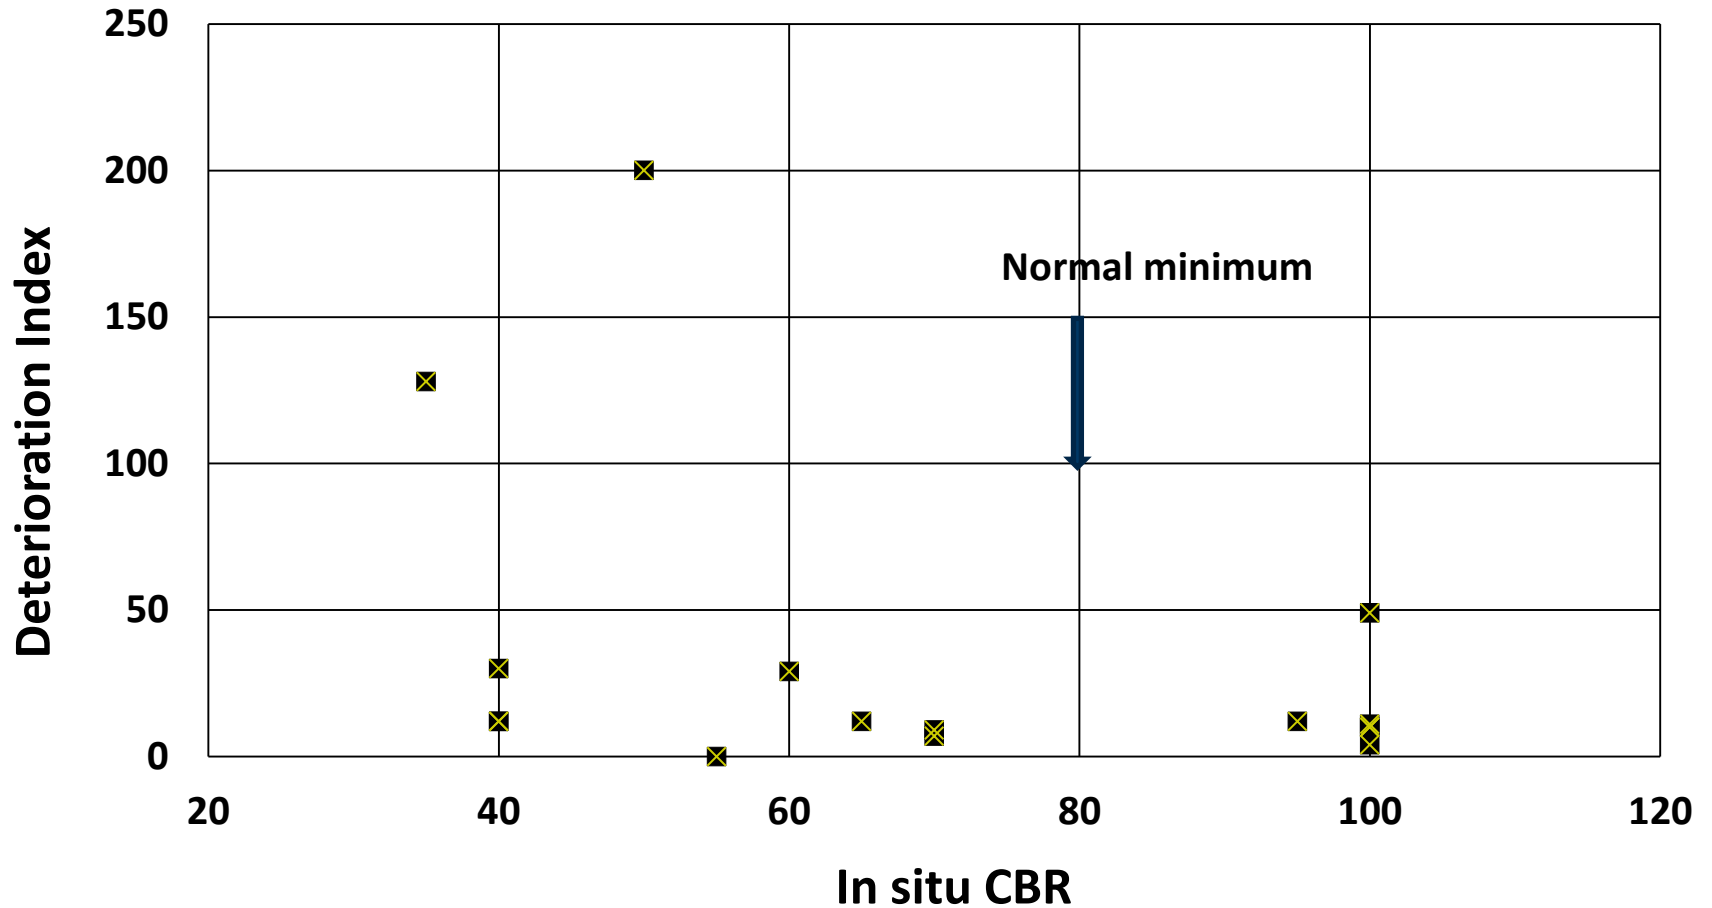
In situ Roadbase CBR

1. 40% of the road bases had in-situ CBR > 90%.
2. 20% of the road bases had in-situ CBR < 55%.
3. 10% of road bases had in-situ CBR < 40%.

No structural failures were noted.

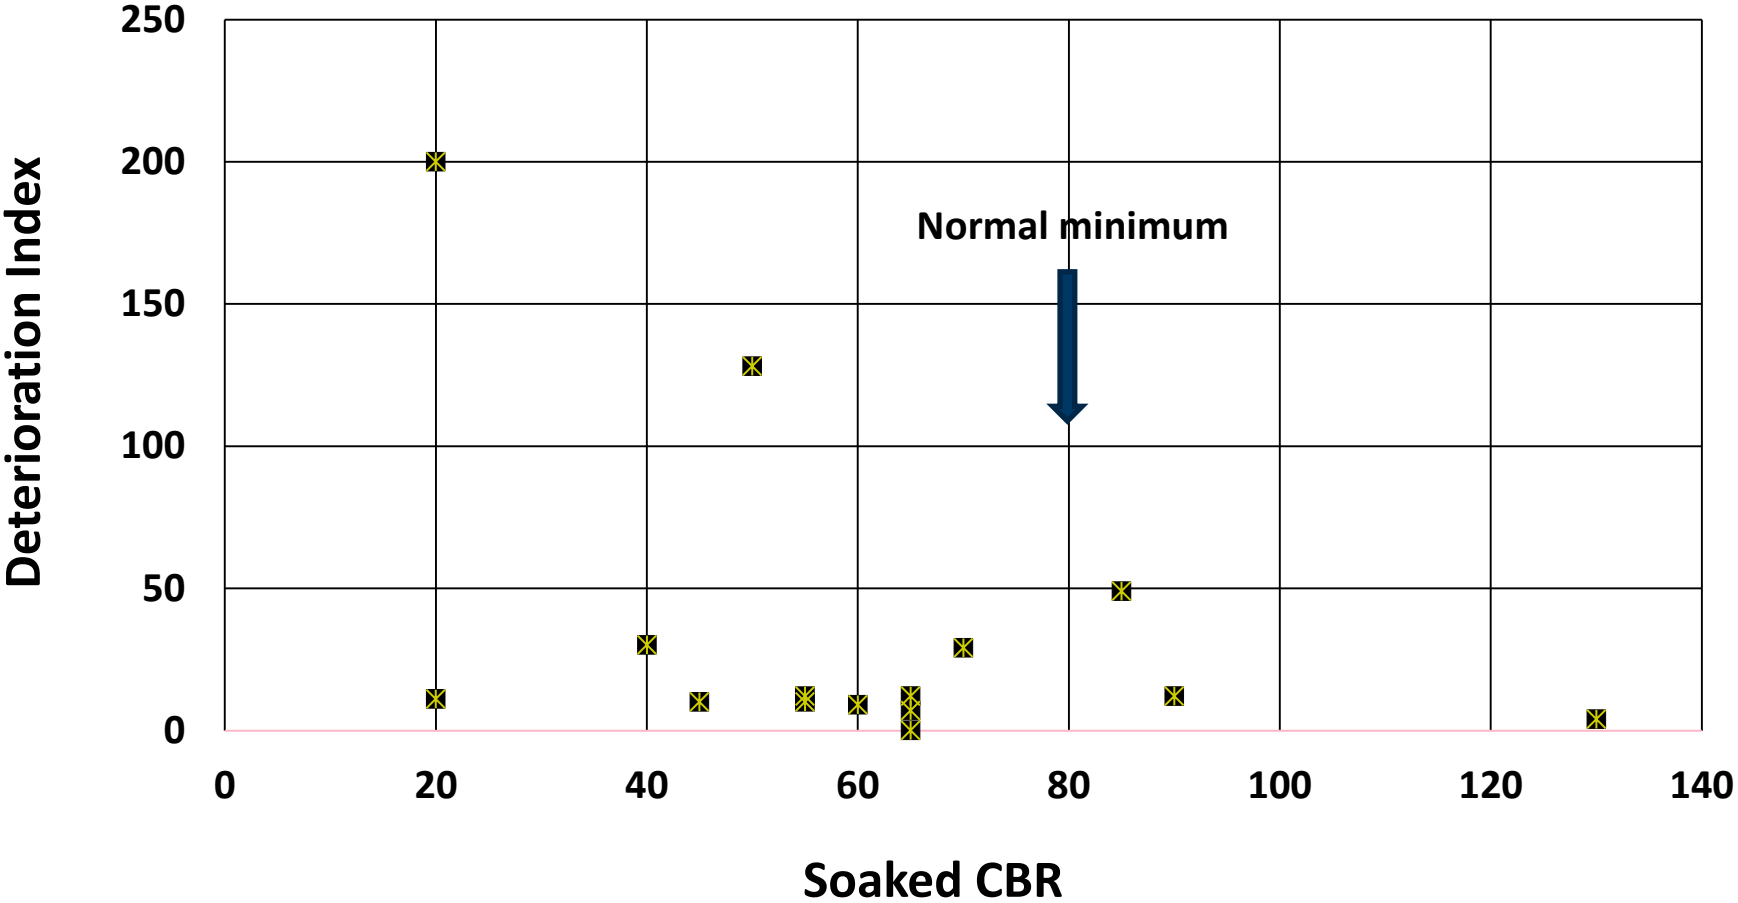
Soaked Roadbase CBR

1. 20% of the road bases had soaked CBR $> 80\%$ CBR, the basic conventional specification.
2. 40% of the road bases had soaked CBR $< 50\%$ CBR, a value frequently used for LVRs
3. 3 road bases had soaked CBRs $< 30\%$

No structural failures were noted

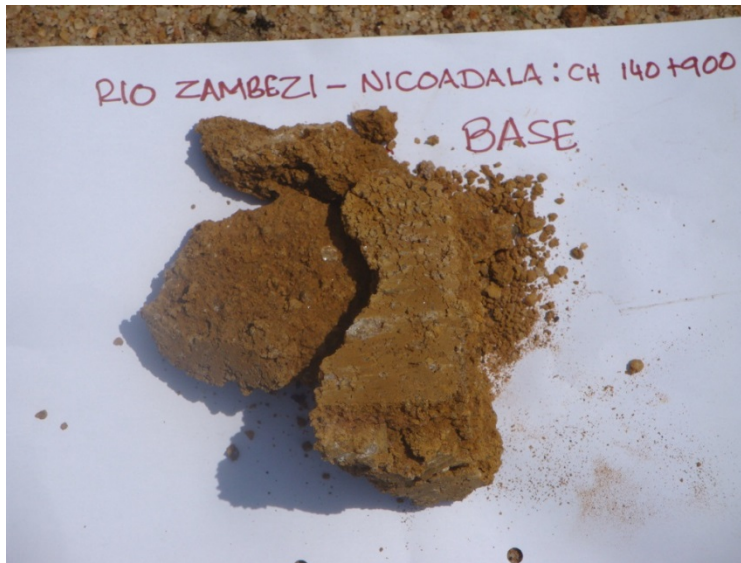
Rio Zambezi Nicoadala Site, N1 North South Highway with Heavy Trucks - 4.5mesas.

**Roadbase - Clayey soil: PI = 20,
Soaked CBR = 5%, moist in-situ.**

Yet No Failures Observed

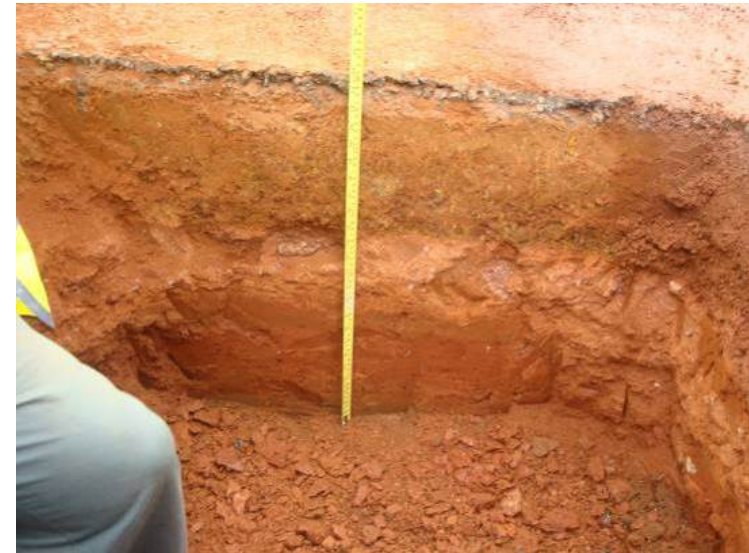
Maniamba Lichinga Site, built in the 70s by the army, on high embankment.

Laterite base: very dry and hard upper part and wet and soft lower part

Red silt subgrade: very dry and hard upper part, wet and soft lower part

No failure. Sandwiched moisture?

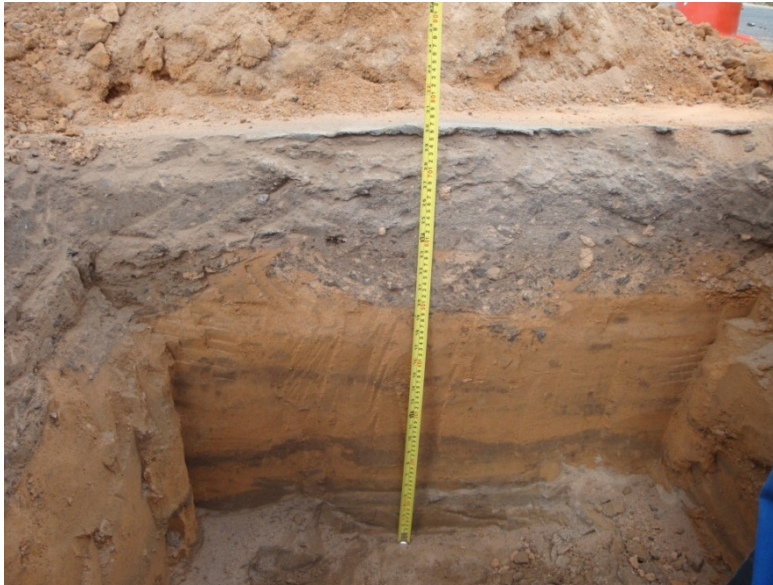
**Oasse Mocimboa da Pria Site,
upgrade to sealed road 13yrs before.
Sand seal, ETB, imported sand
subbase (wet), in-situ grey sand
subgrade (dry)**

**DCP failed to penetrate grey in-situ
sand subgrade – consolidation!!!**

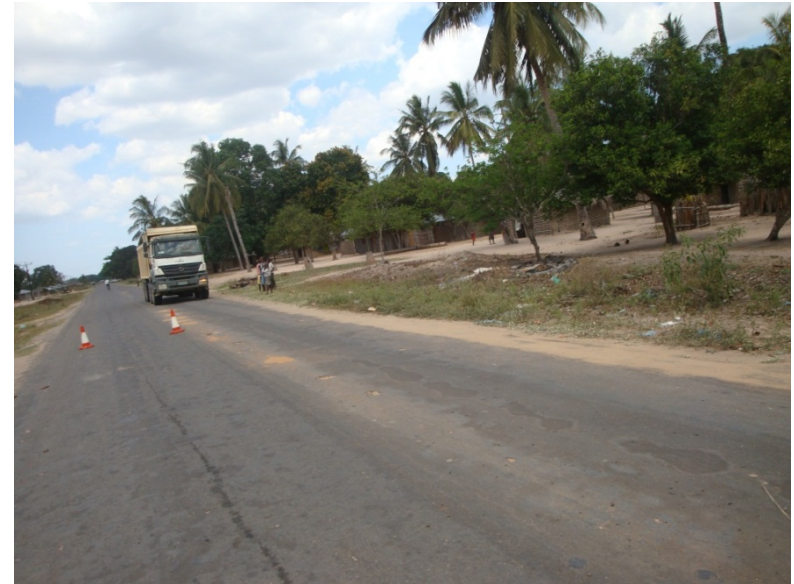
**Oasse Mocimboa da Pria Site,
upgrade to sealed road 13yrs old,
1.27 MESAs.**

**Sand seal, ETB, imported sand
subbase, in-situ sand subgrade**

Sand seal still in good condition???

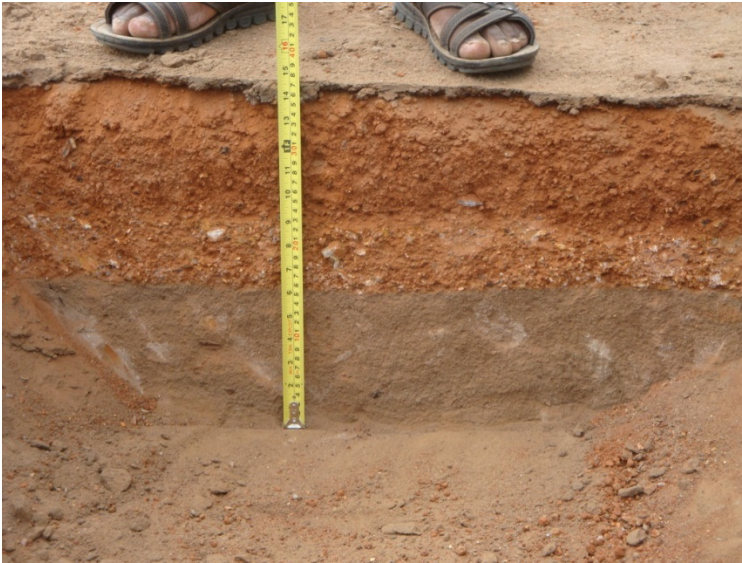
Nametil - Angoche Site, upgraded to sealed road 5yrs before.

Otta seal, laterite base, grey in-situ sand subgrade.

DCP failed to penetrate grey in-situ sand subgrade – consolidation!!!

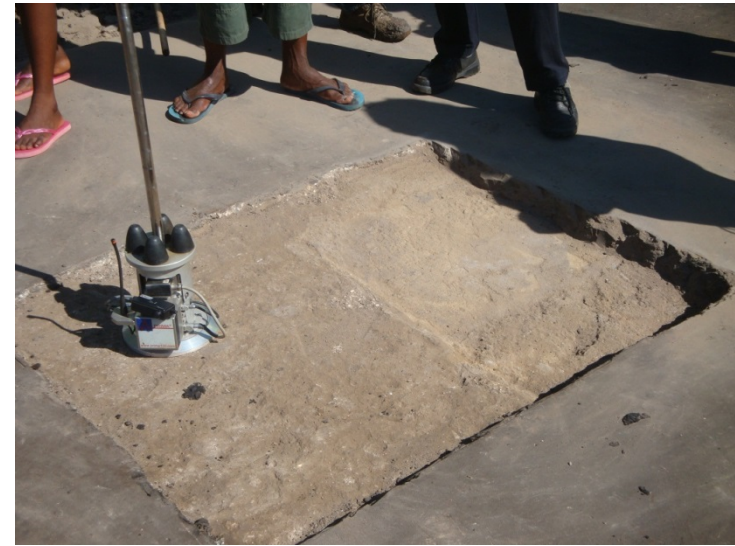
Pambara - Rio Save Site, cement stabilised base > 40yrs old.

Hot sand asphalt, CTB, imported red sand subbase, red silt subgrade.

In-situ red silt stabilised with cement.

No cracks!!! No trace of cement???

100% Carbonation of cement???
