# Rail Accident Report

## **Collision between two trams at Shalesmoor, Sheffield 22 October 2015**

Report 17/2016  
August 2016

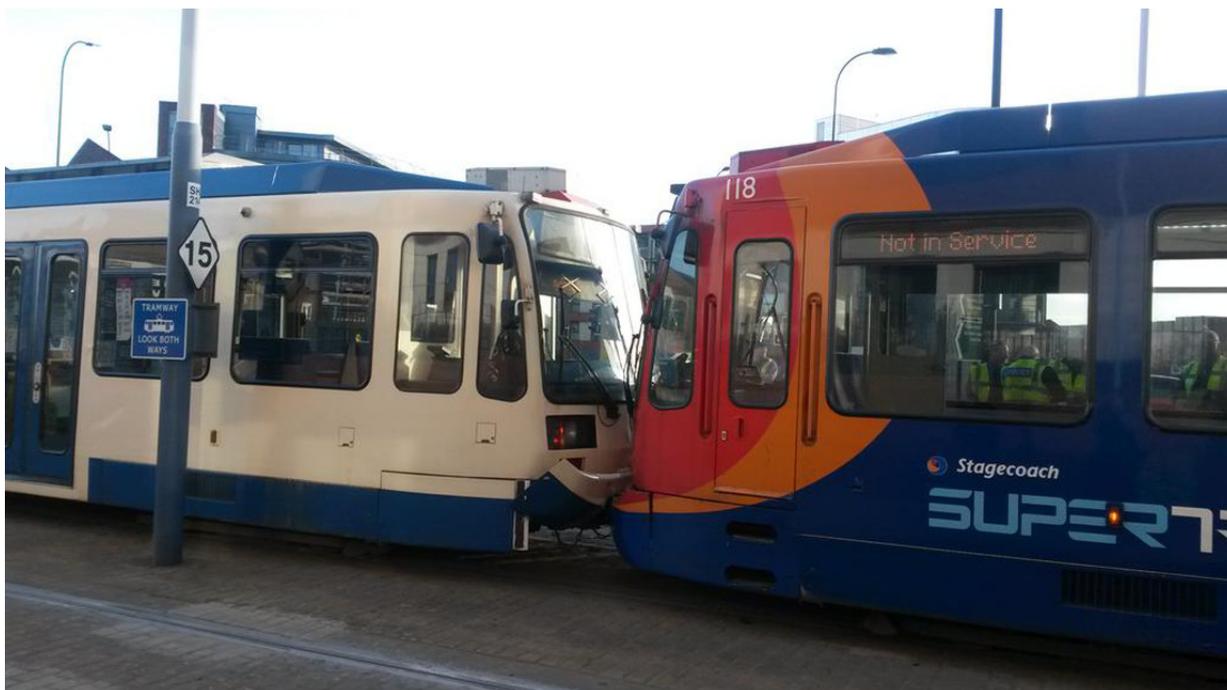
Figure 3: The two trams immediately after the collision (photo courtesy of Sheffield Star)

- 4 A member of Stagecoach Supertram staff and fifteen passengers received minor injuries as a consequence of the collision. Both trams were seriously damaged, and the tramway through Shalesmoor was closed for the remainder of the day while recovery of the damaged trams took place.

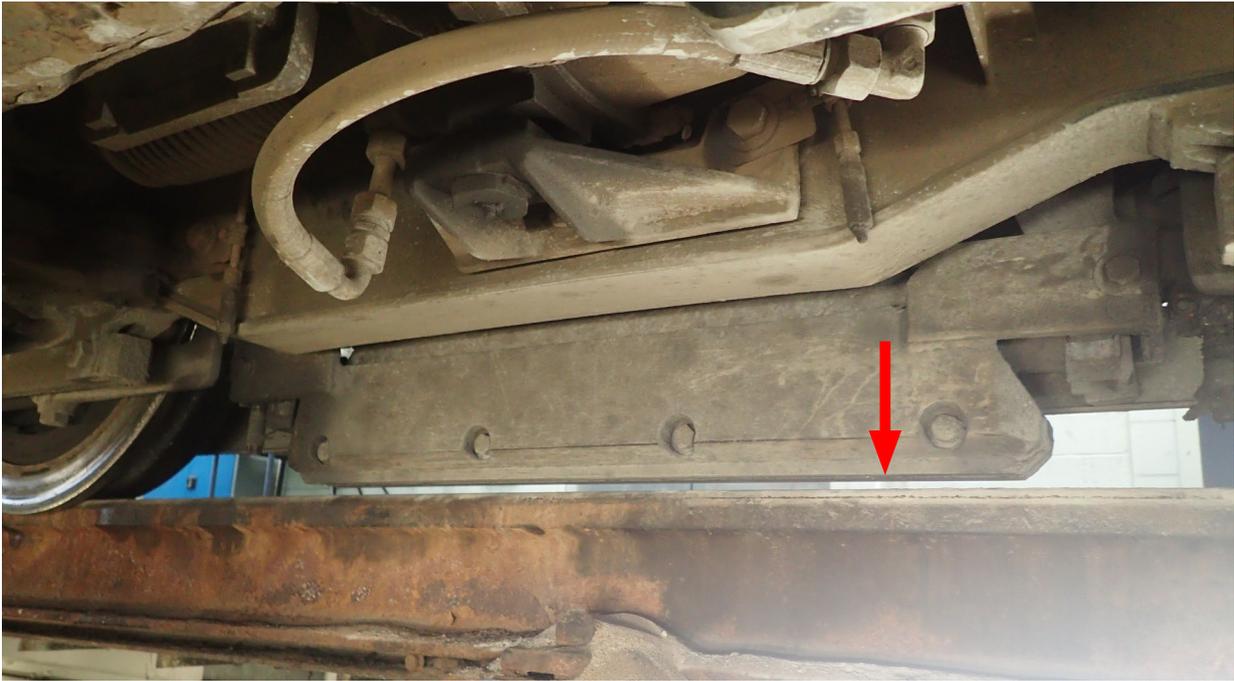
- A pneumatic brake which uses air-operated disc brakes fitted to the vehicle axles.
  - A magnetic track brake which uses electro-magnets to clamp brake shoes directly to the rail head (figure 6). These brakes are only utilised when the driver selects either the hazard or emergency brake (see paragraph 39).

Figure 6: A magnetic track brake shoe as fitted to a Sheffield tram; arrow indicates direction of movement of magnetic track brake when energised

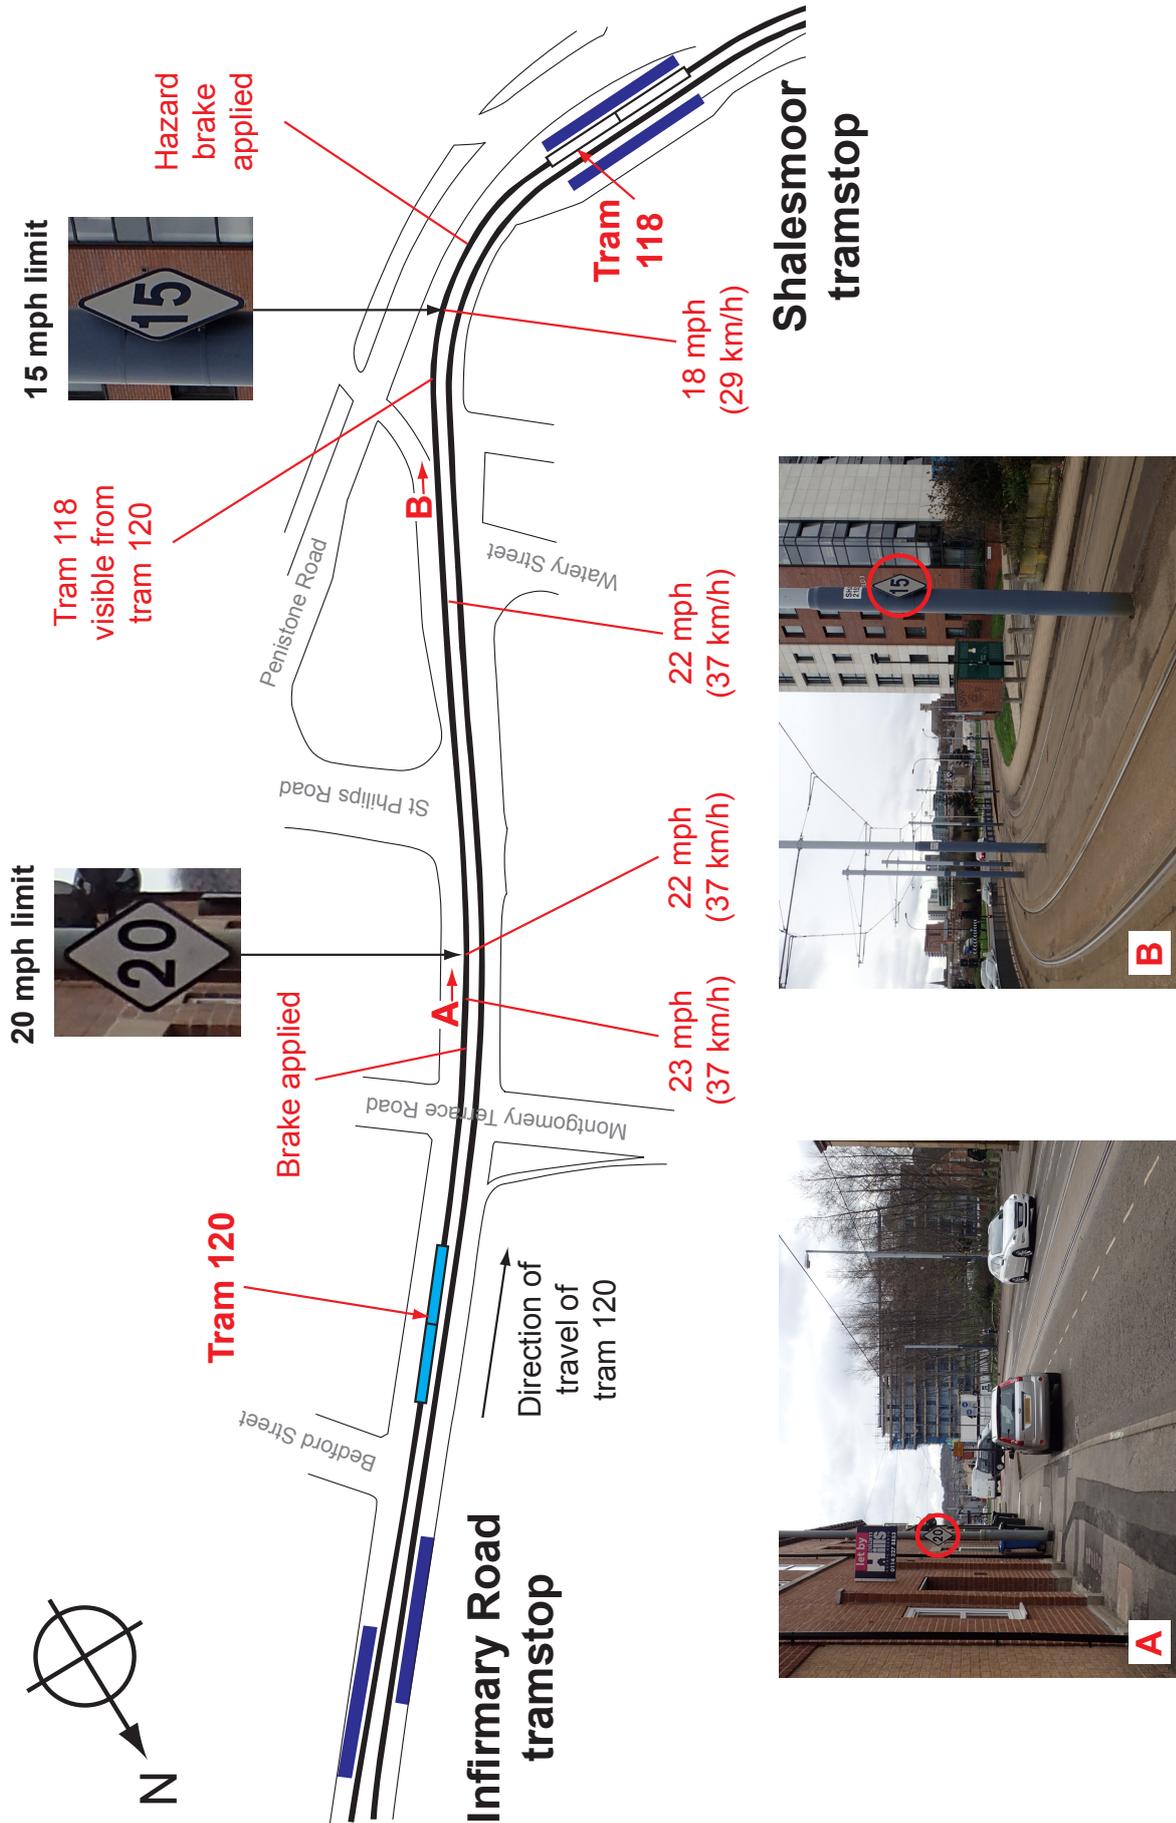
- 44 As the driver of tram 120 proceeded towards Hillsborough from Malin Bridge, he encountered a 'stop' indication from the traffic signal system. This indicated to him that another tram had approached Hillsborough from the Middlewood route, and was a short distance in front. However, tram 118 had departed from Hillsborough tram stop by the time that tram 120 arrived. Tram 120 proceeded towards Shalesmoor, stopping at all three intermediate tram stops. Tram 118 was occasionally visible in the distance. Tram 120 had commenced braking for the tram stop at Shalesmoor from a speed of 23 mph (37 km/h) approximately 230 metres before the point of collision. The tram was still moving at 22 mph (25 km/h) when it passed the 20 mph (32 km/h) speed limit board near St Phillips's Road (paragraph 6 and figure 8). Thereafter, stationary tram 118 would have become visible to the driver of tram 120 approximately 70 metres before the collision (figure 8). Tram 120 was travelling at 18 mph (29 km/h) at the 15 mph (24 km/h) limit (paragraph 6 and figure 8) on the final approach to Shalesmoor tram stop.

- 45 The data recorder on tram 120 showed that the driver deployed the hazard brake 25 metres before the collision, when the tram speed was 14 mph (23 km/h). Had there been normal levels of rail head adhesion, this distance should have been sufficient for tram 120 to stop before colliding with tram 118. However, the low level of rail head adhesion present at Shalesmoor (paragraphs 55 to 58) meant that the hazard brake was significantly less effective than would normally be expected.

Figure 8: Map showing start of braking, 20 and 15 mph signs, point of deployment of hazard brake and point of impact

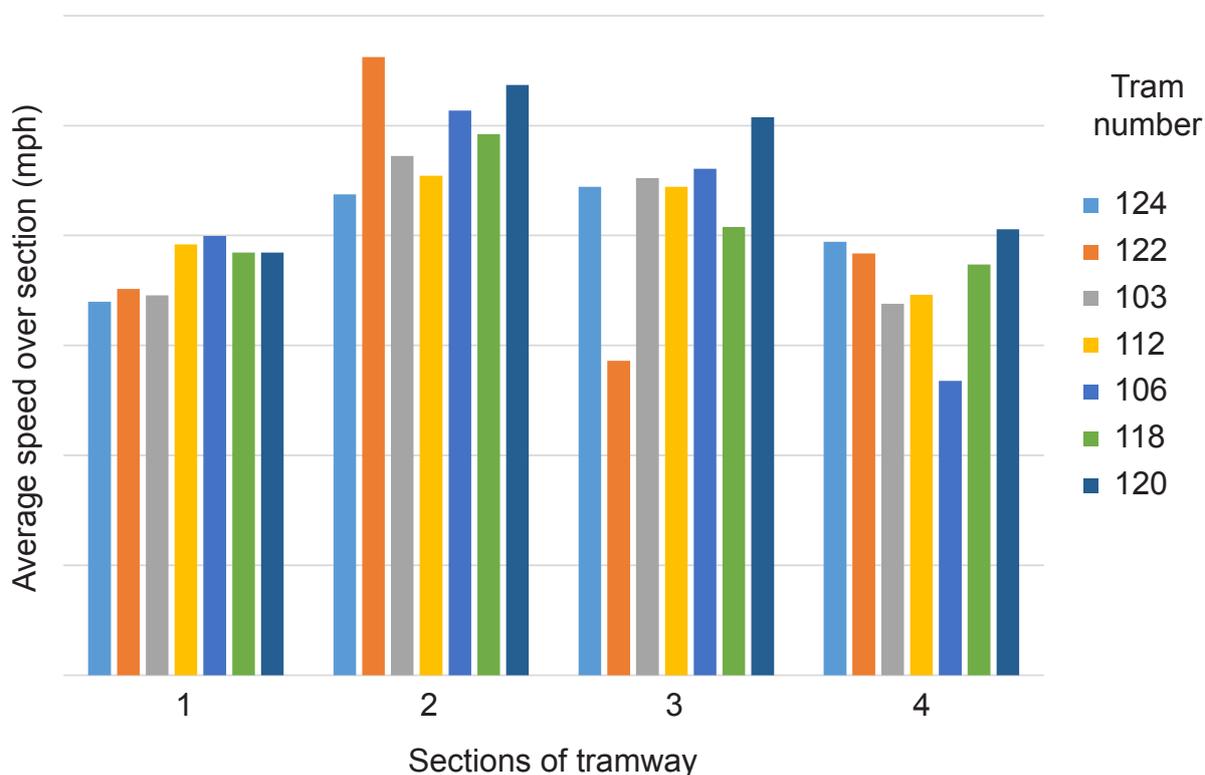
- 46 The RAIB carried out an analysis of tram speeds between Hillsborough and Shalesmoor on the morning of 22 October 2015 before the accident using data from the VIS loop system for four sections of the route. The sections were chosen to minimise, as far as possible, the effect of traffic lights and road congestion. The average speed for each of seven trams on each of the four sections was calculated. This data is shown in figure 9. Tram 120 recorded the highest average speed on two of the four sections, and was above the median for the other two sections.

Figure 9: Comparison of average speeds (mph) of seven trams on four sections of track between Hillsborough and Shalesmoor on 22 October 2015

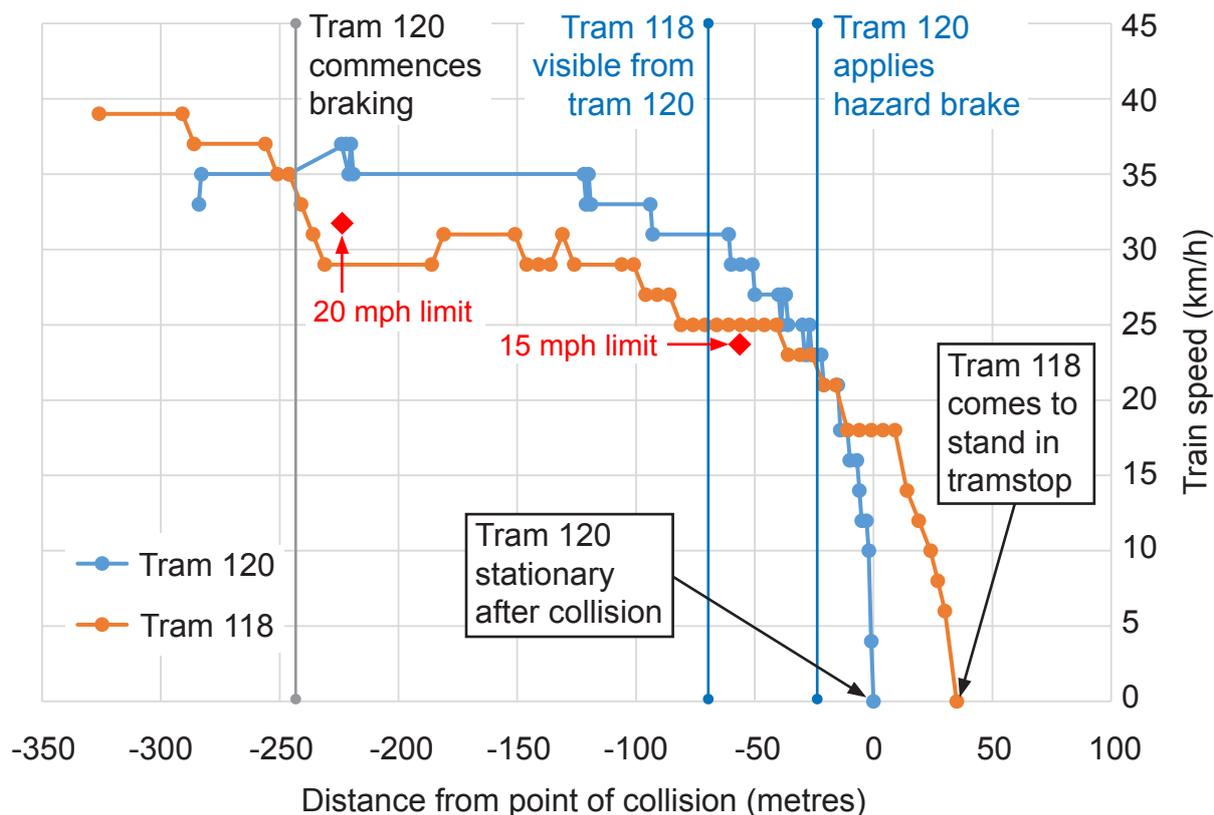
- 47 Using evidence from the On-Tram Data Recorder (OTDR) and Closed-Circuit Television (CCTV) systems fitted to trams 118 and 120, the RAIB compared the speed profile of the two trams on the approach to Shalesmoor tram stop. This data is plotted in figure 10, and indicates that, although the deceleration rates of the two trams are similar (before the application of the hazard brake by tram 120), tram 120 was unable to stop in time because of a combination of its higher initial speed at the 20 mph (32 km/h) speed limit board and the ineffectiveness of the braking systems due to low adhesion conditions.

Figure 10: Comparison of speeds of trams 118 and 120 on approach to Shalesmoor tram stop. The point of collision between the trams was approximately one metre before the point at which they came to a final stop. Note that the stopping points are the front of each of the trams. The difference in stopping points is therefore equal to the length of tram 118.

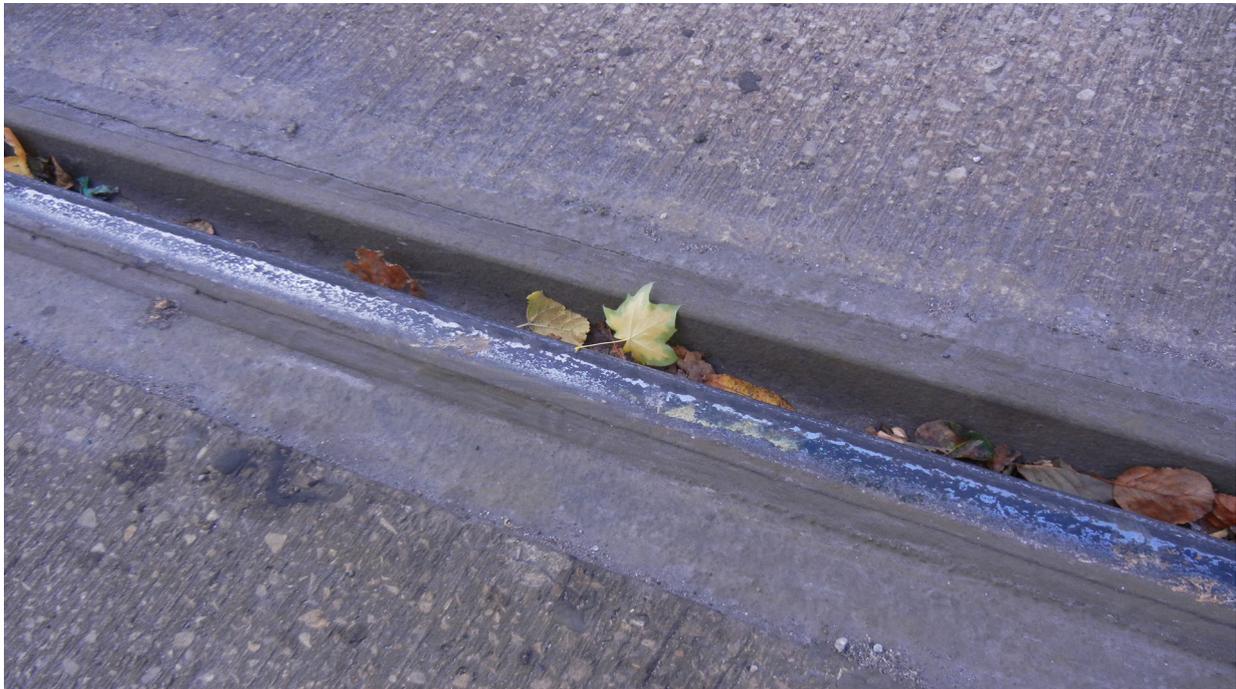
- 55 The area of Shalesmoor is known to be an area at high risk of rail head contamination in autumn and is identified in Stagecoach Supertram's procedure ST0057 Issue 1 Rev b ('Slip Slide – Cleaning and prevention of contaminated rails'). The primary source of this contamination is from fallen leaves.
- 56 It is well established<sup>2</sup> in the railway industry that rail head contamination by leaf detritus can lead to a significant loss of adhesion. Such contamination is generally black in colour and is difficult to remove by scraping. Photographs taken immediately after the accident (figure 11) indicate the presence of such contamination. Analysis of rail head swabs taken by the RAIB on 11 November 2015 revealed the presence of organic contamination which appeared similar to that photographed on the day of the accident.

Figure 11: Photograph of rail head at Shalesmoor, taken immediately after accident. Note that rail head is black in colour and the presence of fallen leaves

- 57 The effect of the rail head contamination from crushed leaves, combined with the probable presence of moisture from dew, lowered the available adhesion at Shalesmoor. Dew is caused by condensation of atmospheric moisture onto cold surfaces; changing atmospheric humidity around sunrise increases the likelihood of dew forming<sup>3</sup>. Calculations by the RAIB based on OTDR<sup>4</sup> data indicate that the effective coefficient of friction ( $\mu$ ) at Shalesmoor on 22 October 2015 was between 0.05 and 0.04, which represents a very low level of adhesion. However, even lower levels of adhesion have been identified as a factor in previous investigations.

- 58 The low rail head adhesion on the approach to Shalesmoor tram stop reduced the effectiveness of the braking systems on tram 120. Evidence obtained from the control systems on the tram indicates that the WSP system on the vehicle was operating correctly. It should be noted, however, that as with any vehicle, a WSP system can only optimise the use of the available adhesion and cannot stop a tram more quickly than adhesion levels allow (ie braking distance increases as adhesion levels fall).

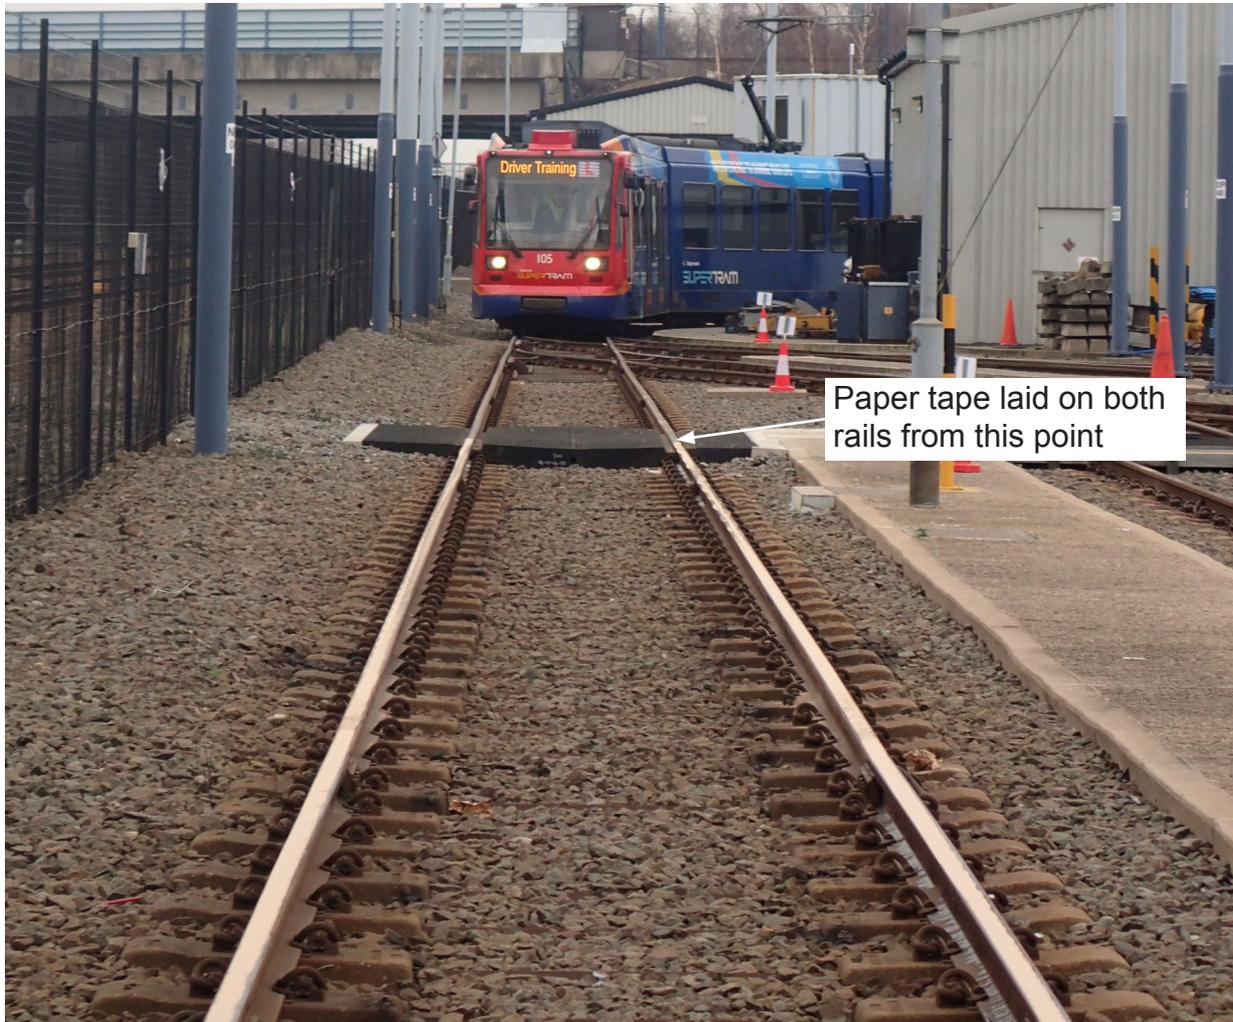
- 60 Low adhesion conditions were created by applying moistened paper tape to the rail head and rolling it onto the surface while spraying water. The paper tape was then run over by multiple passes of a tram. This method of artificially creating low rail head adhesion conditions has been used extensively in the railway industry to generate low adhesion conditions for brake testing and driver training. The paper tape was prone to being scrubbed from the rail head by the tram's magnetic track brakes, and therefore multiple applications of the tape was required to consistently maintain low rail head adhesion conditions. It should be noted that the leaf contamination at Shalesmoor (paragraph 56) is unlikely to have been so easily scrubbed from the rail head by the magnetic track brakes.

- 61 In the tests the stopping distance was found to increase from around 12 metres on dry uncontaminated rail to around 35 metres in the simulated low adhesion conditions, when using the full service brake. When the hazard brake was used (and sanding was automatically activated), the braking distance was found to increase from around 8 metres to around 19 metres.

Figure 12: Testing in simulated low adhesion conditions at Nunnery Depot . The tram is moving towards the viewer. Paper tape has been applied to the railhead from the crossing onwards

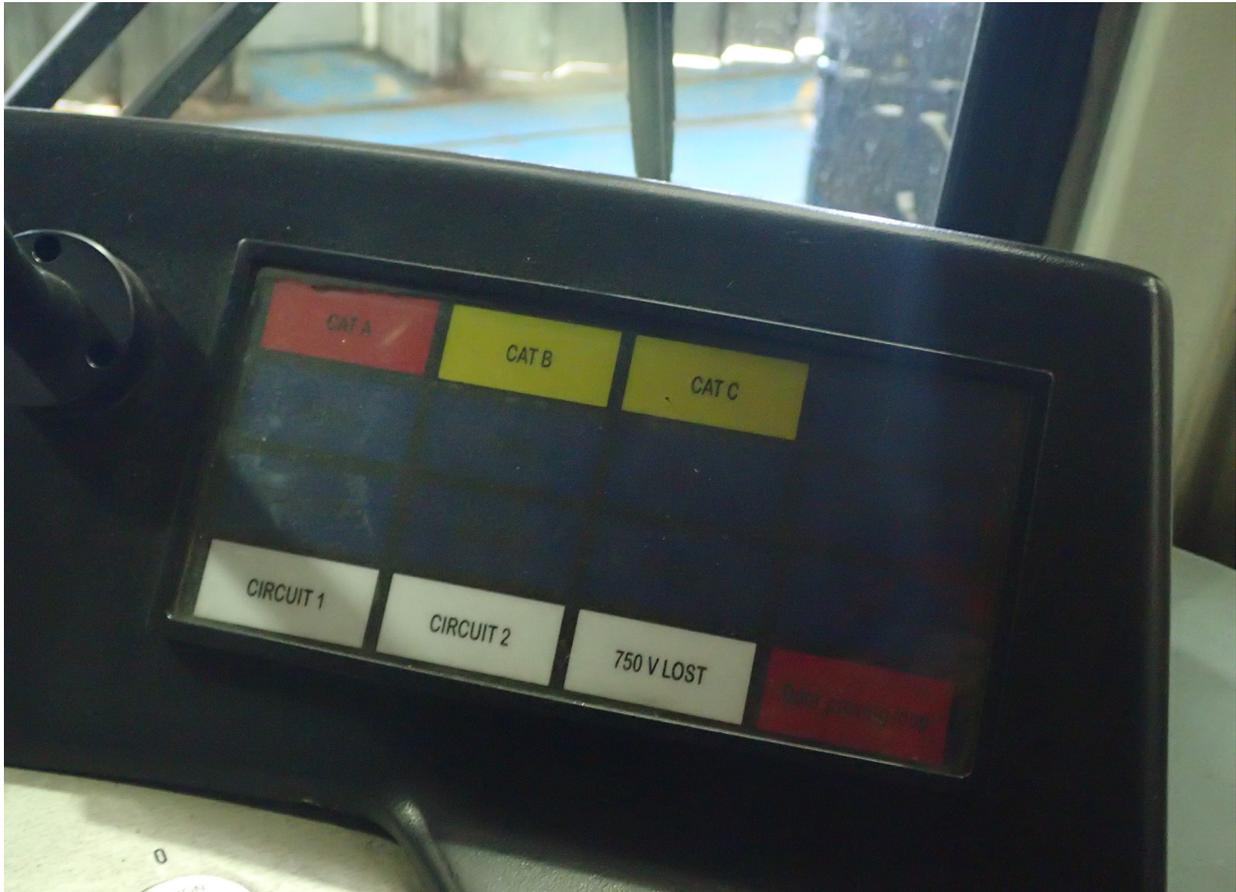
- The audible operation of the sanding system, triggered by the activation of the of the WSP system.
  - An indication appearing on the in-cab vehicle status panel, known as the annunciator panel (figure 13). This panel provides information to the tram driver about the status of several different tram systems. Cat A, Cat B and Cat C indicate fault conditions of varying severity, Cat A being the most severe and requiring the vehicle to be withdrawn from service. Cat A, B or C fault indications are normally combined with other indications which assist tram drivers to understand the nature of the vehicle fault. A 'drive' fault is produced by the tram's traction control units (TCUs) and is indicated by an illuminated segment on the annunciator panel. Cat A, B or C illuminated combined with a 'drive' fault illumination is an indicator of repeated wheel slide.

- 69 Evidence obtained by the RAIB indicates that tram drivers tended to only report low adhesion incidents to the OCC when indications appeared on the annunciator panel. However, the annunciator panel cannot be relied on to indicate all wheel slide events. This is because the software system controlling the annunciator panel uses an internal event counter. Cat A, B, C faults are indicated once the counter has reached set thresholds. However, the counter is reset when the driver changes ends (as happened at Malin Bridge when tram 120 commenced its journey). Following the accident at Shalesmoor, the driver reported that the annunciator panel did not indicate wheel slide on tram 120.

Figure 13: The cab annunciator panel
