**ACCIDENT**

<b>Aircraft Type and Registration:</b>	Piper PA-34-220T Seneca V, OK-OKD	
<b>No &amp; Type of Engines:</b>	2 Continental Motors TSIO-360 piston engines	
<b>Year of Manufacture:</b>	2001	
<b>Date &amp; Time (UTC):</b>	17 August 2015 at 1832 hrs	
<b>Location:</b>	Newquay Airport, Cornwall	
<b>Type of Flight:</b>	Private	
<b>Persons on Board:</b>	Crew - 1	Passengers - None
<b>Injuries:</b>	Crew - 1 (Fatal)	Passengers - N/A
<b>Nature of Damage:</b>	Aircraft destroyed	
<b>Commander's Licence:</b>	Private Pilot's Licence	
<b>Commander's Age:</b>	68 years	
<b>Commander's Flying Experience:</b>	1,300+ hours (estimated, of which 16+ were on type) Last 90 days - 16+ hours Last 28 days - 16+ hours	
<b>Information Source:</b>	AAIB Field Investigation

**Synopsis**

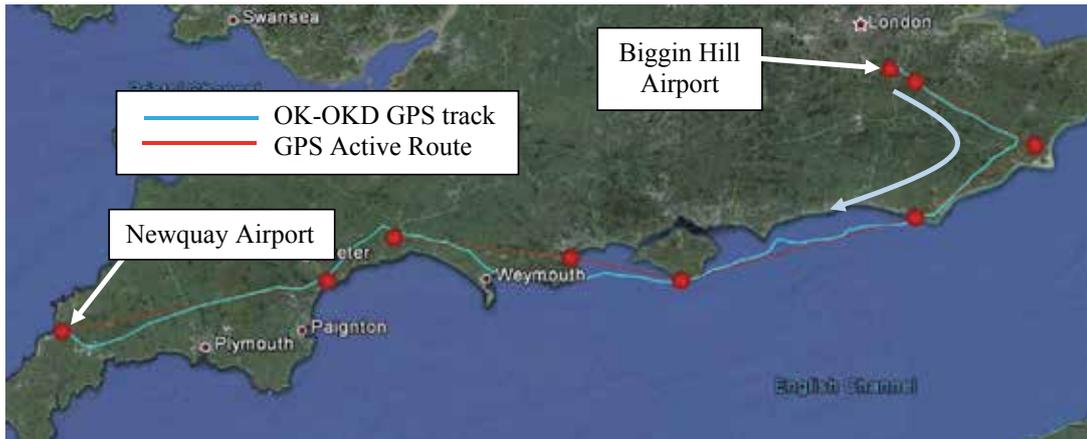
**Figure 1**

The aircraft departed for Newquay at 1634 hrs. It flew south-east towards the coast and then turned west. A plot of the nine waypoints on the planned route, together with the aircraft's recorded track, are shown in Figure 1.

OK-OKD recorded GPS track

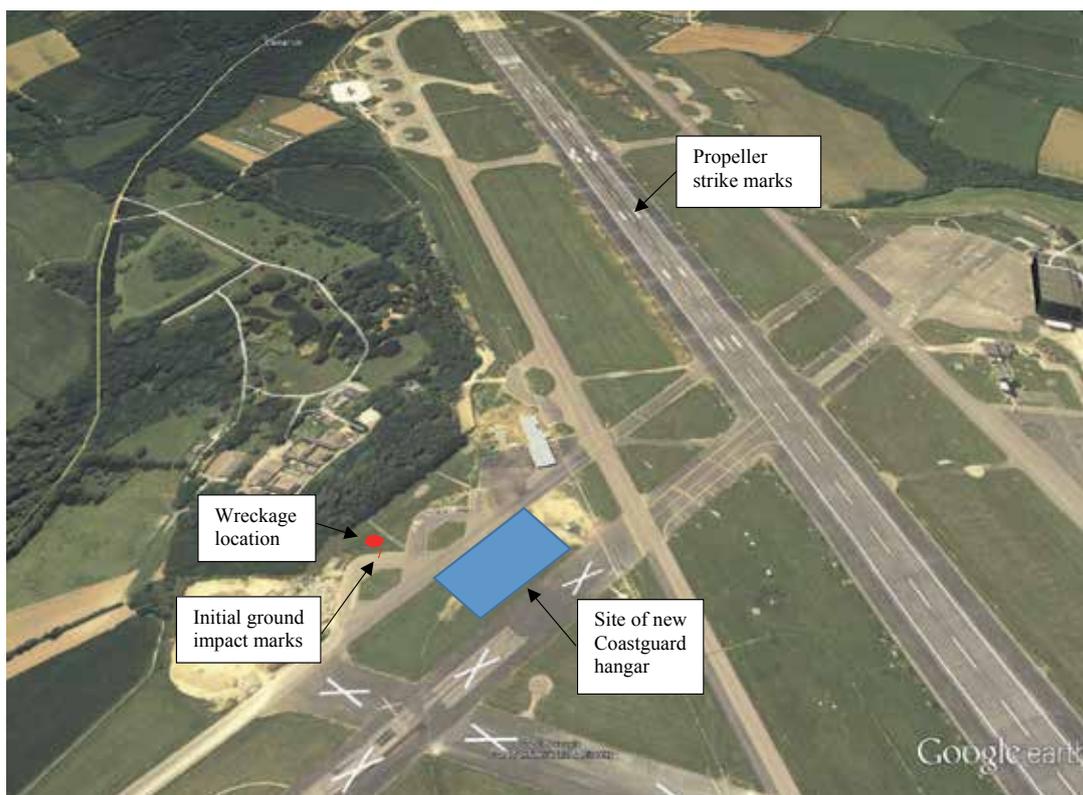
**Figure 2**

Eight propeller strike marks were identified on the runway, along the centreline and approximately 609 m from the threshold for Runway 30. The marks were approximately 72 cm apart and were shallow in depth. No further ground marks were present, until the point where the aircraft made contact with the ground during the final impact sequence. This was located on an old aircraft dispersal area, adjacent to a disused taxiway and near to a new Maritime and Coastguard Agency hangar, which was under construction. Initially, the aircraft struck the surface of the hardstanding and the fuselage nose, engines and wing leading edges left clear impressions in the tarmac, on a heading of 099°M. There were also deep propeller strike marks leading to each engine impression. The aircraft came to rest approximately 20 m away from the initial impact point on a heading of 114°M, on the grass and in an inverted attitude. Debris from the aircraft was scattered around the area of the main fuselage.

Accident site relative to the runway, looking back down Runway 30 from the direction of the Control Tower

Analysis of evidence from the wreckage and accident site showed that the aircraft struck the ground almost vertically and came to rest inverted. The final position of the wreckage relative to the initial impact ground marks showed that there was some rotation to the right in yaw. This was consistent with the right wing of the aircraft stalling in a turn to the right and the aircraft entering an incipient spin. This was supported by the radar data and witness statements.

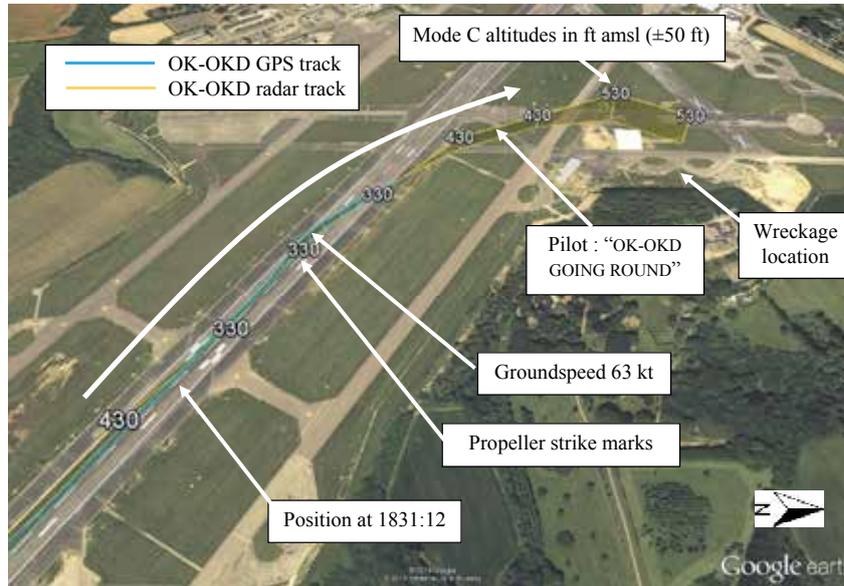
Figure 4

ceased at 1831:25 hrs but the Newquay Airport radar head continued recording Mode C altitude and position every four seconds. Due to the limitations in the accuracy of the radar position, groundspeed for the remainder of the flight could not be calculated accurately but the recordings showed a turn to the right, following the approximate route described by eyewitnesses. The corrected Mode C altitude increased from 330 ft ( $\pm 50$  ft) to a maximum of 530 ft amsl ( $\pm 50$  ft) over a period of 18 seconds.

OK-OKD GPS and radar tracks showing corrected Mode C altitudes in ft amsl

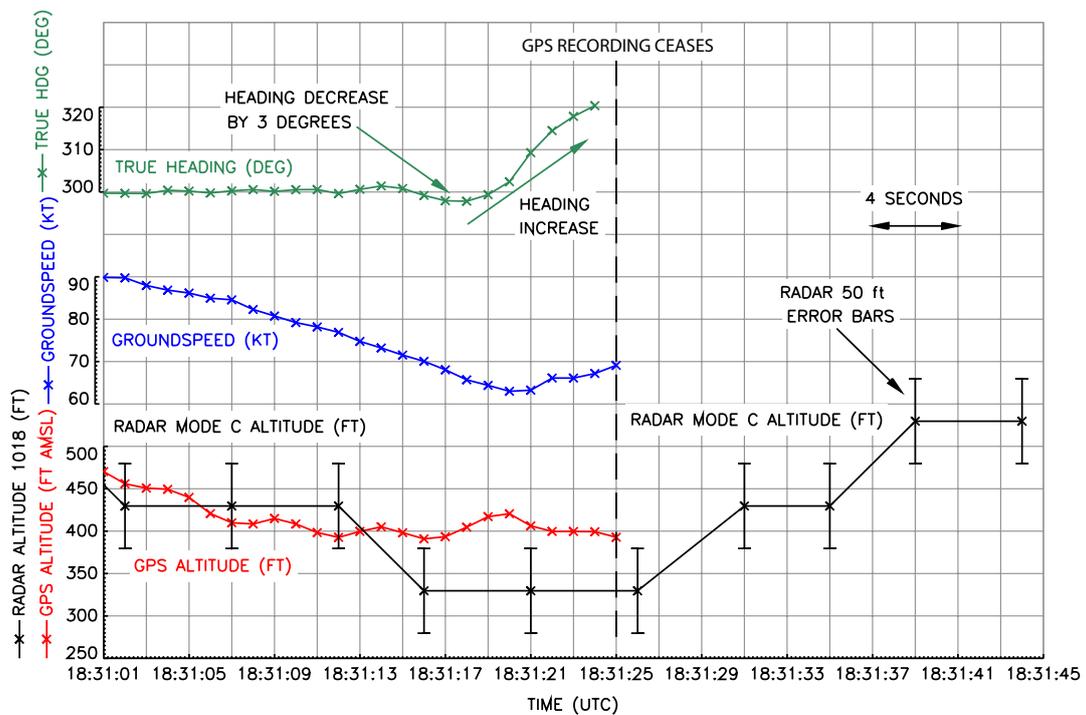
Figure 5

The heading then increased and continued to do so until the end of the GPS recording (see Figures 4 and 5). At 1831:20 hrs, the aircraft reached its minimum derived groundspeed of 63 kt as the GPS altitude increased to 421 ft amsl, over the runway. The GPS recording

OK-OKD GPS and radar data
