ACCIDENT

Aircraft Type and Registration:	Ikarus C42 FB UK, G-IKUS	
No & Type of Engines:	1 Rotax 912ULS piston engine	
Year of Manufacture:	2004 (Serial no: PFA 322-14130)	
Date & Time (UTC):	30 May 2016 at 1100 hrs	
Location:	Strubby Airfield, Lincolnshire	
Type of Flight:	Private	
Persons on Board:	Crew - 1	Passengers - 1
Injuries:	Crew - 1 (Minor)	Passengers - 1 (Minor)
Nature of Damage:	Aircraft substantially damaged	
Commander's Licence:	National Private Pilot's Licence	
Commander's Age:	56 years	
Commander's Flying Experience:	1,450 hours (of which 1,092 were on type) Last 90 days - 35 hours Last 28 days - 12 hours	
Information Source:	Aircraft Accident Report Form submitted by the pilot and additional inquiries by the AAIB

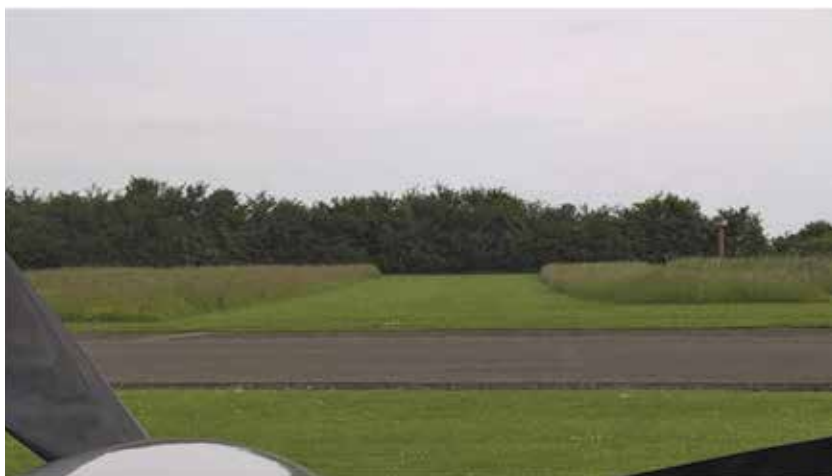
Figure 1

The pilot was attempting to take off from a mown strip of grass perpendicular to, and north of the asphalt runway at Strubby Airfield (Figure 1). When he realised he would not clear the hedge at the end, he turned to avoid it and the aircraft impacted the ground. The pilot referred to the strip as Runway 36, but the airfield owner advised that it was not a designated runway.

Mowed strip in the direction of takeoff

Using commercially available aerial imagery, the length of the mowed strip was estimated to be 140 m. The takeoff weight was reportedly 446 kg and manufacturer's performance data states that at a Maximum Take Off Weight of 450 kg, the takeoff distance to clear a 15 m obstacle is 205 m.

The pilot stated that he had taken off from the mowed strip previously and he believed his ability to climb on the accident flight had been compromised by rotor effect from the hedge, which he estimated to be between three and four metres in height.

CAA Safety Sense Leaflet 7c (*'Aeroplane Performance'*) reminds pilots of the actions necessary to ensure adequate takeoff performance for the conditions.
