Report on the investigation of a fire  
in the engine room on the  
suction dredger

***Arco Avon***

12 miles off the coast of Great Yarmouth  
resulting in one fatality  
on 18 August 2015

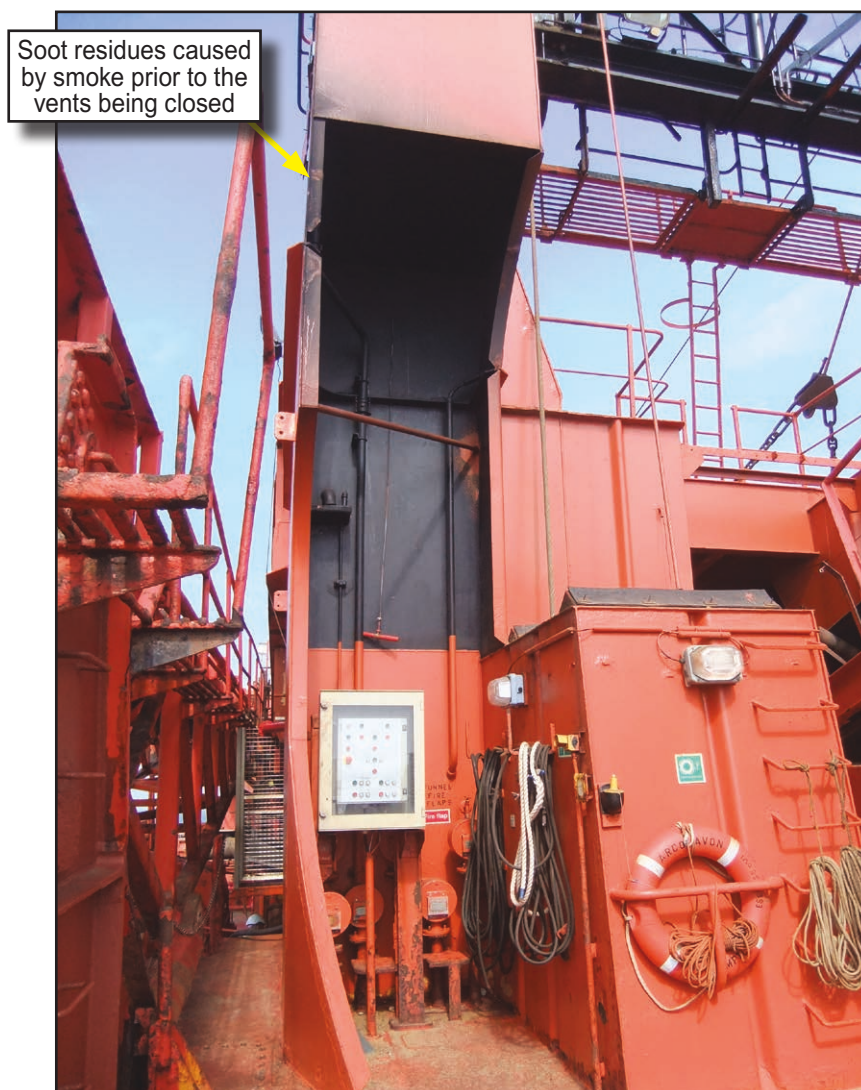
**Figure 2:** Port engine room vent

The master looked aft as the crew were mustering and noted smoke coming from engine room vents (**Figure 2**). Having established that there was a fire in the engine room, the master immediately made two telephone calls to the engine room, both of which were unanswered. Following a discussion with the master, the chief engineer was about to leave for the engine room to investigate further when the third engineer telephoned the bridge. He told the chief engineer that there was a fire in the vicinity of No.2 generator and that he had been hurt. The chief engineer told him to evacuate the engine room. The call had been made from the machinery control room (MCR), which meant that the engineer had to re-enter the engine room and exit through the fire as there was no direct escape route from the MCR.

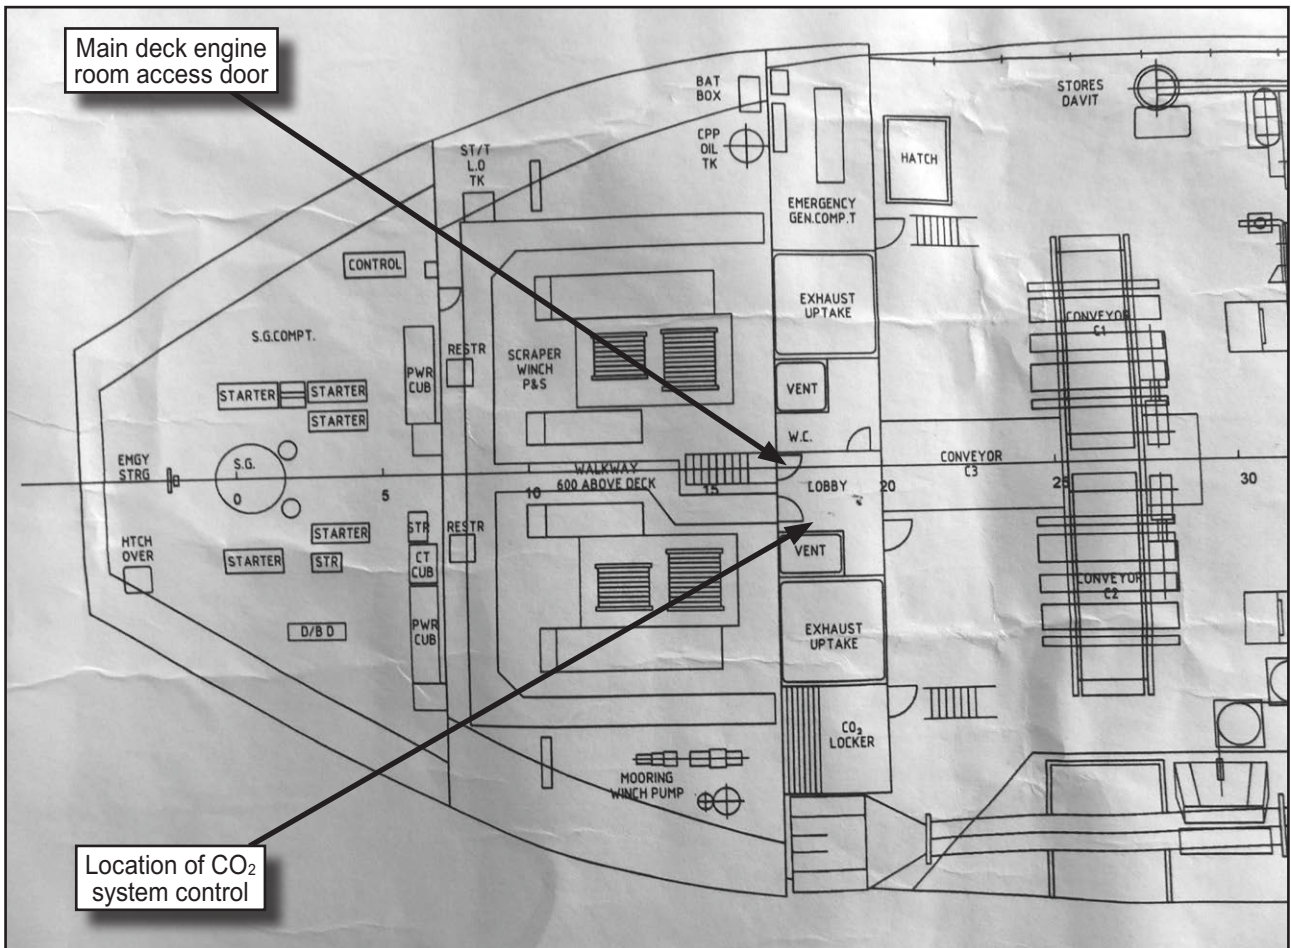
Figure 3a: Engine room main deck access

As the chief engineer and the bosun reached the aft end of the main deck, they met the third engineer, who had just exited the engine room through the doorway to the main deck (**Figure 3a**). His clothes appeared to have been burned off, and he was showing obvious signs of physical trauma, but he was able to walk unaided. He spoke briefly to the chief engineer, repeating the information relayed in his earlier telephone call. The chief engineer told the bosun to take the third engineer to the crew mess room and to summon first-aid assistance; he then relayed this information to the master via a portable very high frequency (VHF) radio. At approximately 2322, as the bosun and third engineer were crossing the main deck, the vessel's main power supply failed, leaving the deck in darkness. After a few seconds, power was briefly restored but then failed again. Several seconds later, the emergency generator started, restoring emergency lighting. The bosun and the third engineer were then able to continue to the mess room, where the third engineer was left in the care of the cook. The bosun then returned to the aft end of the main deck to continue closing the machinery space ventilation flaps. The chief engineer had remained at the aft end of the main deck and opened the engine room access door. He was met by dense smoke and heat, and concluded that the fire team would be unable to enter the engine room.

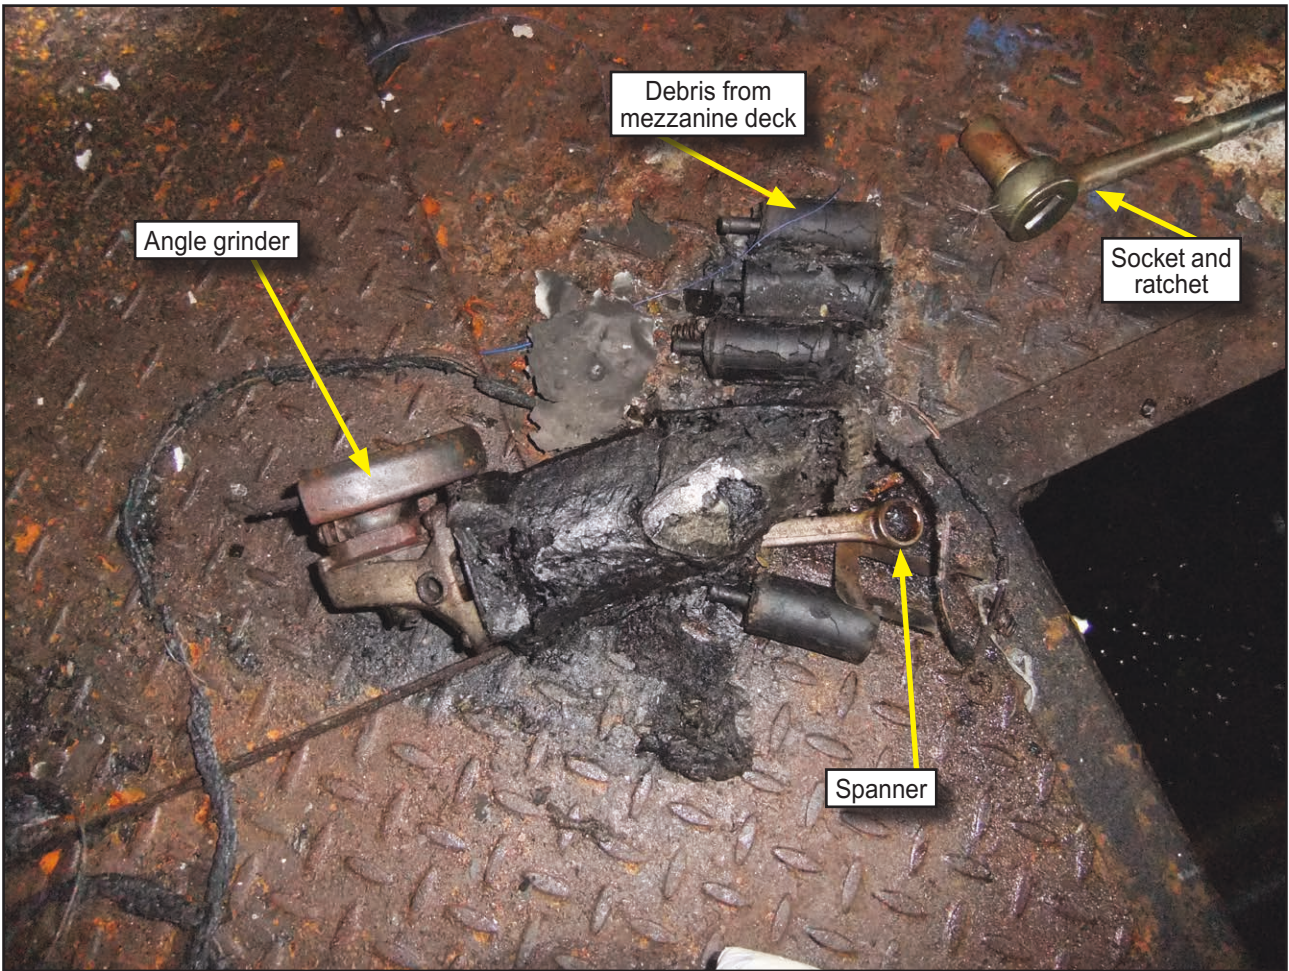
**Figure 8a:** Tools and angle grinder as found

Floor plates adjacent to No.2 generator were missing, giving access to a defective fuel pipe located beneath the floor plates. An angle grinder, a spanner, and a ratchet with an attached socket were located on the floor plates adjacent to the access opening (**Figure 8a**). A cable reel to provide power to the angle grinder was plugged into a nearby power socket (**Figure 8b**). A number of hose clips and pieces of rubber jointing material were found on the workshop bench along with spare angle grinder discs and, in the vicinity, an operators' handbook.

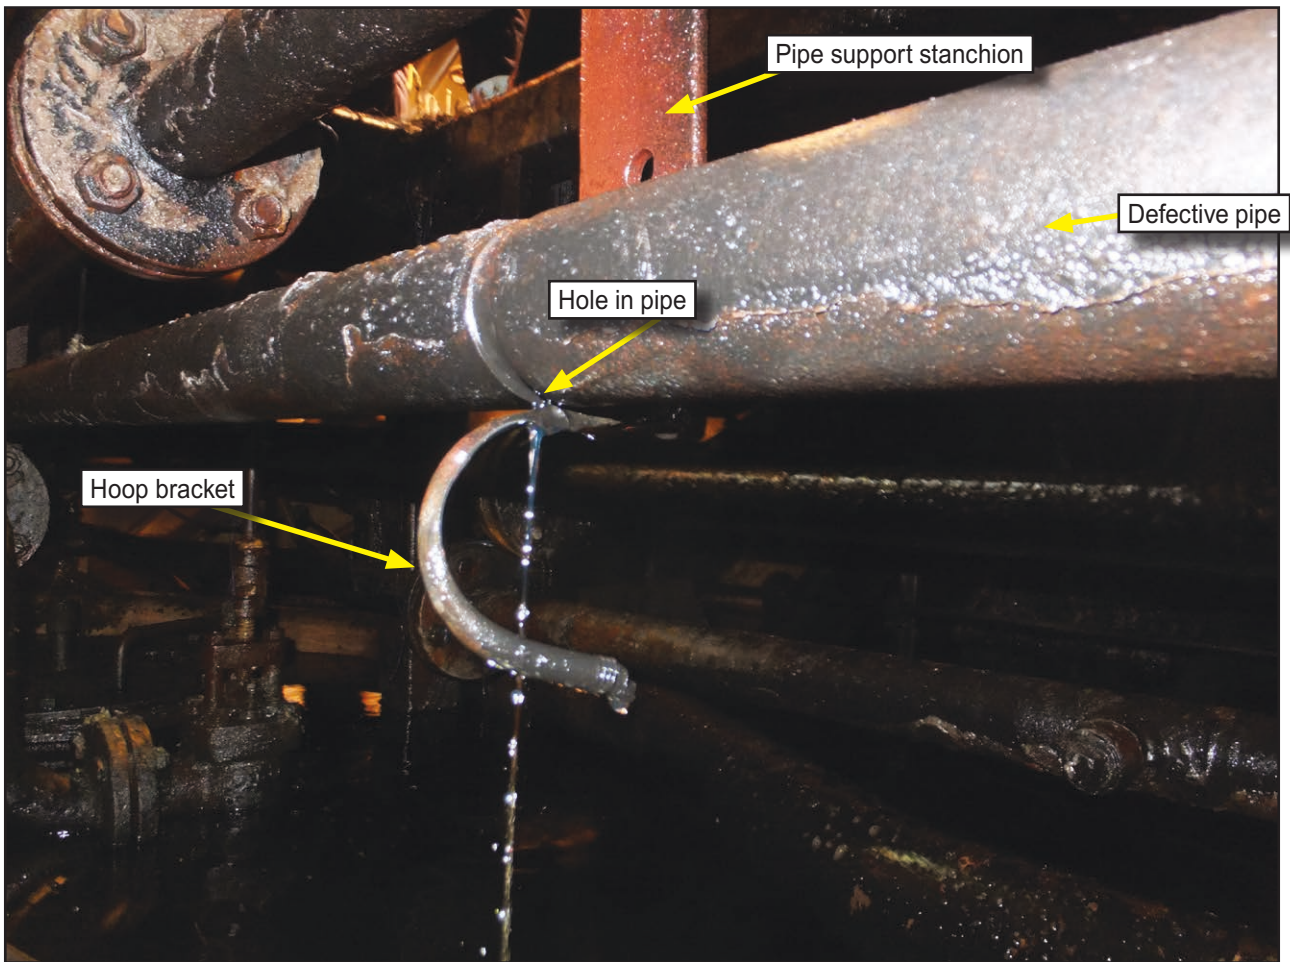
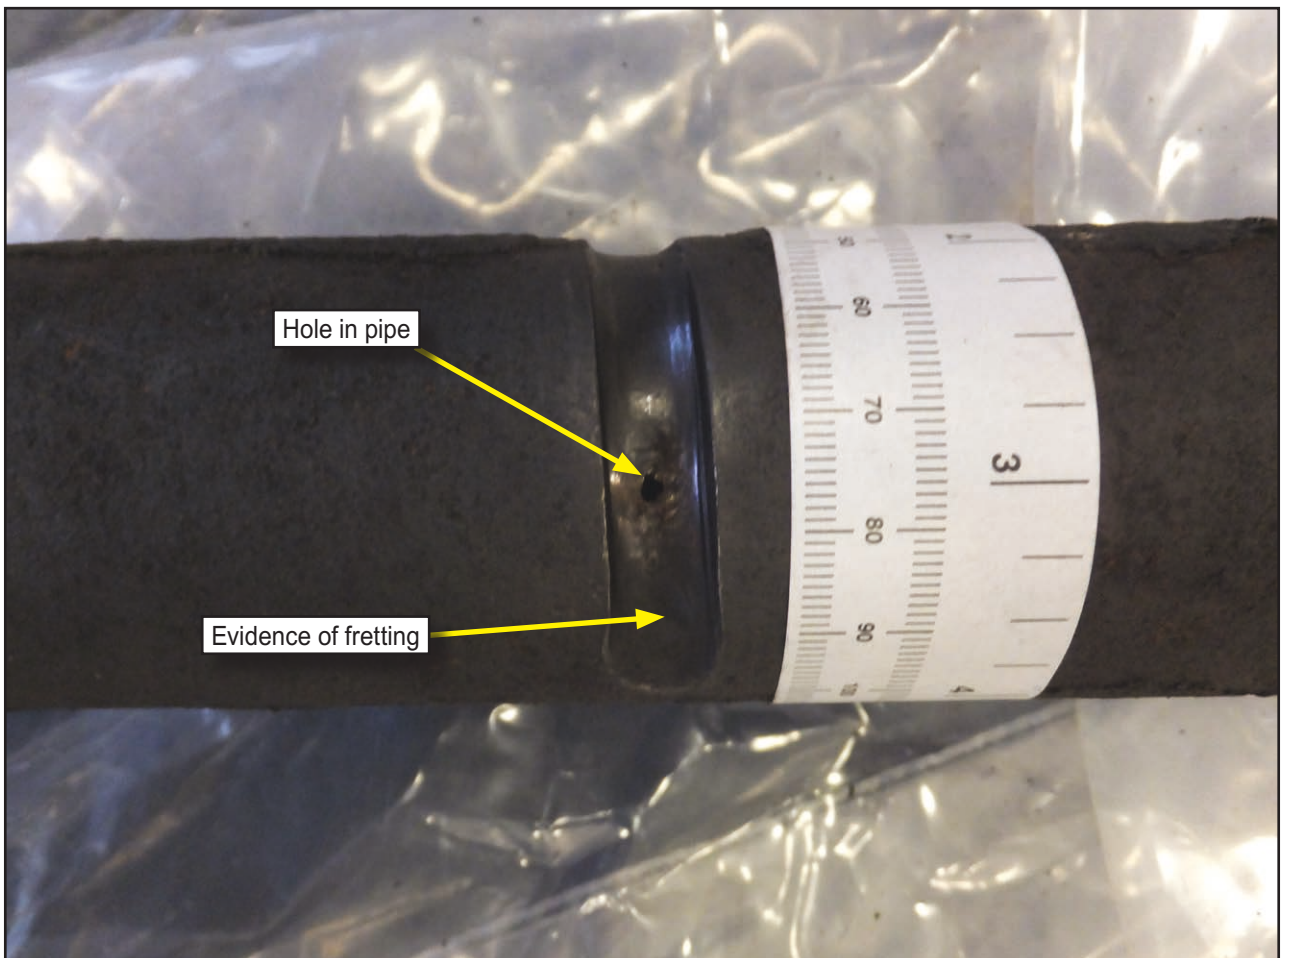
The hoop bracket supporting the fuel pipe at the position of the leak was hanging below the pipe with one retaining nut still in place (**Figures 9 and 10**). The other end of the bracket was sheared off and the remaining nut was seized onto the bracket. The bracket had significant material wastage and was twisted along its length (**Figures 11a and 11b**).

**Figure 9:** Pipe showing leak and partially detached hoop bracket

**Figure 10:** Defective fuel pipe

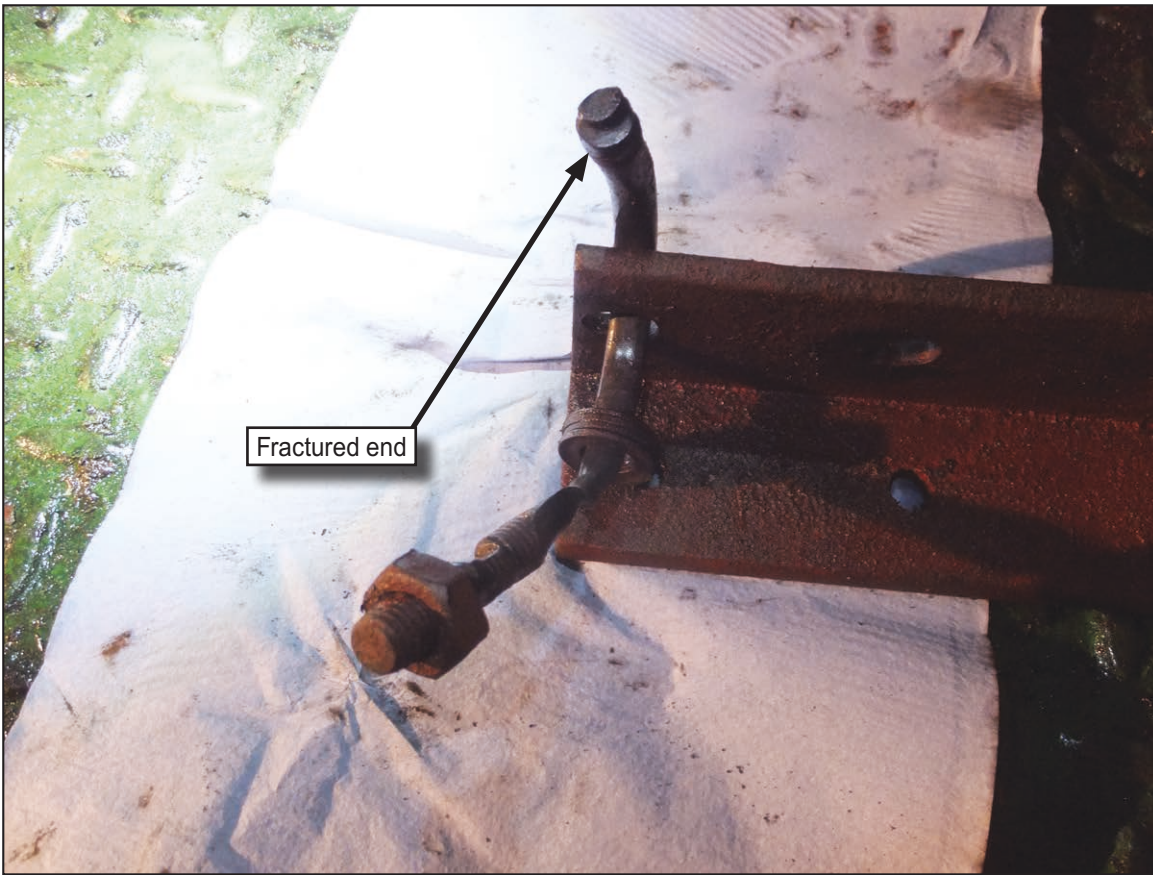
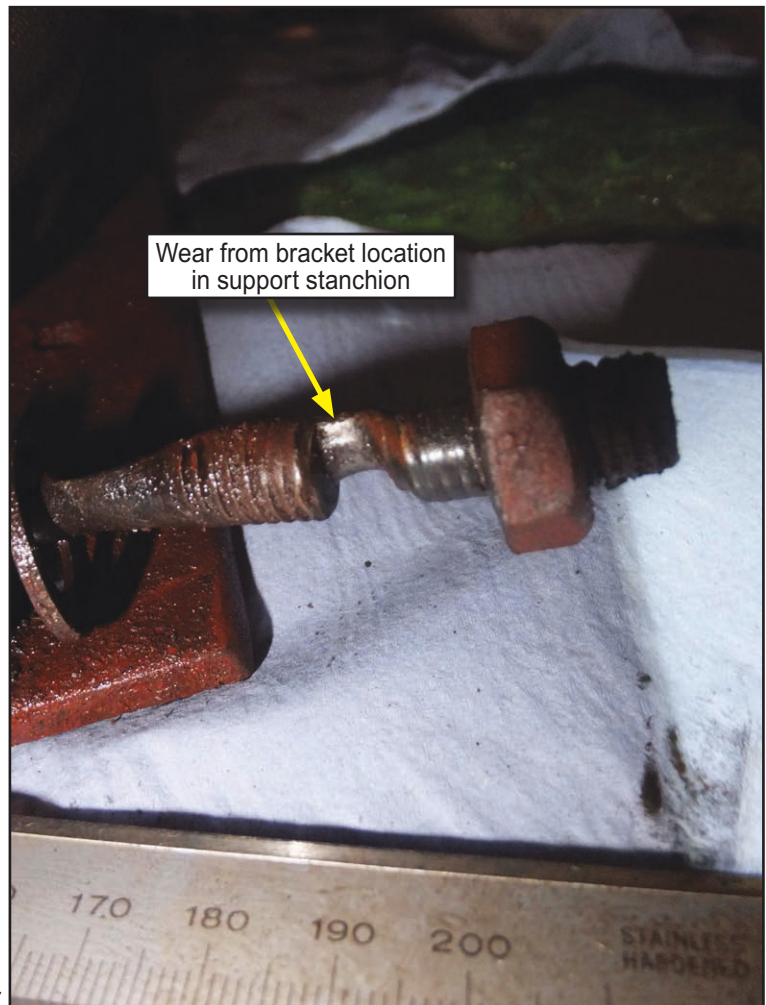
**Figure 11a:** Hoop bracket

**Figure 11b:** Hoop bracket wear

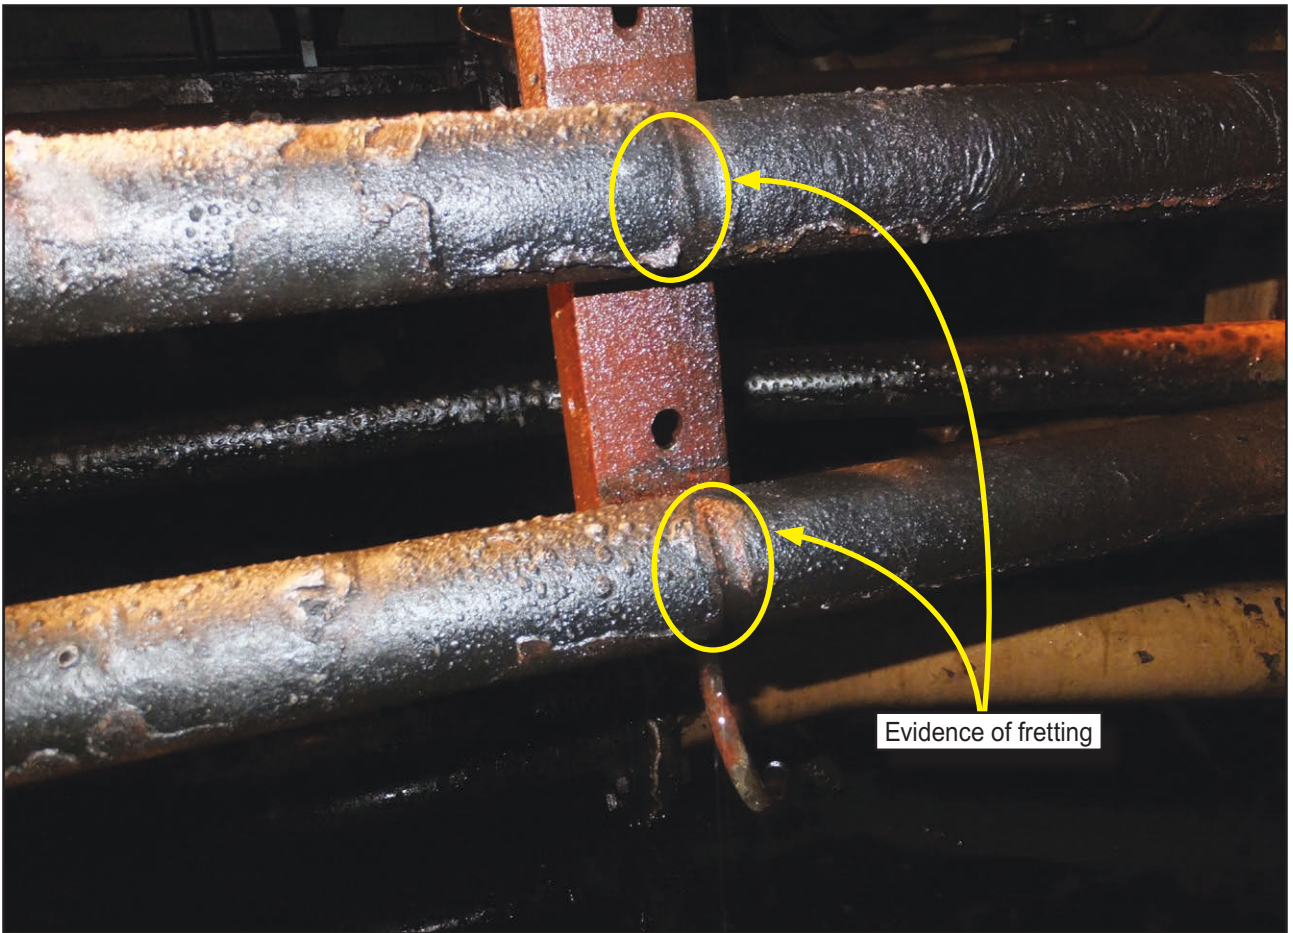
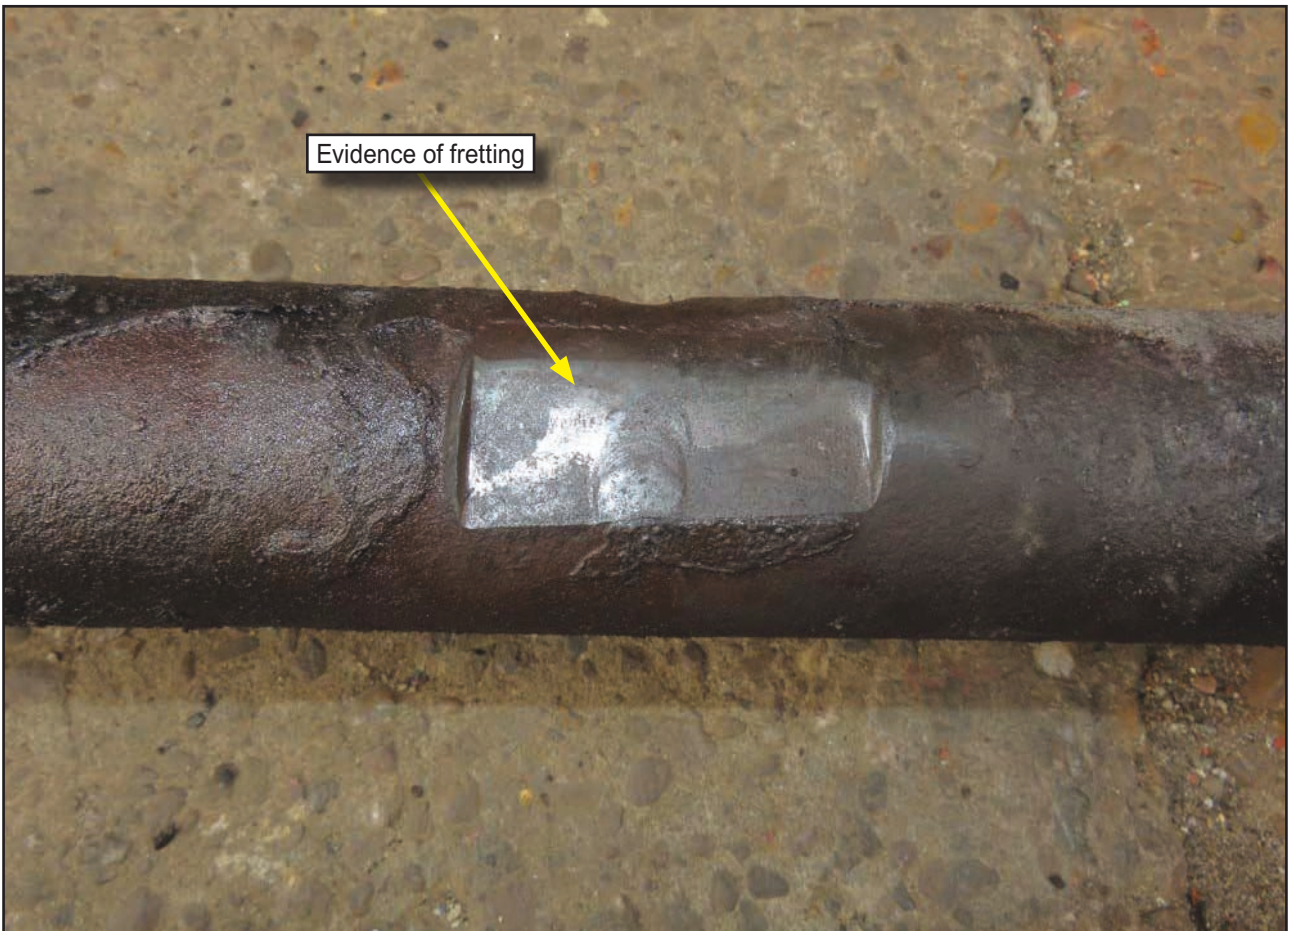
Along the length of the defective fuel pipe there was evidence of fretting in way of the support brackets and from contact with other pipes where flanged pipe joints rested against the fuel line (**Figures 12a and 12b**).

**Figure 12a:** Evidence of additional fretting

**Figure 12b:** Evidence of pipe interference

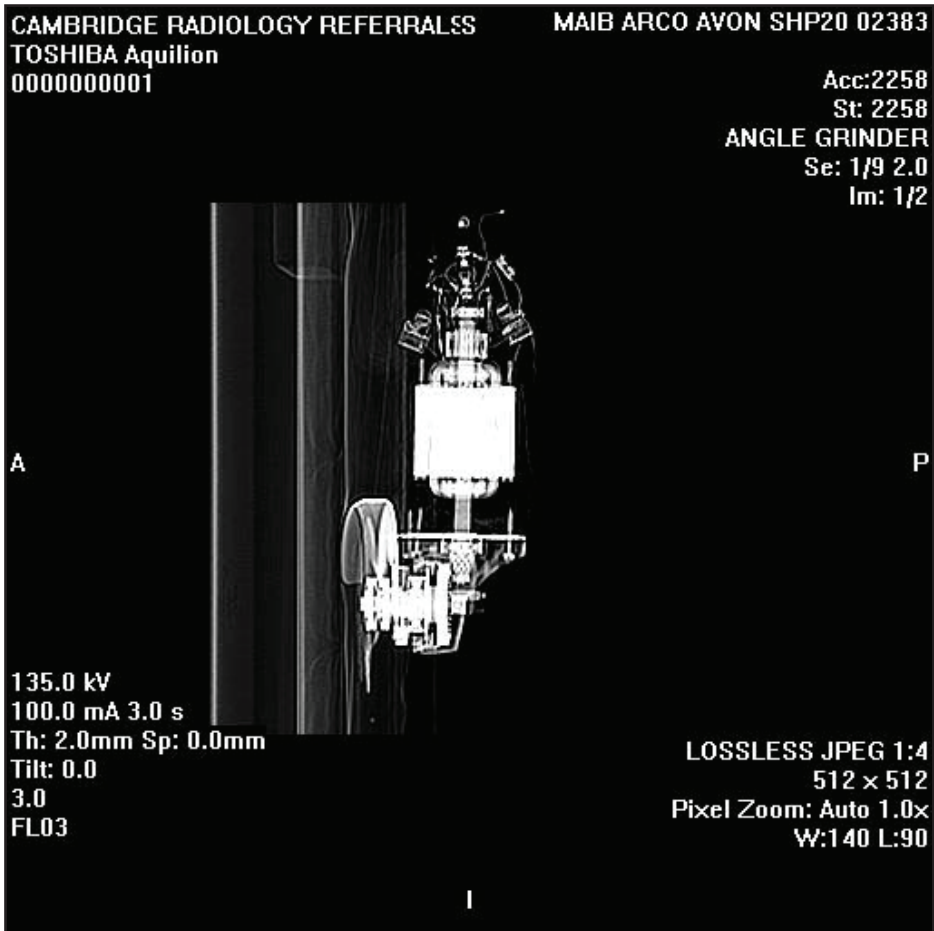
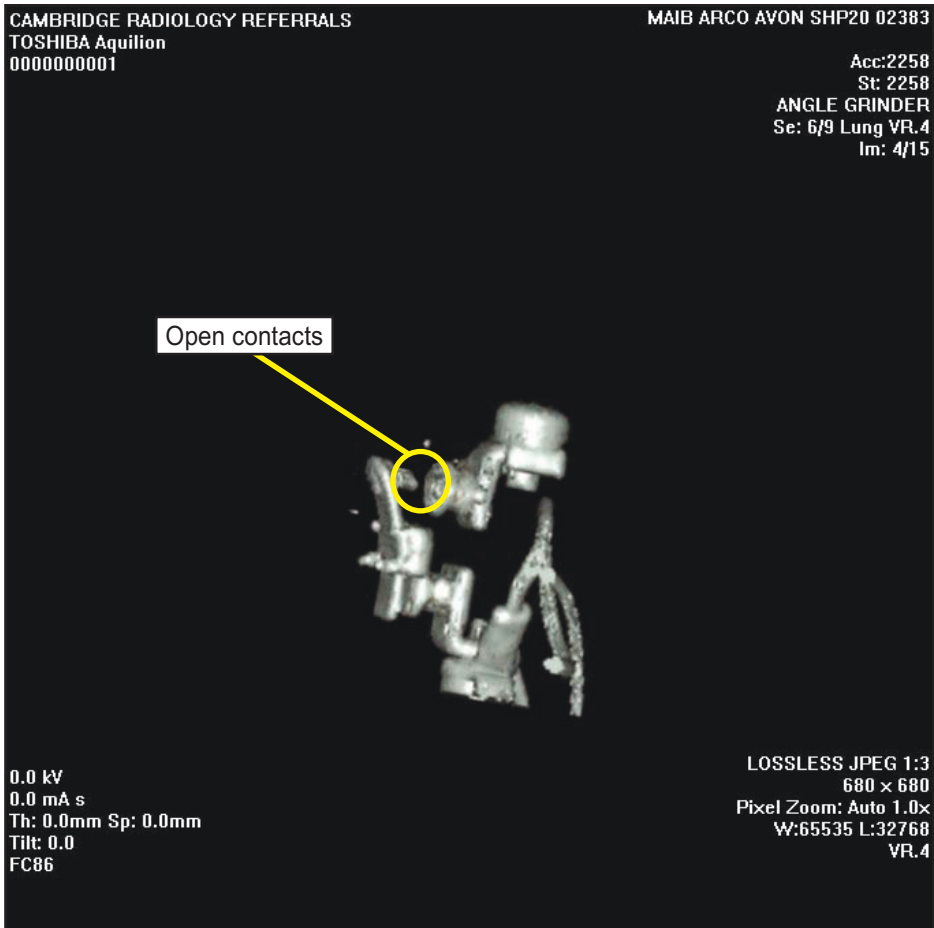
The angle grinder found on the engine room floor plates adjacent to the failed fuel pipe was examined using a computerized axial tomography scanner (CAT scan) to determine its operating condition (**Figure 14a**). The scan identified that the operating switch contacts were open, indicating that the grinder had been switched off (**Figure 14b**).

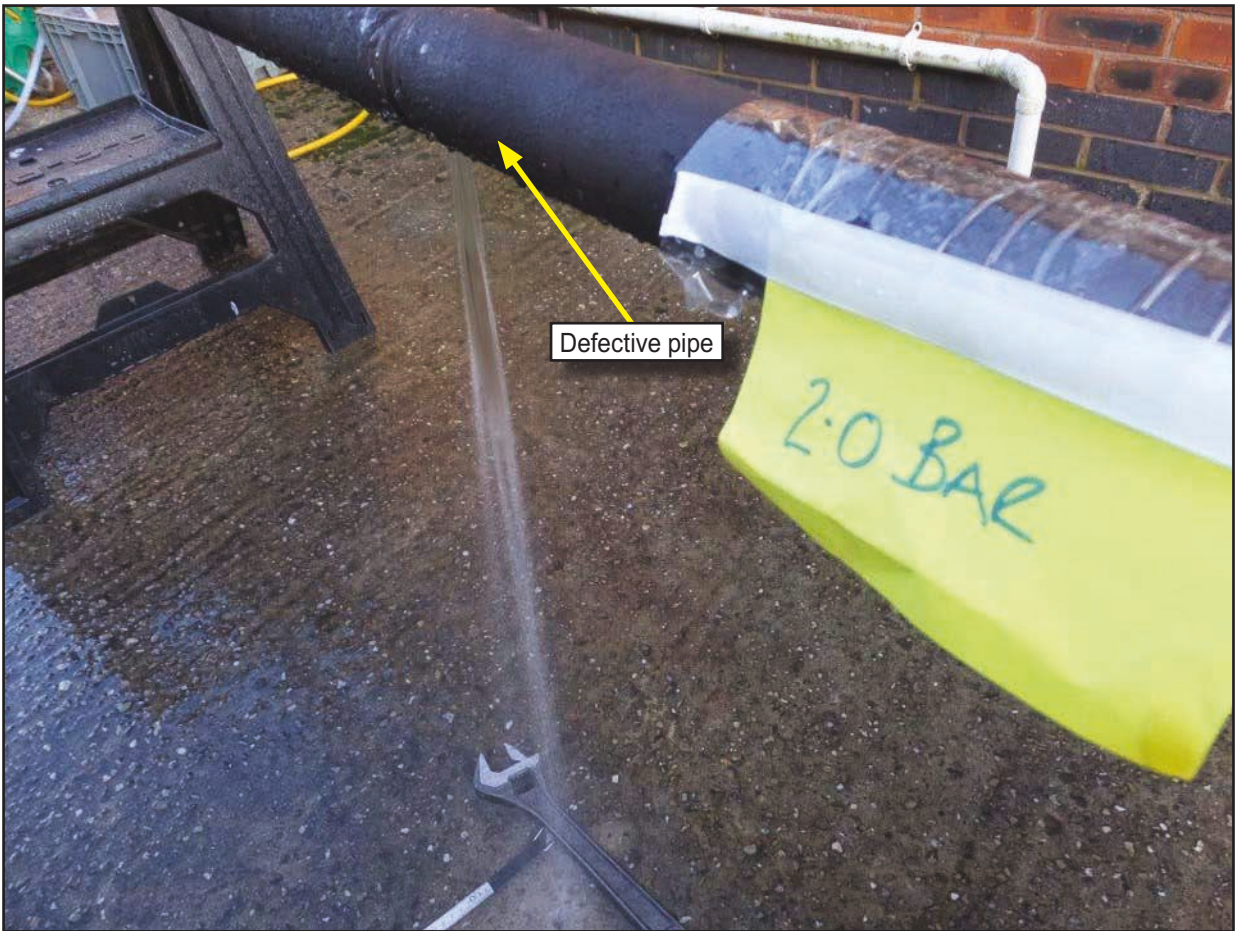
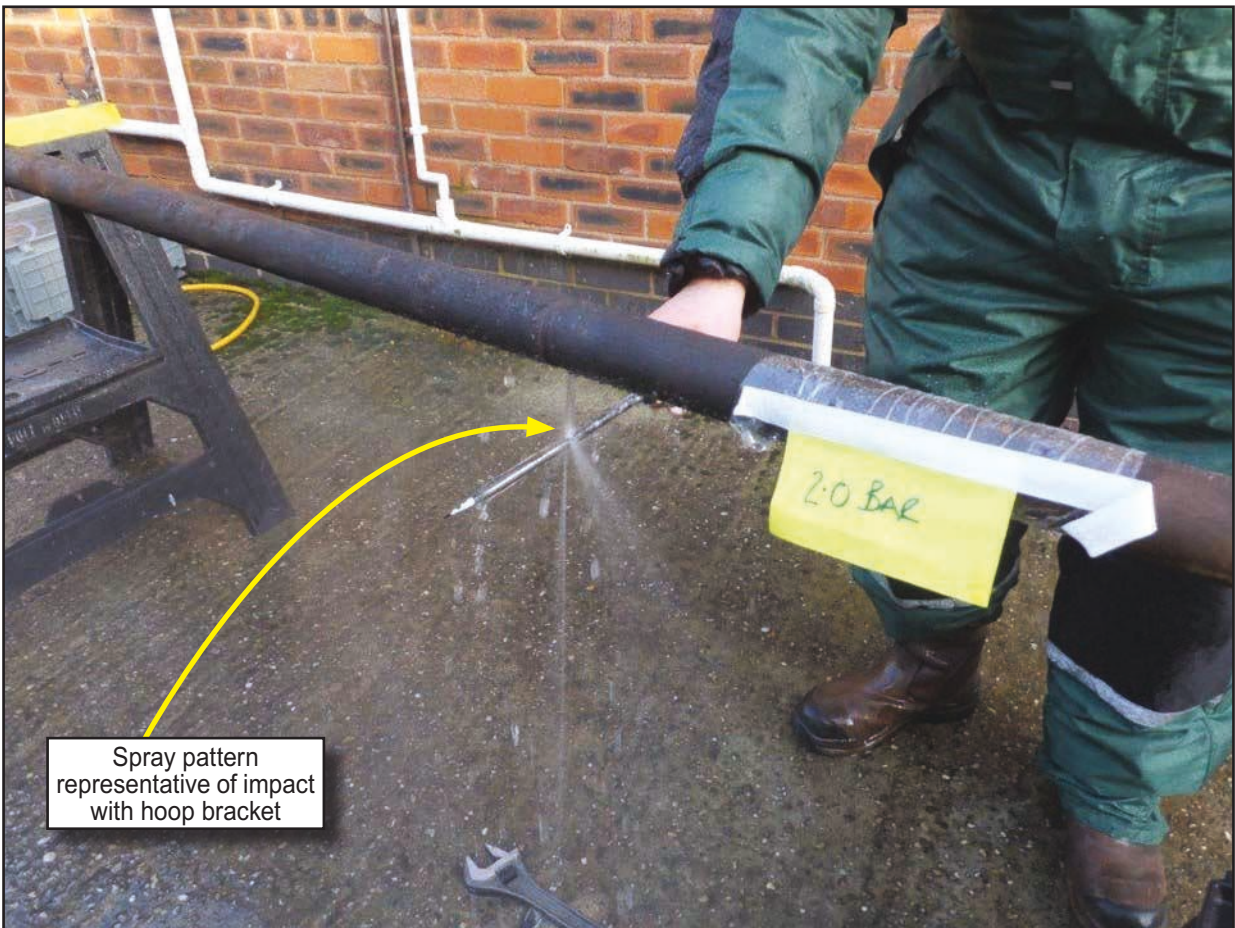
Flow and spray tests on the defective fuel pipe were conducted by the MAIB in conjunction with Burgoynes, Consulting Scientists and Engineers, who were acting on behalf of HAML. Tests were carried out using water at a range of pressures from 1 through to 5 bar, with 2 bar being deemed most representative of the likely pressure in the pipe at the time of the accident. The tests showed a powerful jet of fluid spraying from the hole in the defective pipe. The flow and pressure were sufficient for the fluid to atomise as it hit the ground beneath the test rig (**Figure 15a**). When a screwdriver was introduced into the jet to simulate the position of the hoop bracket, the degree of atomisation increased significantly (**Figure 15b**).

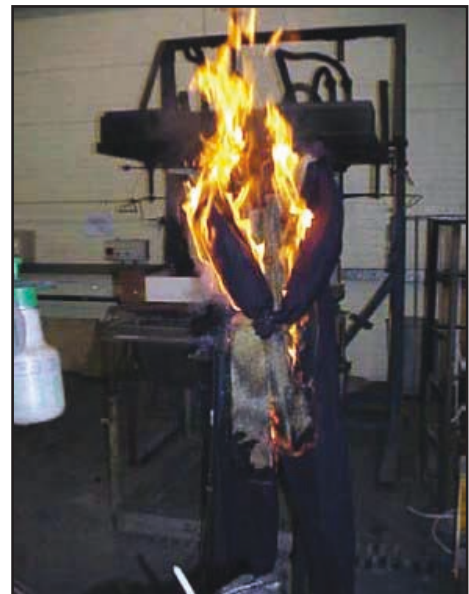
- Tests on a full sized manikin clothed in separate tests with an FR and non FR "coverall" demonstrated the value of FR treated materials when subjected to sparks from an angle grinder. The FR coverall did not ignite after 5 minutes of sustained spark impingement whereas the non FR coverall ignited after approximately 20 seconds and burnt to completion.' (**Figure 16**)

**Figure 16:** Coverall ignition and flame spread test after approximately 45 seconds (ignition occurred at approximately 20 seconds)
