ACCIDENT

Aircraft Type and Registration:	Beech B200 Super King Air, G-BYCP	
No & Type of Engines:	2 Pratt & Whitney Canada PT6A-42 turboprop engines	
Year of Manufacture:	1981 (Serial no: BB-966)	
Date & Time (UTC):	3 October 2015 at 0920 hrs	
Location:	Near Chigwell, Essex	
Type of Flight:	Non-commercial	
Persons on Board:	Crew - 1	Passengers - 1
Injuries:	Crew - 1 (Fatal)	Passengers - 1 (Fatal)
Nature of Damage:	Aircraft destroyed	
Commander's Licence:	Commercial Pilot's Licence	
Commander's Age:	40 years	
Commander's Flying Experience:	1,941 hours (of which 162 hours were on type) Last 90 days - 61 hours Last 28 days - 50 hours	
Information Source:	AAIB Field Investigation

Synopsis

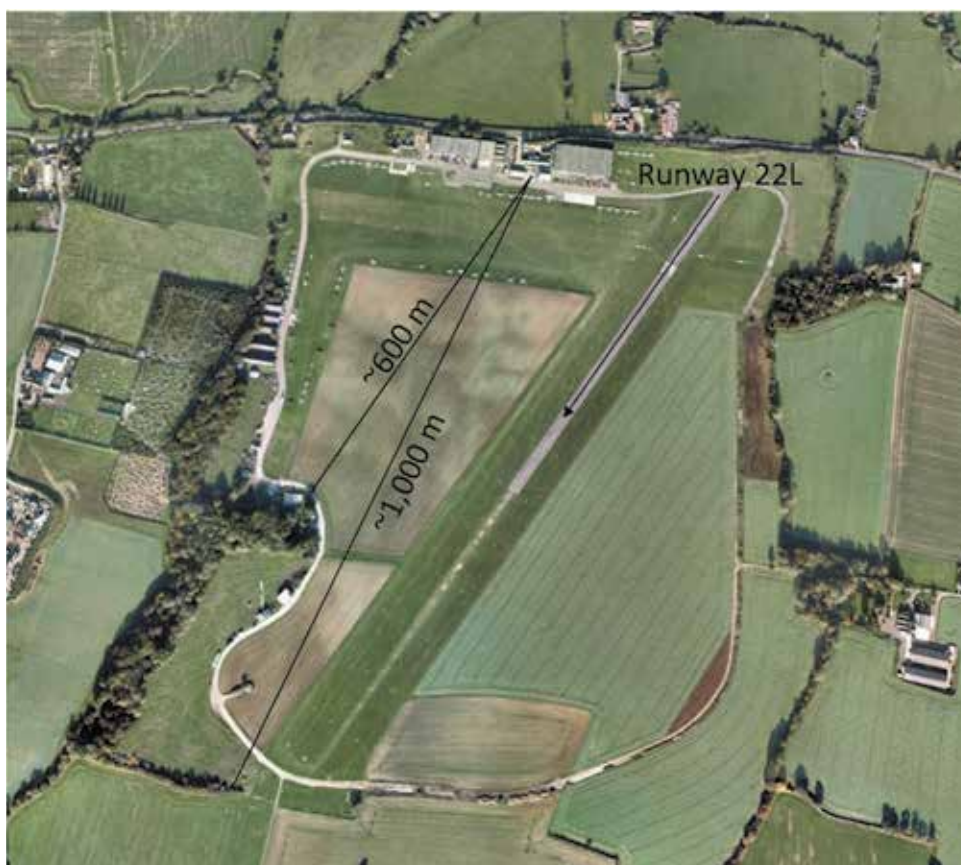
Figure 1

The pilot reported for work at approximately 0715 hrs for a planned departure at 0815 hrs but he delayed the flight because of poor meteorological visibility. The general weather conditions were fog and low cloud with a calm wind. At approximately 0850 hrs the visibility was judged to be approximately 600 m, based on the known distance from the operations room to a feature on the aerodrome (Figure 1). At approximately 0915 hrs, trees were visible just beyond the end of Runway 22L, indicating that visibility was at least 1,000 m and the pilot decided that conditions were suitable for departure.

Measurement of visibility at the departure aerodrome

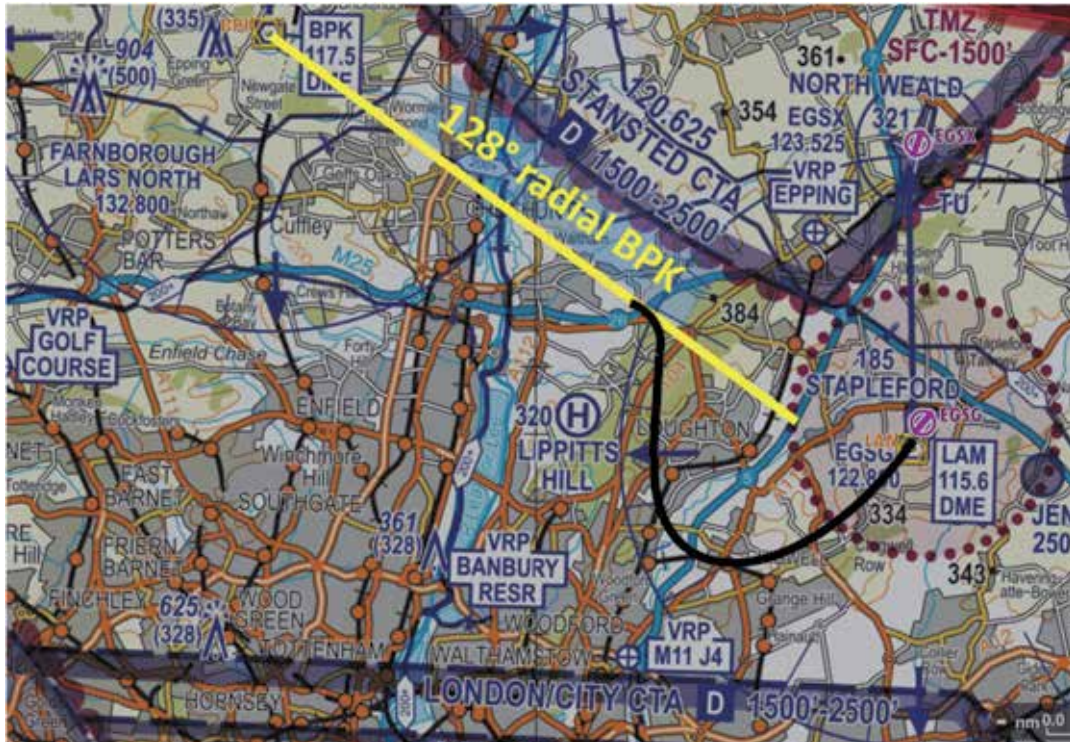
Figure 2

Approximate planned departure track and local airspace

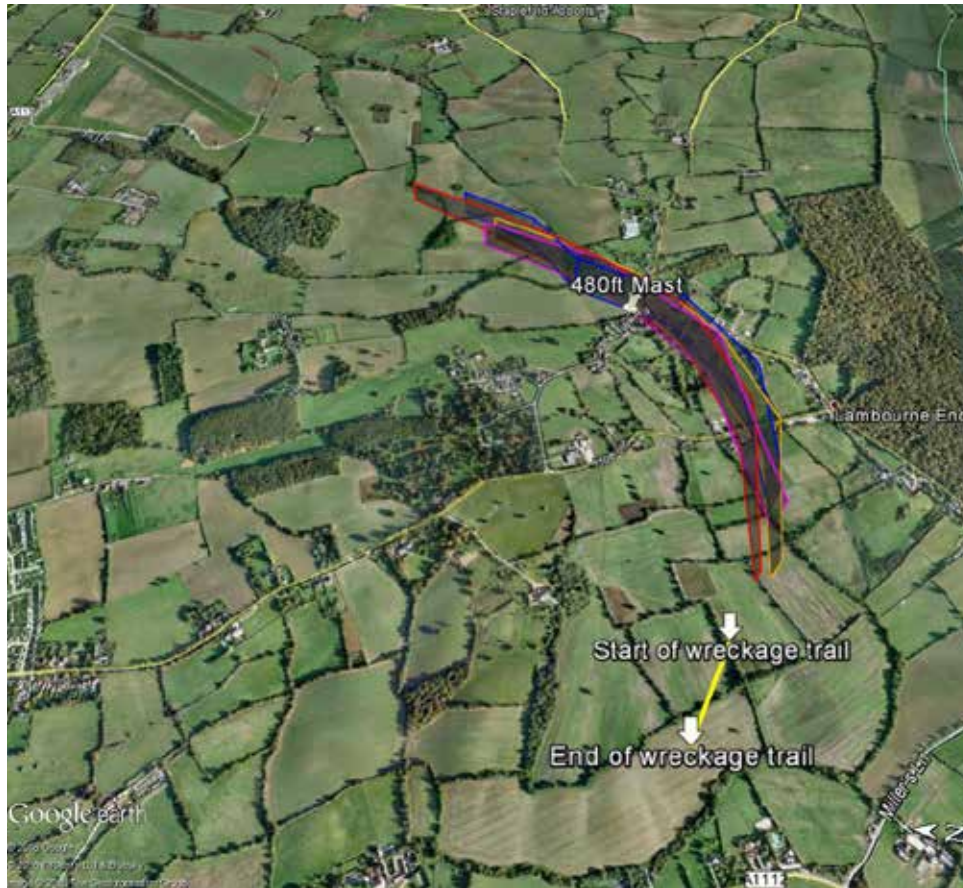
Figure 4
Ground track data

Ground tracks from the four radar installations are shown in Figure 4. Figure 5 shows the altitude and groundspeed values transmitted by the aircraft plotted against time. In the case of altitude, the values have been corrected for the regional pressure setting. In the upper half of Figure 5, the altitude trace, which shows merged altitude data from each radar installation, was used to derive the vertical speed trace.

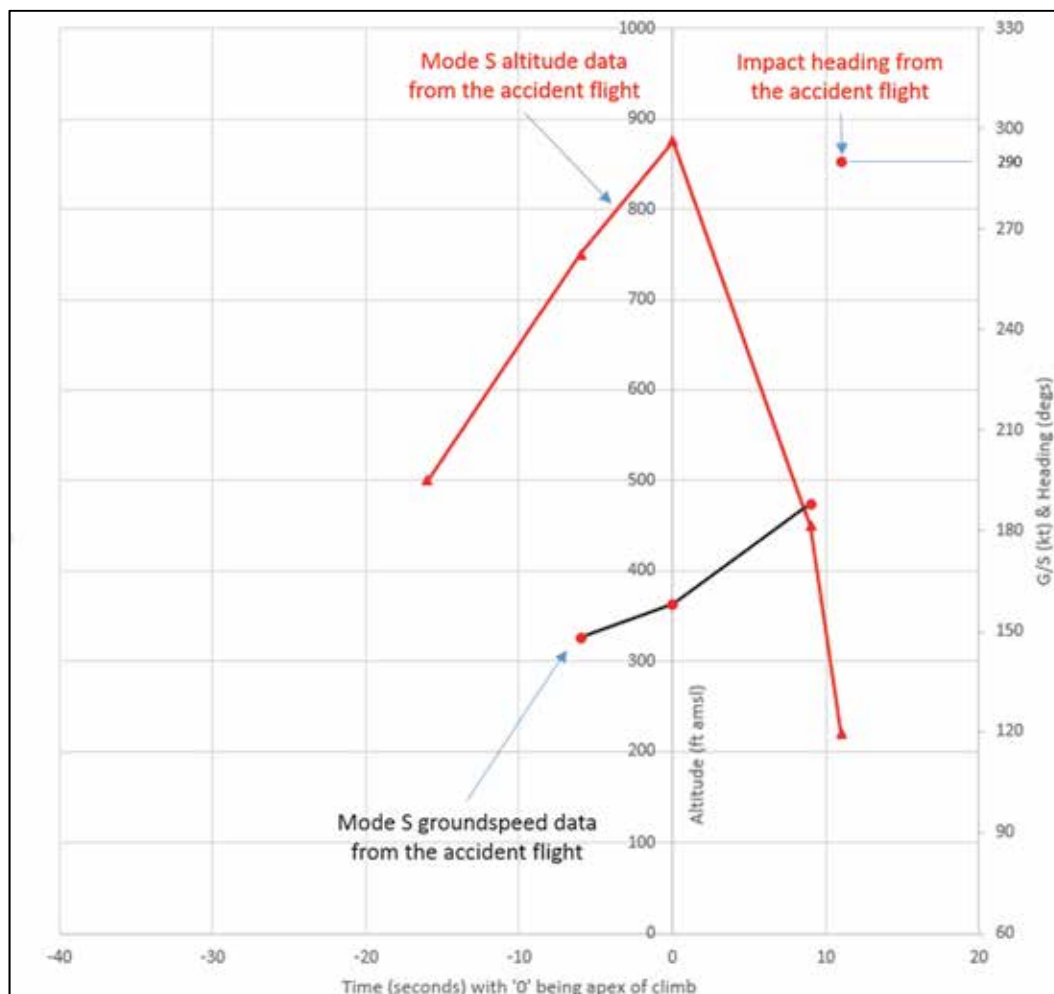
Figure 8
Accident flight profile

The AAIB 'flew' a B200 King Air full-flight simulator in an attempt to match the accident flight profile derived from radar data (ground track, altitude and groundspeed) and physical evidence (the track of the wreckage trail, and the aircraft attitude at impact). The simulator was programmed to reflect the weight and balance of G-BYCP and the environmental conditions on the day of the flight. The aircraft was turned onto a heading of 205°M after takeoff and the climb was flown both manually and with the autopilot engaged. Takeoff power was set for the duration of each flight. The flight profile generated from radar and physical data, which the trial attempted to match, is shown in Figure 8. Time is set to zero at the apex of the climb for comparison purposes.

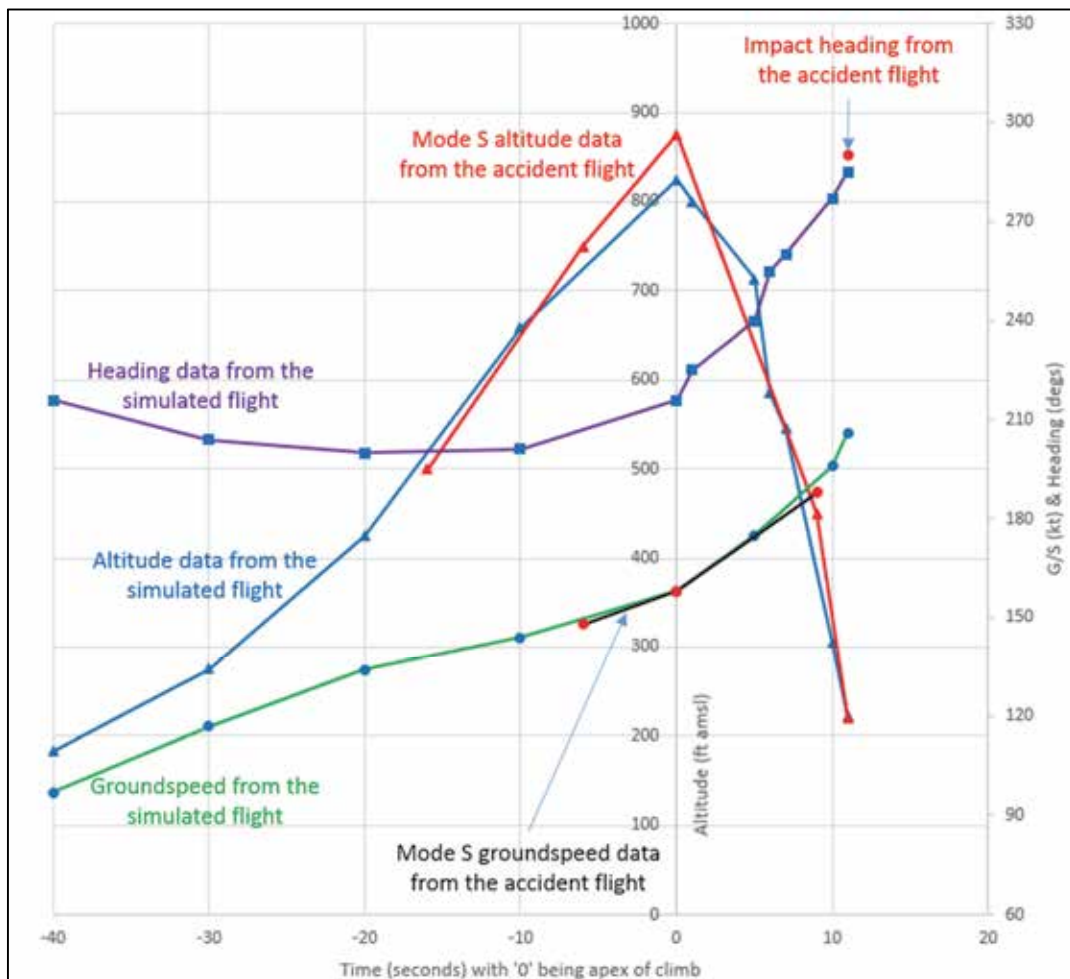
The flight profile from the simulated flight is shown in Figure 9 superimposed upon the accident flight profile.

Simulated and accident flight profiles
