INCIDENT

Aircraft Type and Registration:	Boeing 747-436, G-CIVX	
No & Type of Engines:	4 x Rolls-Royce RB211-524G2 turbine engines	
Year of Manufacture:	1998 (Serial no: 28852)	
Date & Time (UTC):	30 January 2016 at 1712 hrs	
Location:	After takeoff from London Heathrow Airport	
Type of Flight:	Commercial Air Transport (Passenger)	
Persons on Board:	Crew - 17	Passengers - 293
Injuries:	Crew - None	Passengers - None
Nature of Damage:	None	
Commander's Licence:	Airline Transport Pilot's Licence	
Commander's Age:	N/A	
Commander's Flying Experience:	N/A hours Last 90 days - N/A hours Last 28 days - N/A hours	
Information Source:	AAIB Field Investigation

Synopsis

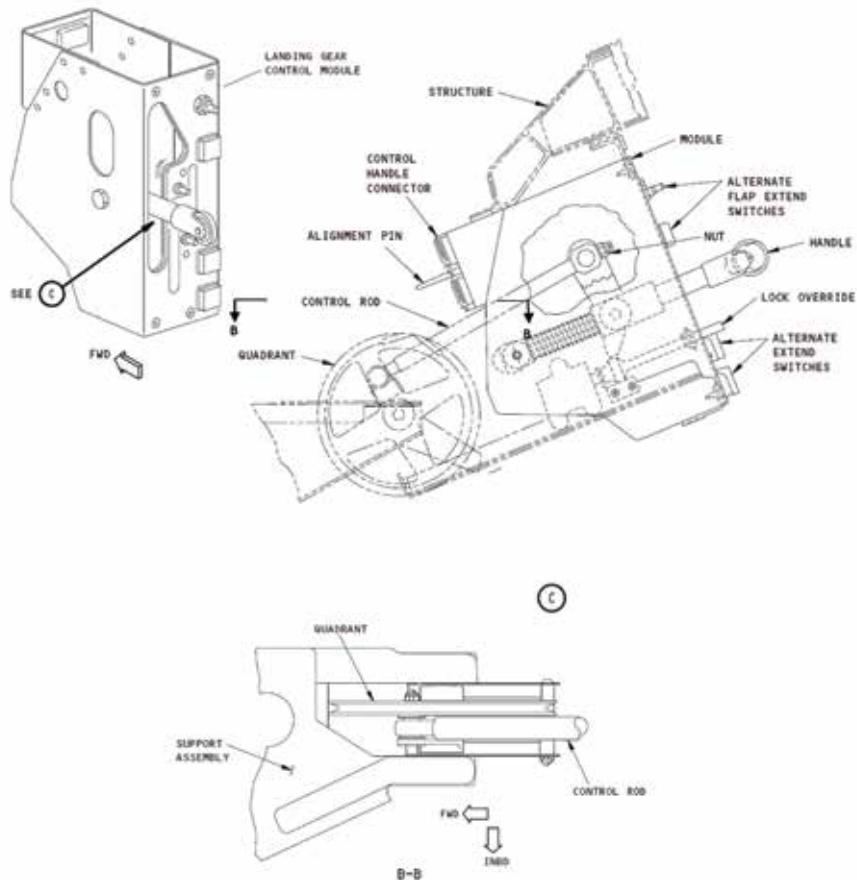
Figure 1

Inspection and function checks were carried out at the operator's main base following the incident. The LGCM was found to be mechanically jammed in the UP position. The lever could only be moved to the OFF or DN positions by the application of excessive force.

Landing Gear Control Module showing handle and control rod

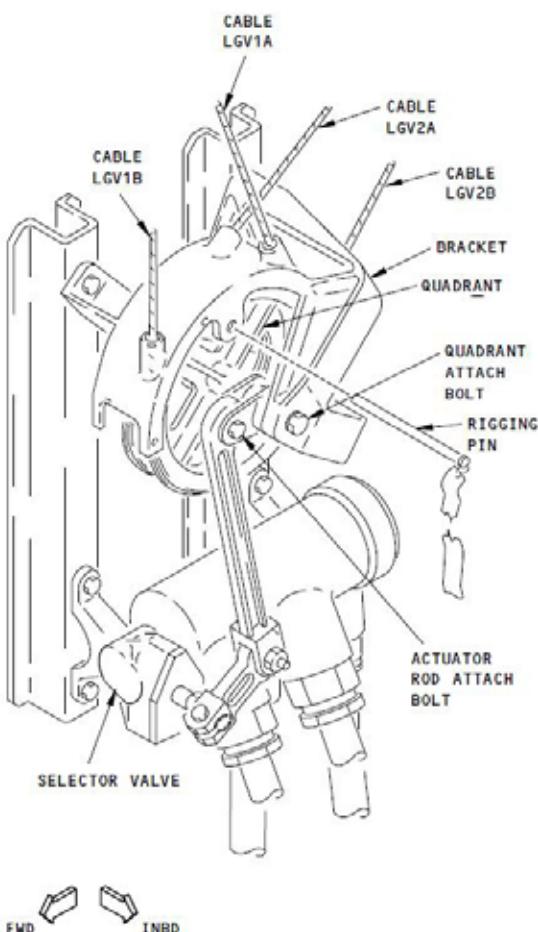
**Figure 3**

The quadrant in each wheel well is connected to a selector valve by a mechanical lever. When a replacement LGCM is installed, it is a requirement in the Aircraft Maintenance Manual (AMM) to insert a rig pin in the selector valve quadrant (Figure 3).

Wing Gear Selector Valve Installation - note rig pin
(Nose/Body Gear Selector Valve Installation similar)

The jammed landing gear lever was attributed to a rig pin not being inserted in the landing gear system during maintenance, which led to additional and unnecessary shims being used to rig the landing gear lever.

- a. Updating the TR so that technical management are consulted if more than three rigging shims are used for this task and to include a requirement to fit rig pins and to check that the rig pins can be inserted freely once function checks are completed;
- b. Holding staff briefings to reinforce the requirements to adhere to handover procedures;
- c. Publishing a bulletin to highlight this incident, including the distraction aspect;
- d. Introduction of additional skills training in task card generation.
