Report on the investigation of a  
fatal man overboard from the fishing vessel

***Aquarius* (BF 89)**

east of Aberdeen

on 17 August 2015

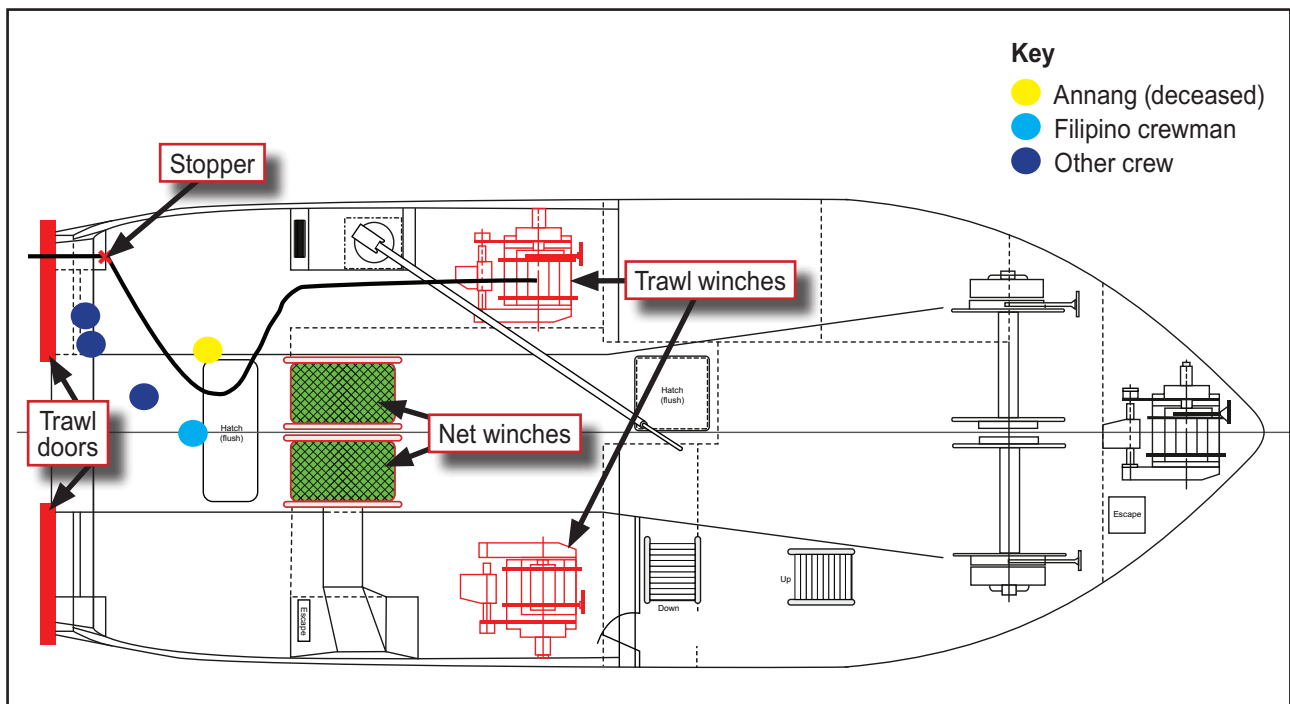
Figure 6: Positions of the deck crew when the stopper failed

Ghanaian crewman, Annang Nuerthey, was thrown overboard from the UK registered stern trawler *Aquarius* because he was kneeling within a bight of a trawl wire that suddenly came under tension when the stopper taking the weight of the wire failed.

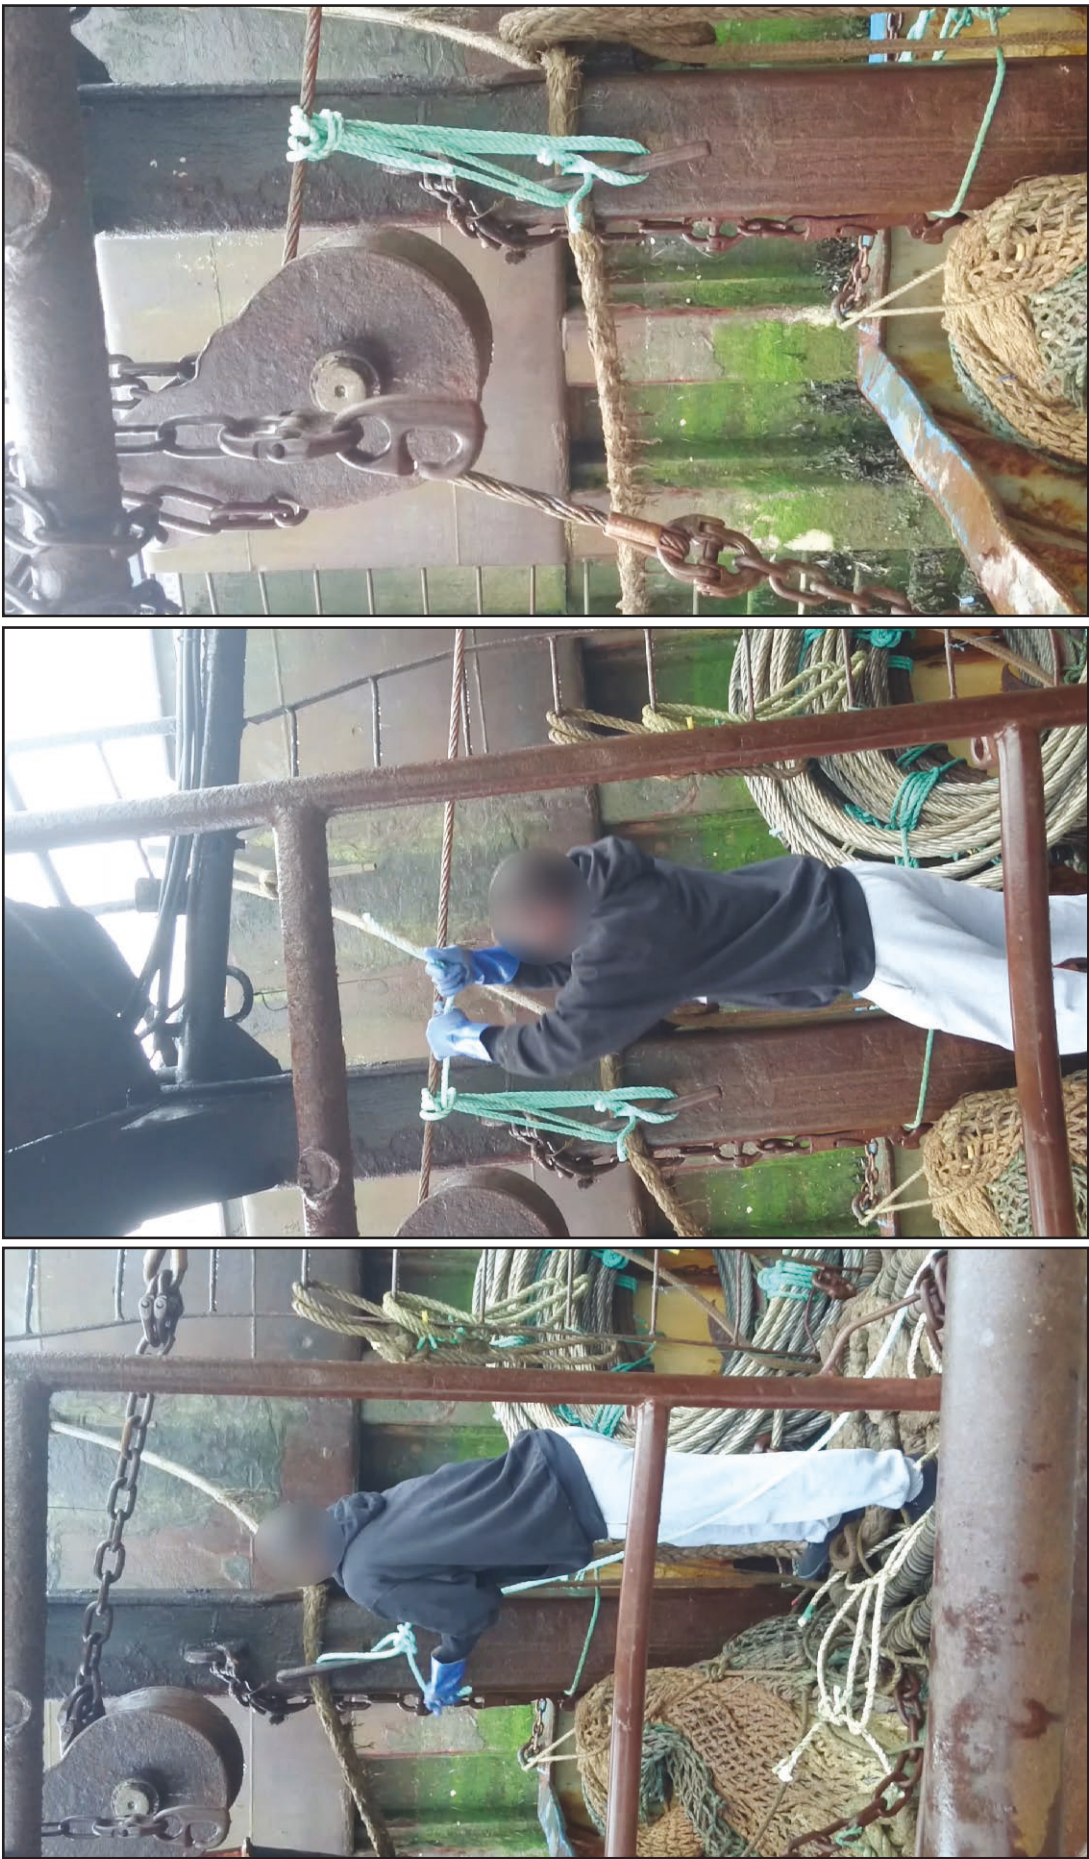
**Figure 9:** Reconstruction of application of the stopper hitch from cleat on port side to the warp

During the MAIB inspectors' initial inspection of the accident site, the deck crew were asked to demonstrate how the stopper had been applied. It was observed that the crewman initially secured one end of the stopper rope to a cleat on the port side of the stern gantry (**Figure 9**). He then looped the other end of the rope over the warp and around the cleat three times before tying it off around the warp with a series of half hitches. When the warp winch was veered, it was noted that the stopper hitch moved aft and entered the gantry block (**Figure 10**). The steel wire warp was then seen to slip a short distance through the hitch before the stopper tightened and took the strain.

The hitch used to create the stopper, and the manner in which the stopper was applied, were not in accordance with the guidance provided in CoSWP or seamanship manuals (**Figure 12**). The stopper should have been applied in such a way that it could take the strain before it entered the gantry block. The effect of crushing the stopper rope against the steel groove of the gantry block wheel would have caused further damage to the man-made fibre rope.

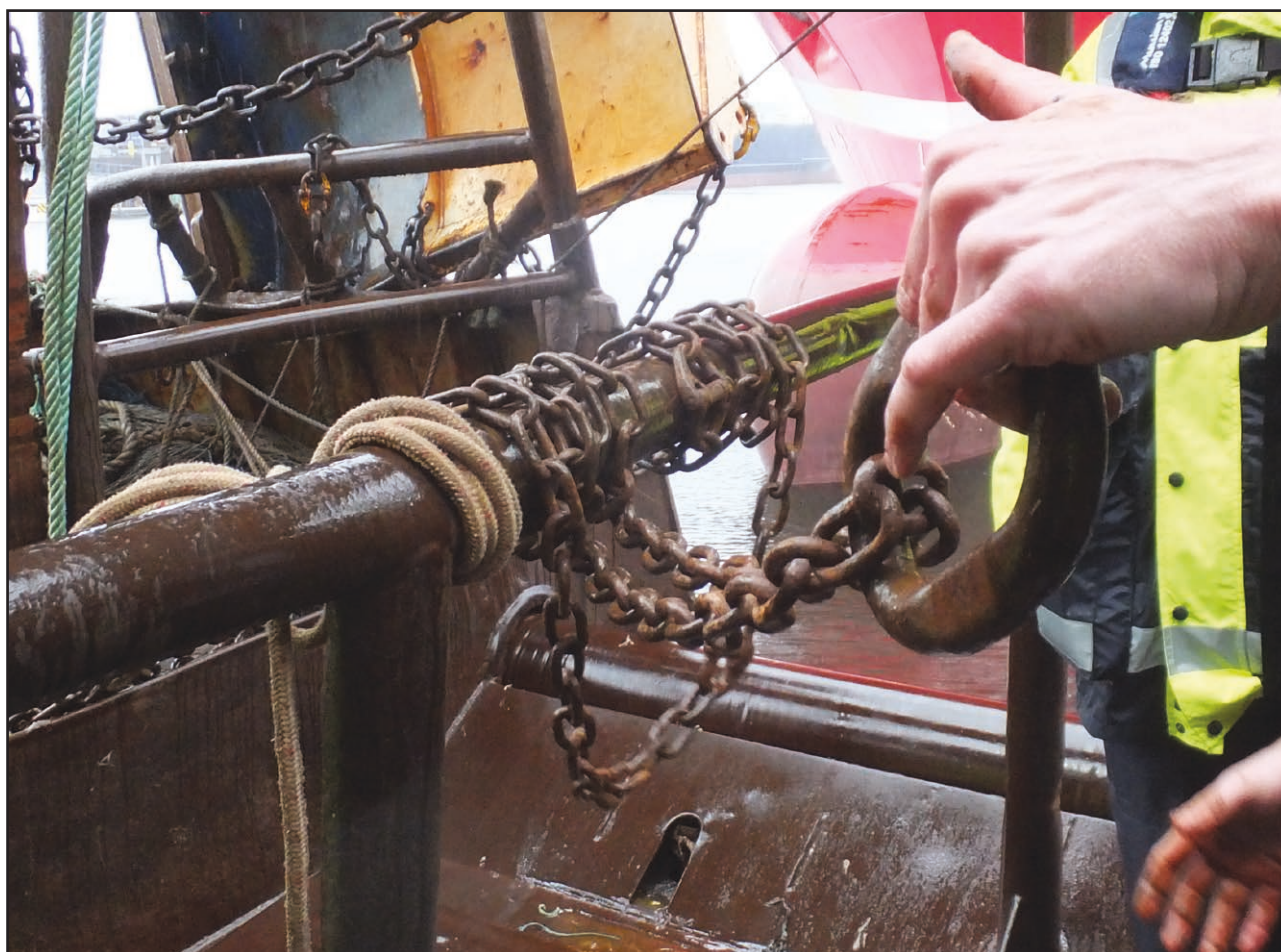
**Figure 11:** Endless chain available for use on *Aquarius*

An endless chain (**Figure 11**) for stoppering the trawl warps was carried on board *Aquarius* and had been used by the skipper and his crew on numerous occasions previously.
