## Fatal accident while manoeuvring *Svitzer Moira* alongside an unmanned tug Royal Portbury Dock, Bristol 29 December 2015

### SUMMARY

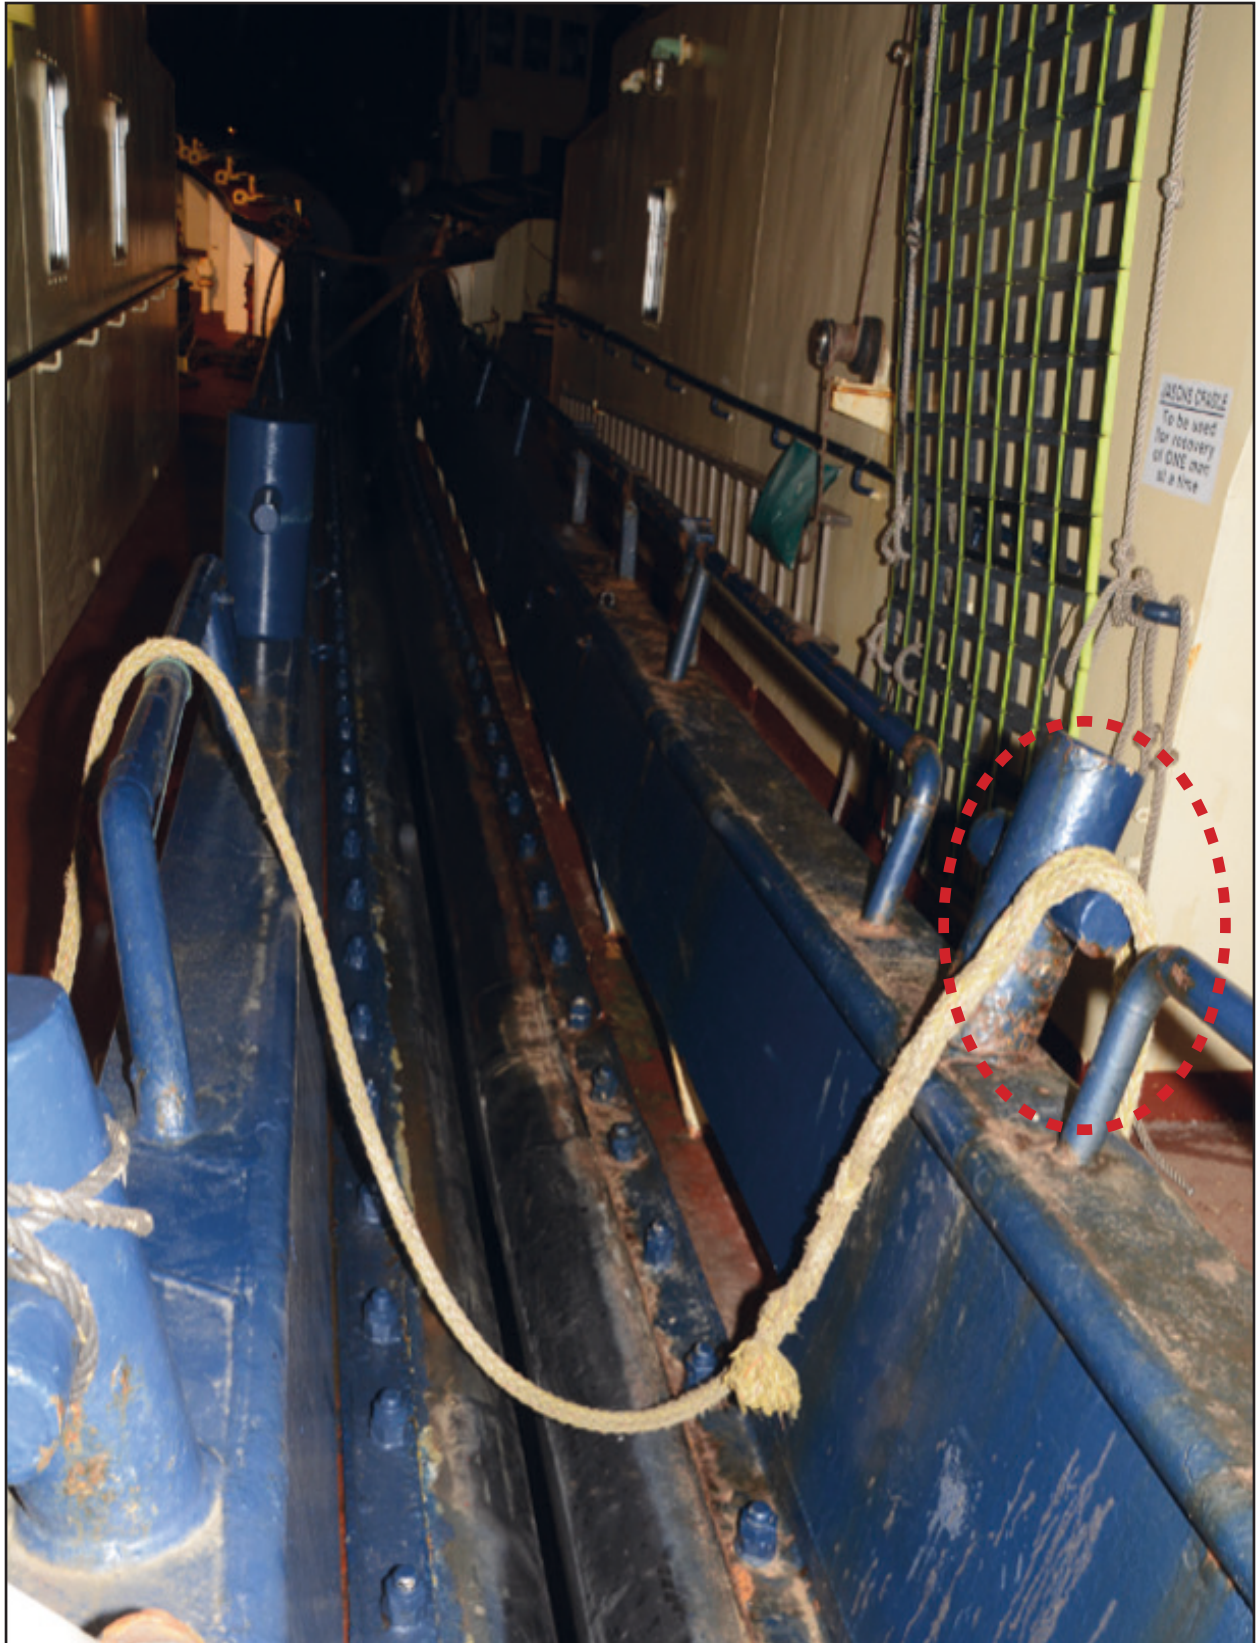
**Figure 3:** Amidships mooring rope as found following accident (reconstruction)

The status of the amidships mooring rope indicates that the engineer had made an attempt to pass the eye of the rope over the corresponding bitts on *Svitzer Ellerby* but was unsuccessful. The open bulwark gate suggests that the engineer had opened it, to transfer to the unmanned tug in order to place the rope correctly over the bitt.

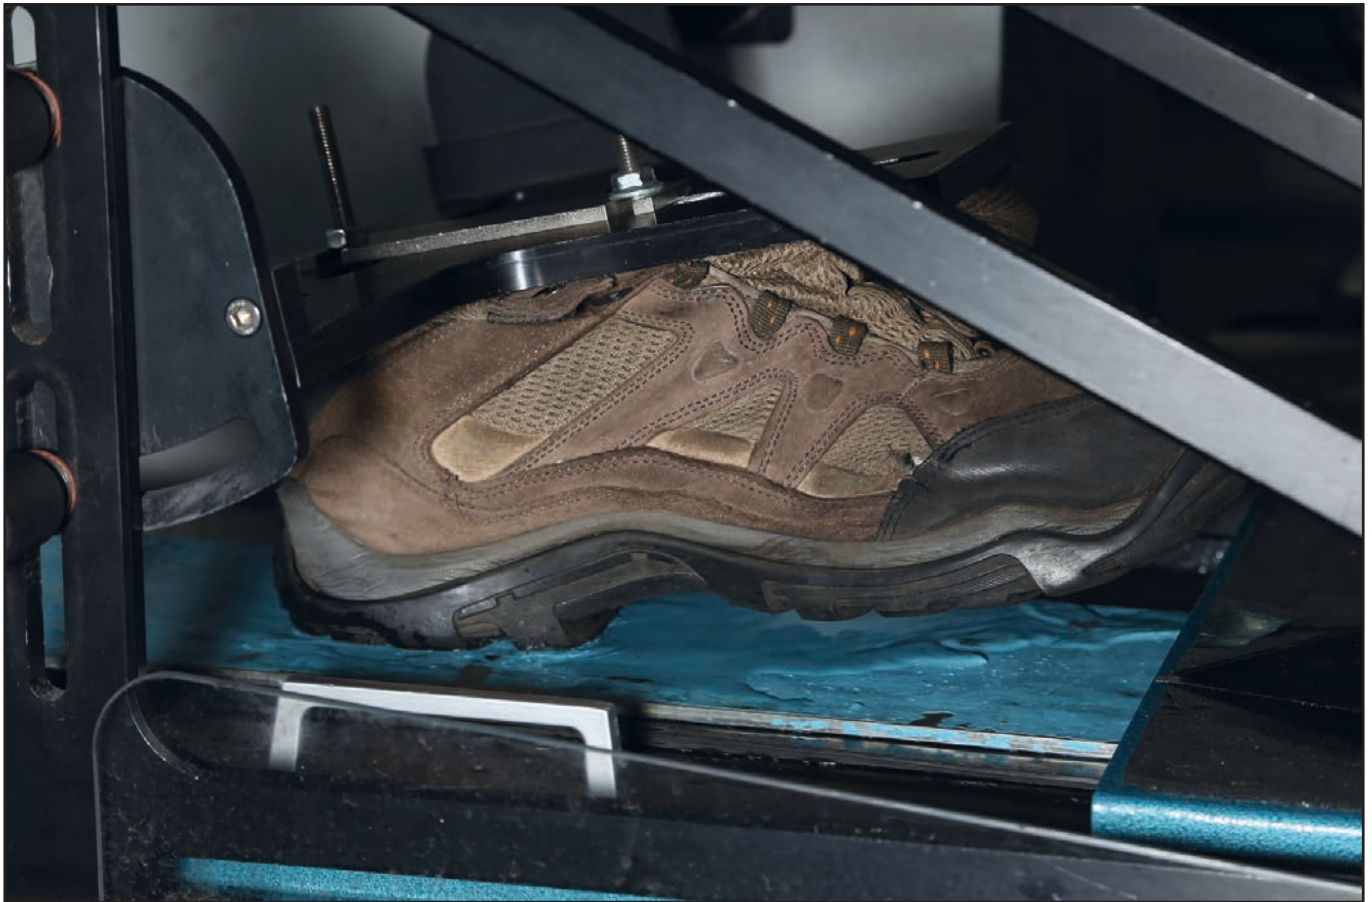
**Figure 5:** Walking boot undergoing slip resistance testing

Independent comparative slip resistance tests were conducted on the walking boots the engineer was wearing at the time of the accident and a new pair of safety boots of the type supplied to him by the company (**Figure 5**). The tests concluded:

*'The worn boots are clearly not in a condition that would be recommended for wearing in the work place due to the general state of wear of the upper, sole and construction. The integrity of the construction in particular is of concern with the shoe bottom coming away from the upper presenting a safety risk. The outsole itself is also in need of replacing being materially changed from its original design and the wearing face breaking down.'*

*Notwithstanding the above, however, there is no indication from the slip resistance testing completed and reported here, that the worn boots would have been expected to have a significantly different level of slip resistance performance in wear on wet and otherwise contaminated surface from the new boots.*

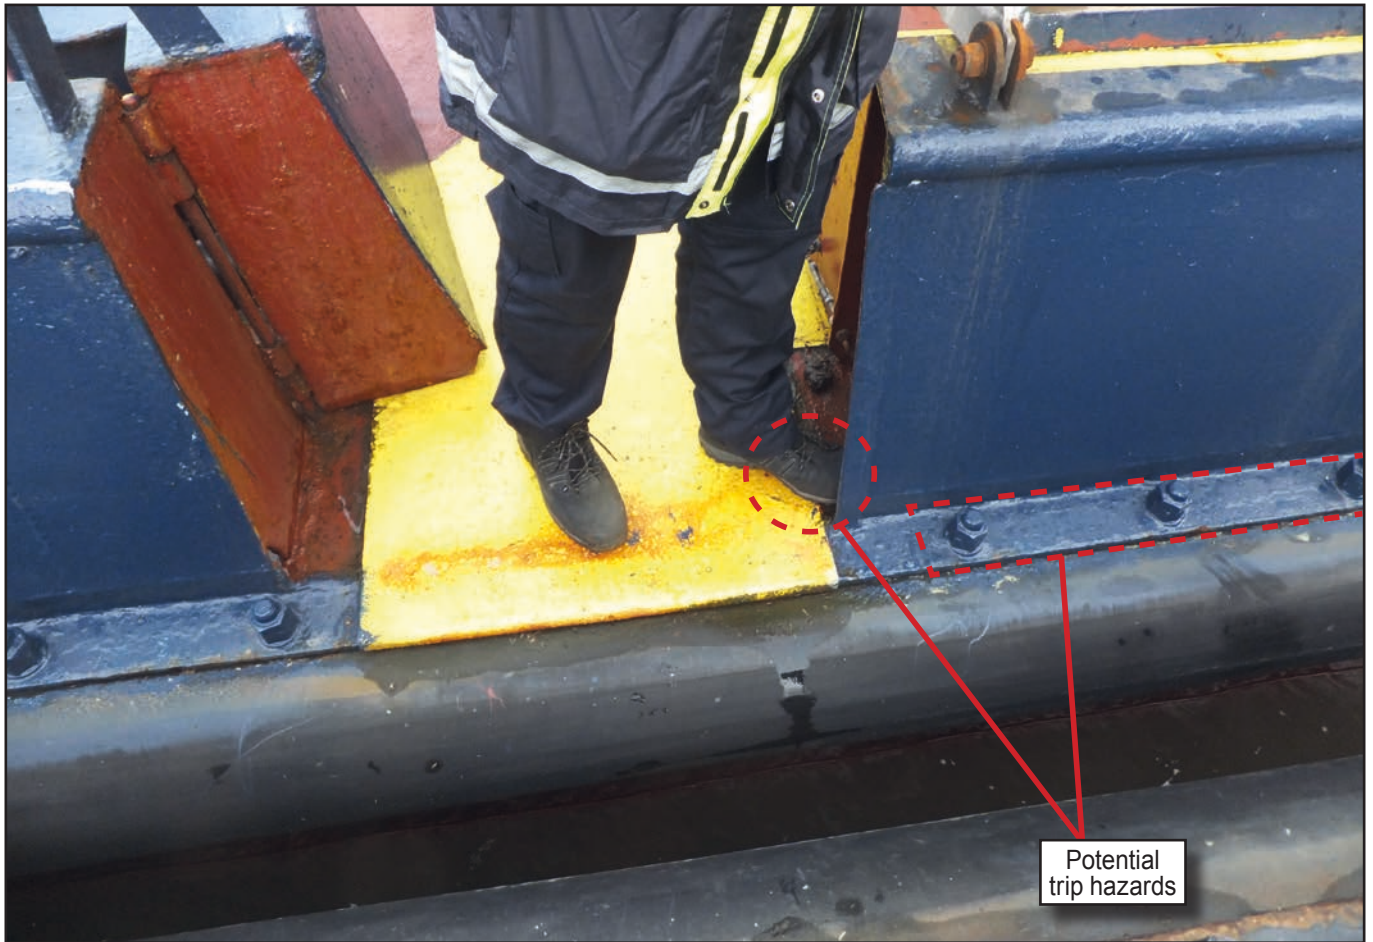
**Figure 6:** Bulwark structure, fendering and securing bolts

There were several trip hazards in the vicinity of the bulwark gate. These included the bulwark structure and the bolts used to secure the fendering in position (**Figure 6**). *Svitzer Moira* was well illuminated but *Svitzer Ellerby* was in darkness, giving rise to an increased risk of tripping (**Figure 7**).

It is probable that the engineer fell forward, possibly as a result of slipping or tripping as he exited through the bulwark gateway in an attempt to pass between the two tugs. As he fell he might have extended his right arm for protection, and possibly struck his head against something, rendering him unconscious.
