Report on the investigation of the collision
between the stern trawler
Karen (B317)
and a dived
Royal Navy submarine
in the Irish Sea
on 15 April 2015

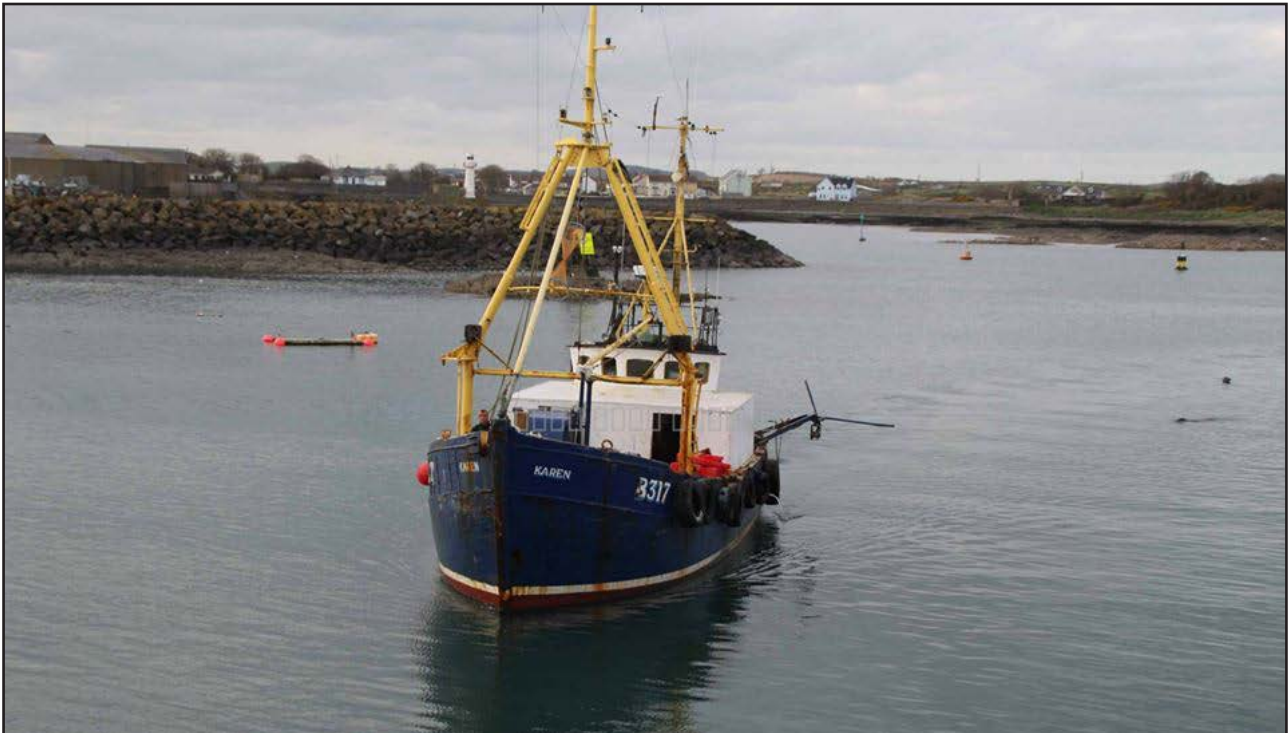
Figure 4: *Karen* returning to Ardglass – damage evident on port side

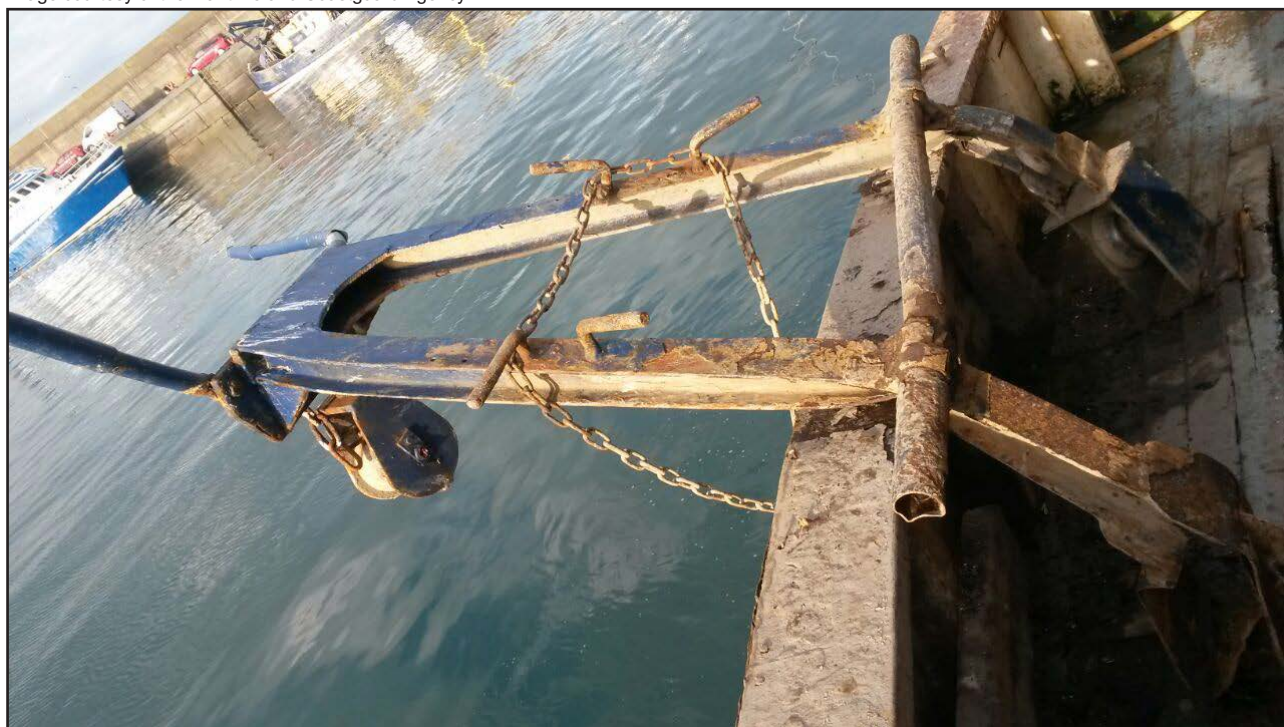
- The port gallows structure was distorted and had collapsed onto the port after bulwark. The bulwark's top rail was cracked where the port gallows had collapsed onto it (**Figure 6**).
- Deck planking around the port gallows' foundation plate was broken and damaged (**Figure 7**).
- The internal transverse beam in the fish hold that supported the hydraulic winch bedplate was cracked (**Figure 8**).

Figure 6: *Karen* – damage to port gallows and bulwark top edge

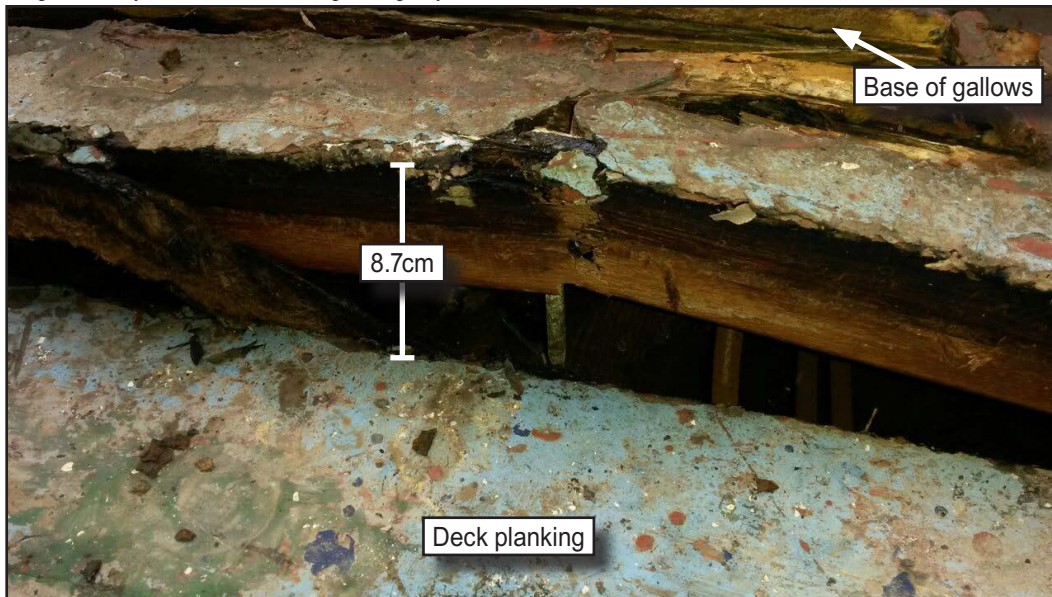
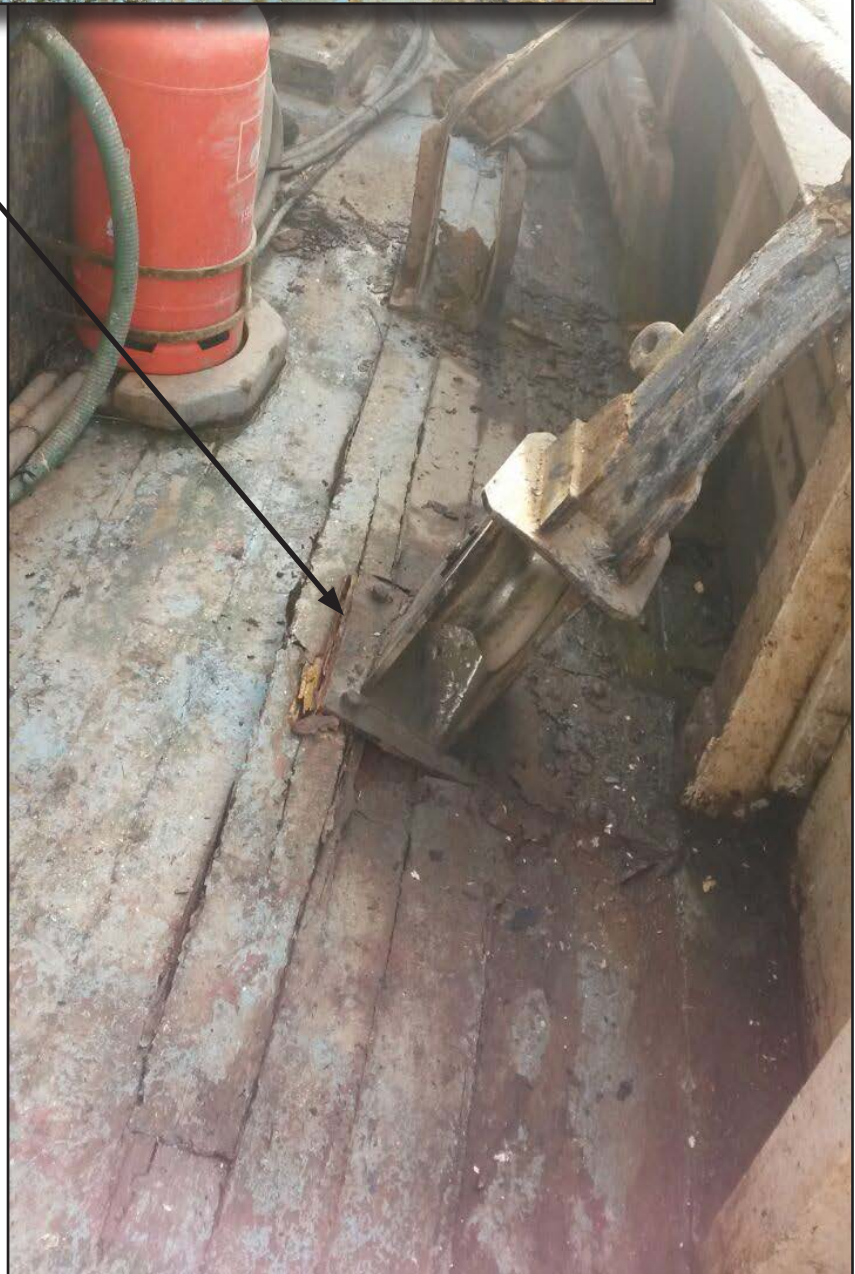
Figure 7: *Karen* – damage to deck planking around port gallows foundation plate

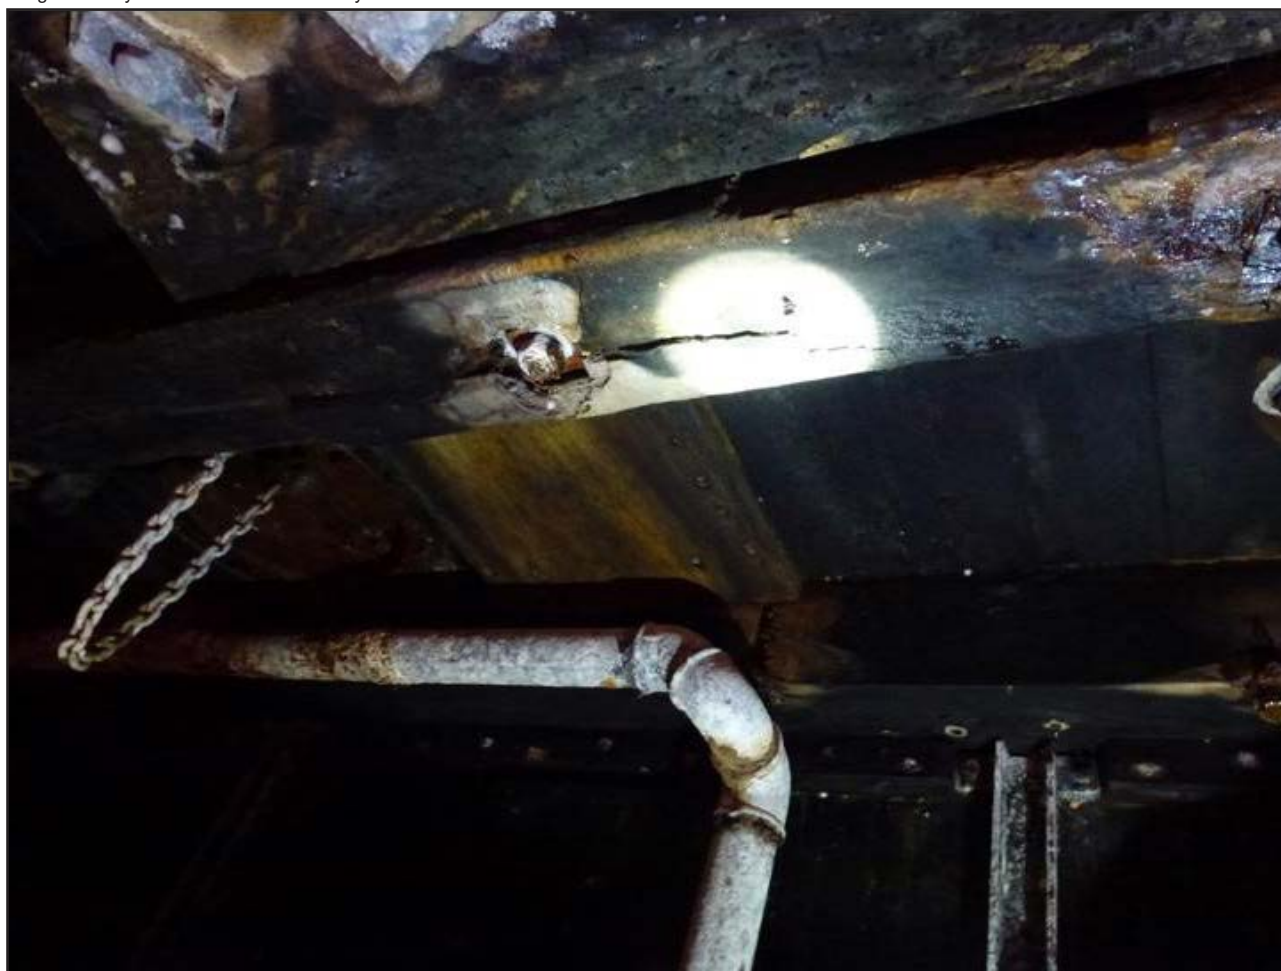
Figure 8: *Karen* – crack in fish hold transverse beam used to support the hydraulic winch bedplate

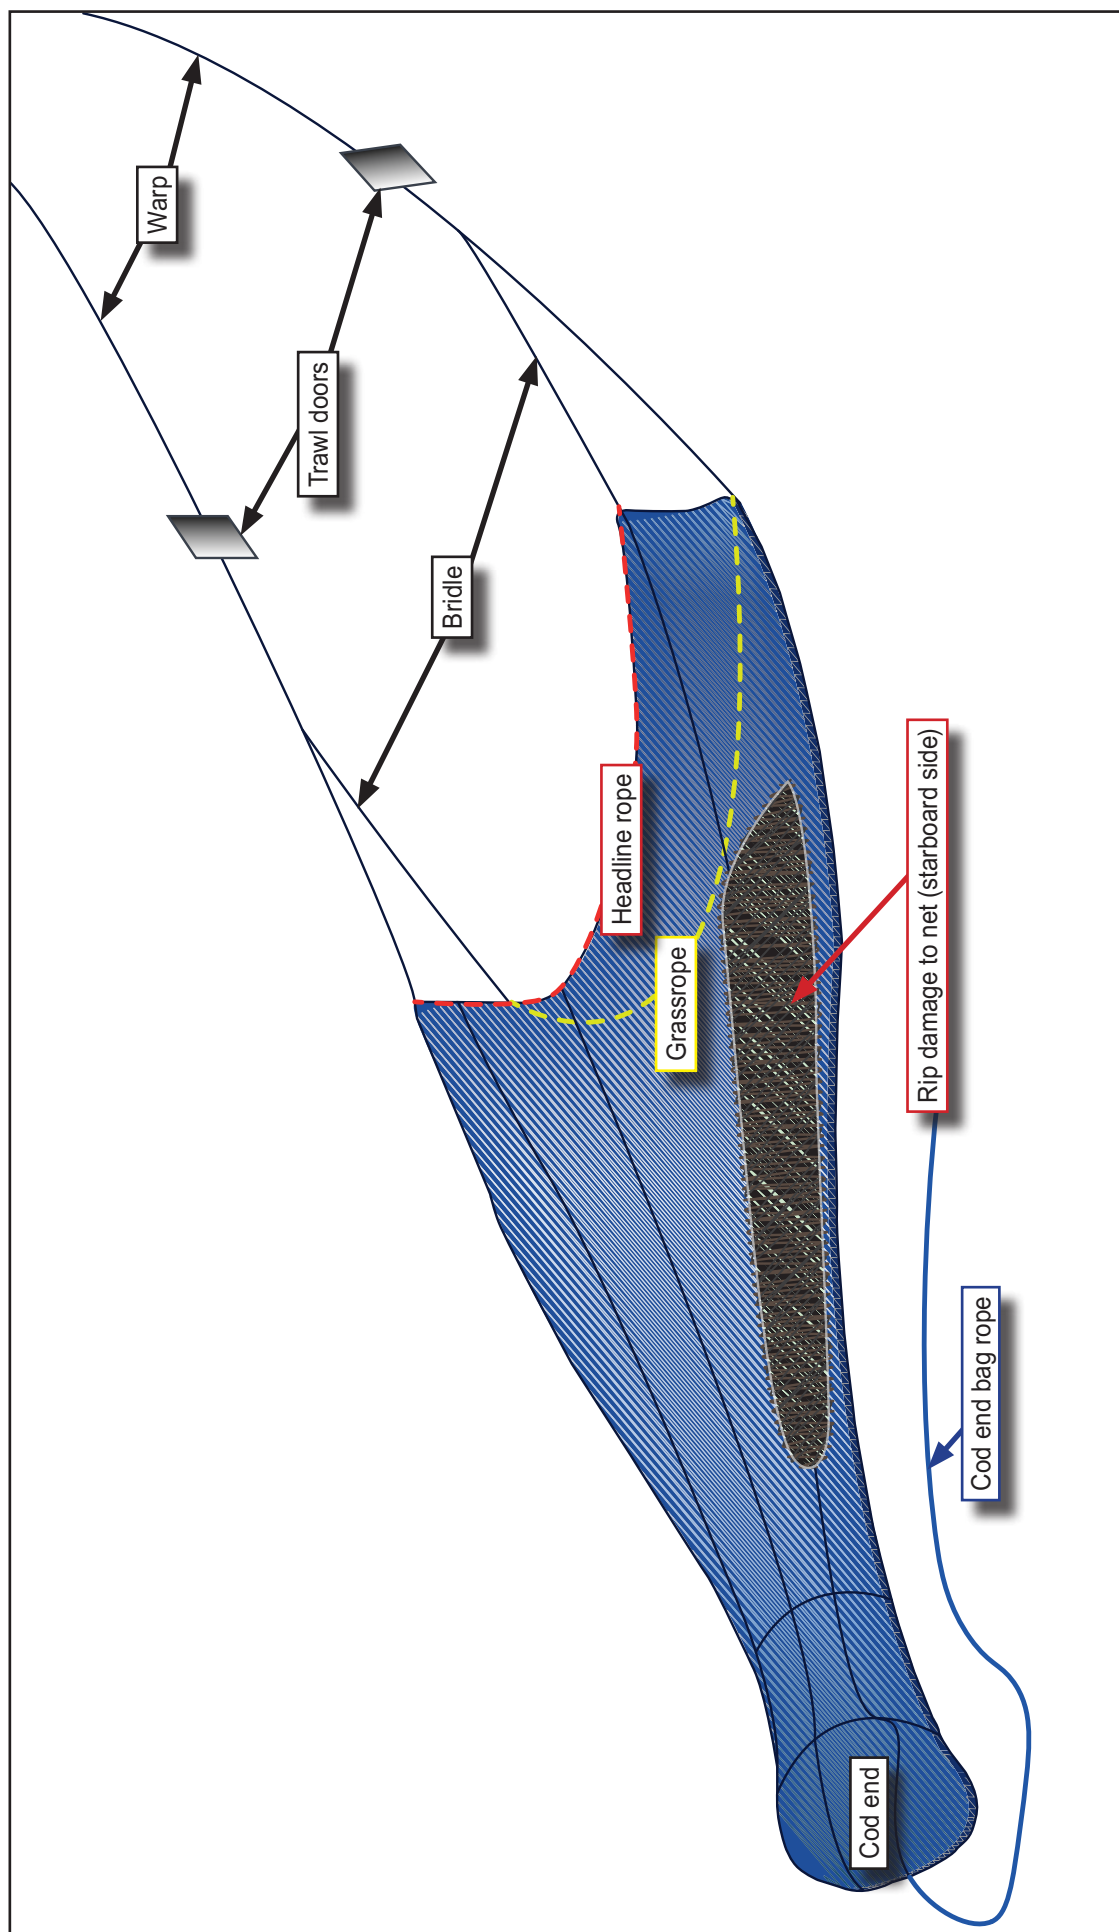
Karen's net and one of its trawl doors were recovered off the seabed in the same fishing grounds by other trawlers in the weeks after the accident. The recovered net was identified as having originated from *Karen* based on its Northern Ireland Government identification tag⁹. MAIB inspectors examined the net and found extensive damage to the mesh on the starboard side (**Figure 9**). The headline rope and grass rope were both damaged and broken and the cod end rope appeared to have been cut.

Figure 9: Diagram of fishing gear showing areas of damage and sections removed for further analysis

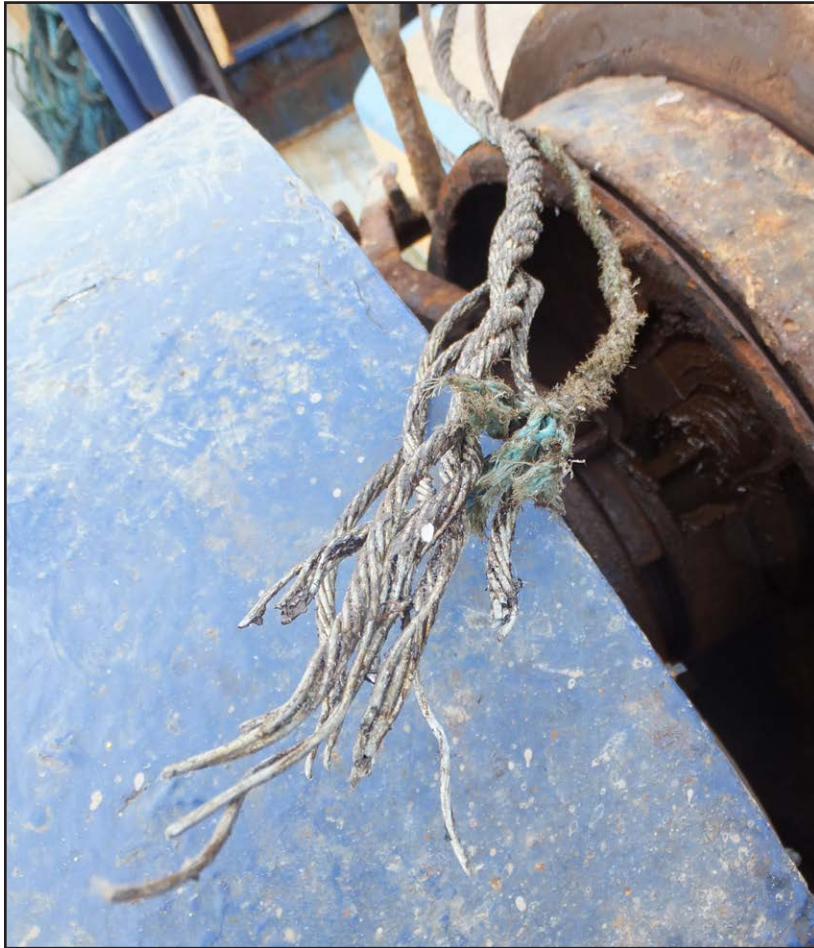
Samples of the recovered net and the broken end of the port trawl warp that had remained on board *Karen* after the accident (**Figure 10**) were sent to Materials Technology Limited (MTL) for laboratory examination. Key conclusions of the MTL examination report included:

Figure 10: *Karen* – broken end of the port trawl warp that was left on board after the warp parted

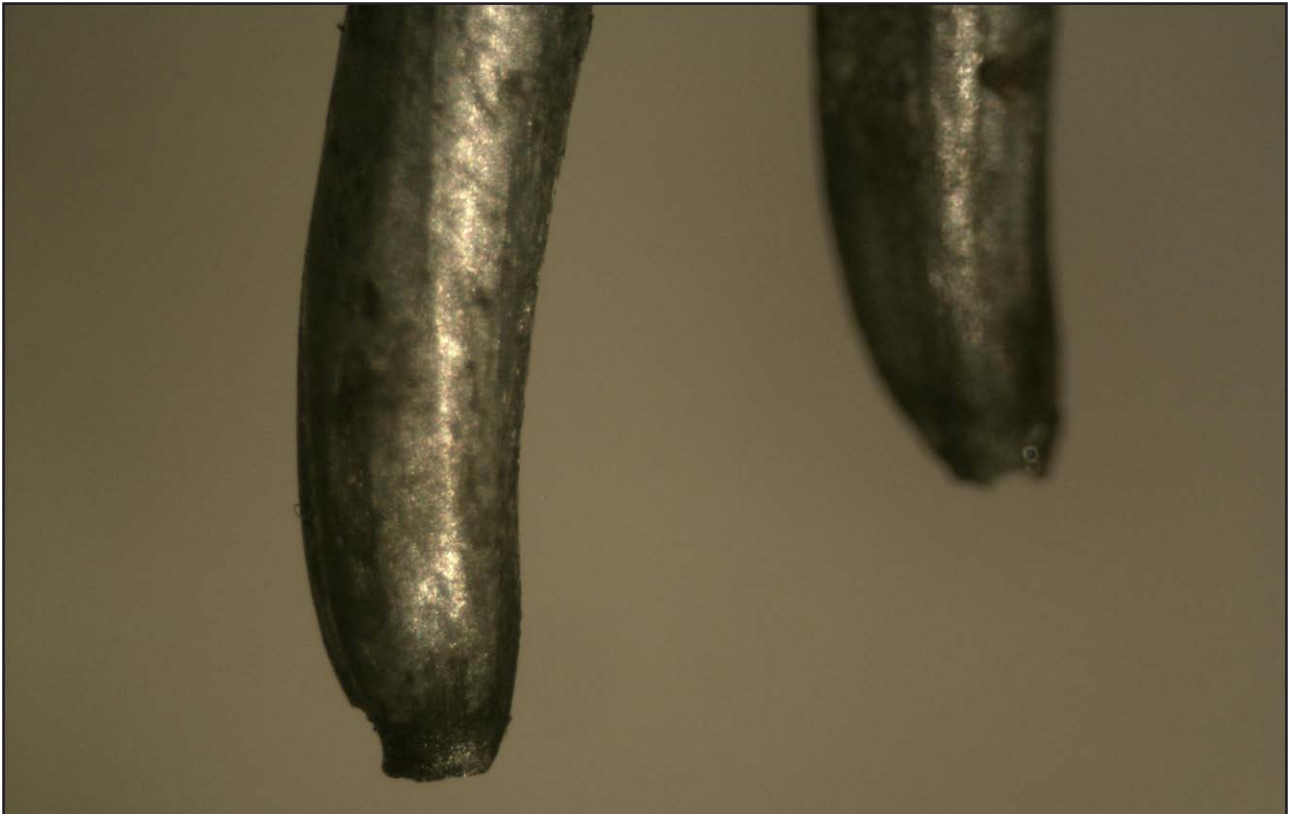
- The port trawl warp showed evidence of failure due to tensile overload, and the applied failure load would have been in the region of 13 tonnes(t) (**Figure 11**).
- Samples from the headline and grass ropes both showed evidence of tensile overload failure; their steel wire cores were also heavily corroded (**Figure 12**).
- The cod end bag rope had been cleanly cut with a sharp single blade or cropper (**Figure 13**).

Figure 11: Close-up of strands of the port warp showing 'cup and cone' ductile failure indicative of overload failure

Once the submarine's forceful pull was applied to the warps, the gear will have lifted off the seabed and, in order to apply a minimum 13t force, the trawl doors, or possibly the net, must have become snagged on the submarine. Additionally, the damage to the transverse beam in the fish hold, which the winch bedplate was bolted onto, can almost certainly be attributed to the excessive, albeit brief, load on the port warp. It has not been possible to determine how the cod end bag rope was cleanly cut, but there is no evidence to suggest that this was done by the submarine or its crew.

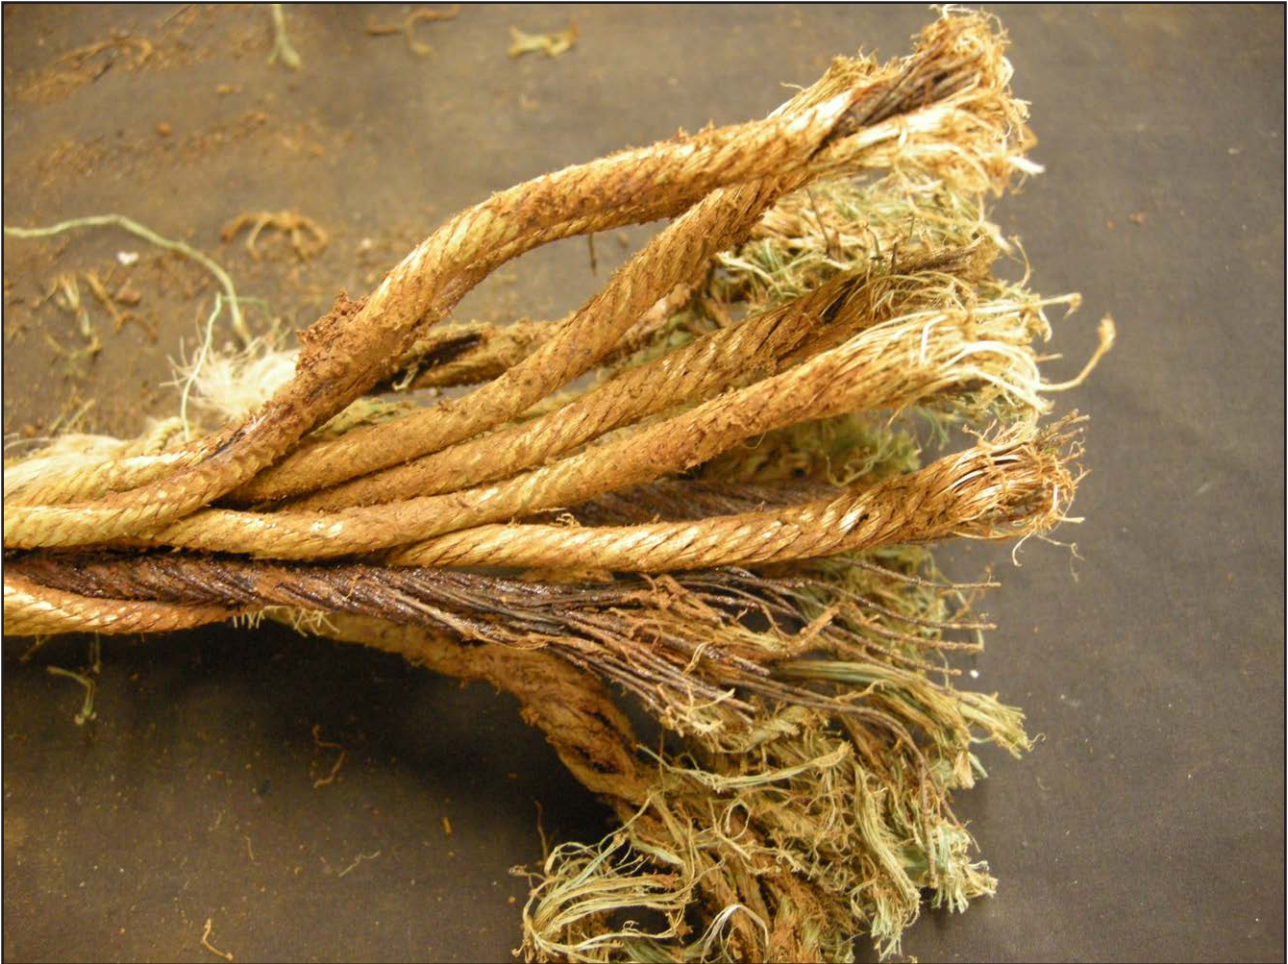
Figure 12: Starboard grass rope point of failure showing corroded central steel wire rope and external sisal core

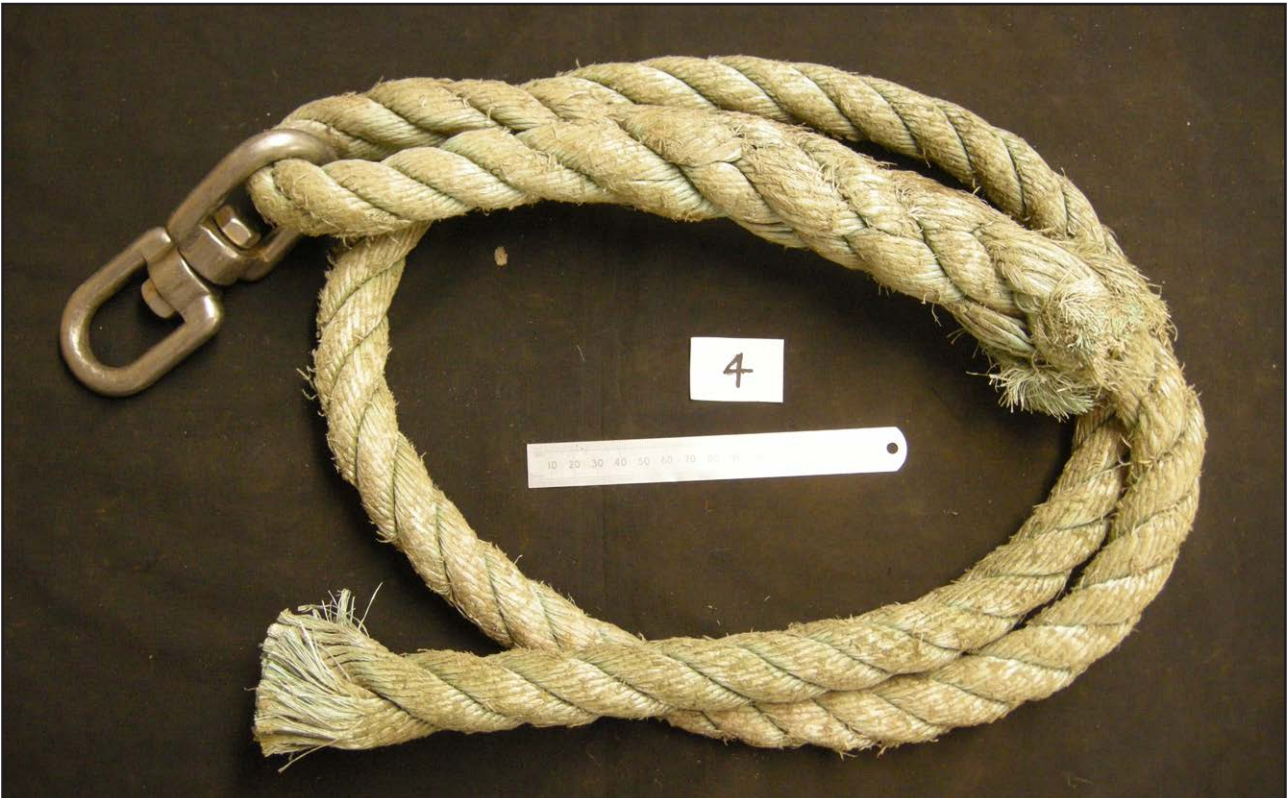
Figure 13: Cod end bag rope showing spliced shackle and cut end
