Rail Accident Investigation Branch

Rail Accident Report

Collision at Knockmore Junction, Northern Ireland 4 February 2016

Report 20/2016
October 2016

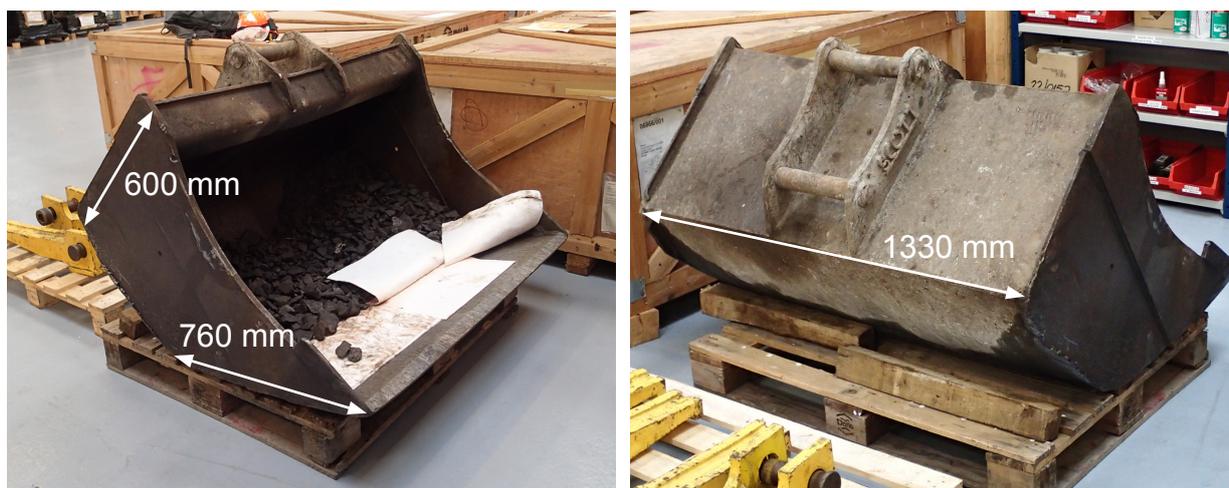
- 18 The excavator bucket was manufactured specifically for NE Rail and weighed approximately 670 kg; it was 1330 mm wide (figure 5). The bucket was this width to maximise digging efficiency when working between rails fixed at the 1600 mm track gauge used throughout Ireland.

Figure 5: The excavator bucket after the accident

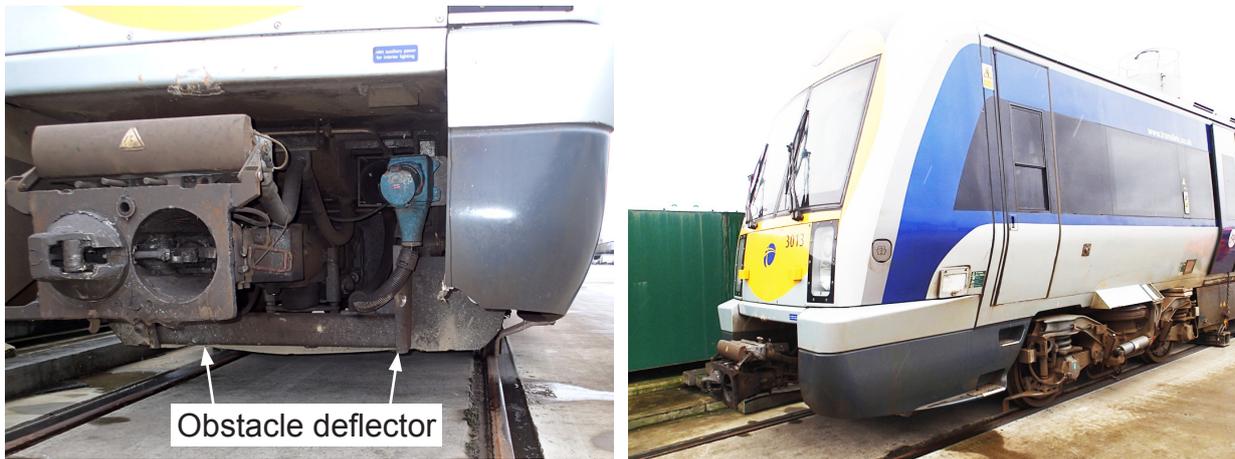
- 40 The train pushed the bucket along the track, damaging rail fixings and sleepers as it passed. As it did so, the leading vehicle was lifted vertically as the train's obstacle deflector rode over the top of the bucket which then passed between the train's *lifeguards*, devices intended to deflect objects from the path of the leading wheels (figures 7 and 8). As the leading vehicle continued to ride further over the bucket, the leading bogie to vehicle body fastening was badly damaged and the battery box was dislodged (figure 9).

Figure 7: The front of train B301 after the accident

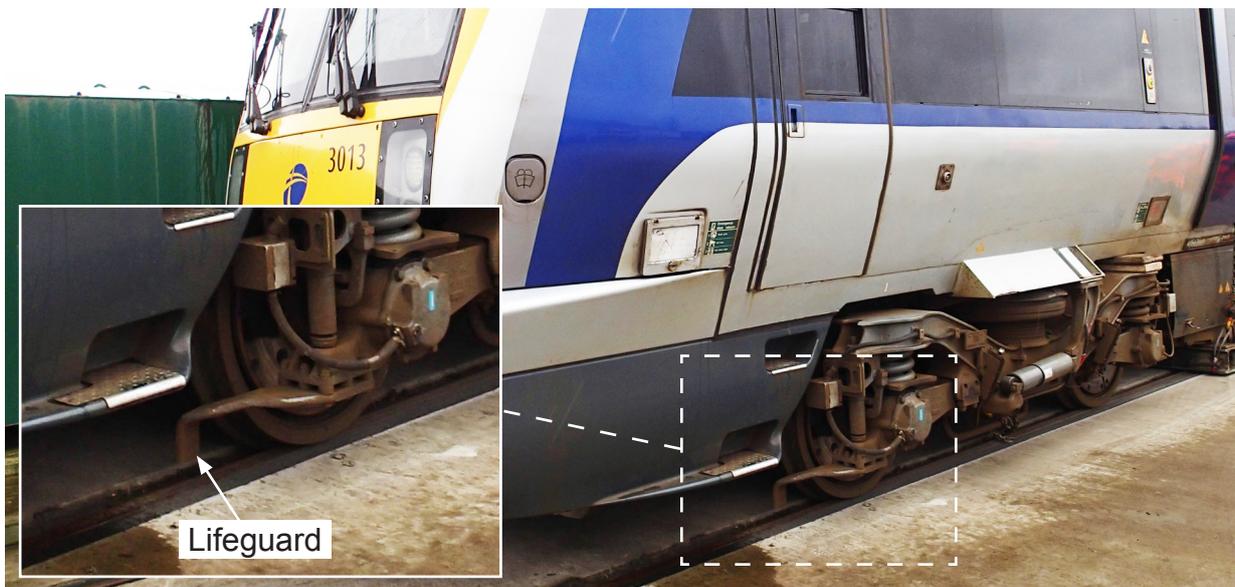
Figure 8: Side view of train B301 after the accident showing the left side lifeguard ahead of the leading bogie

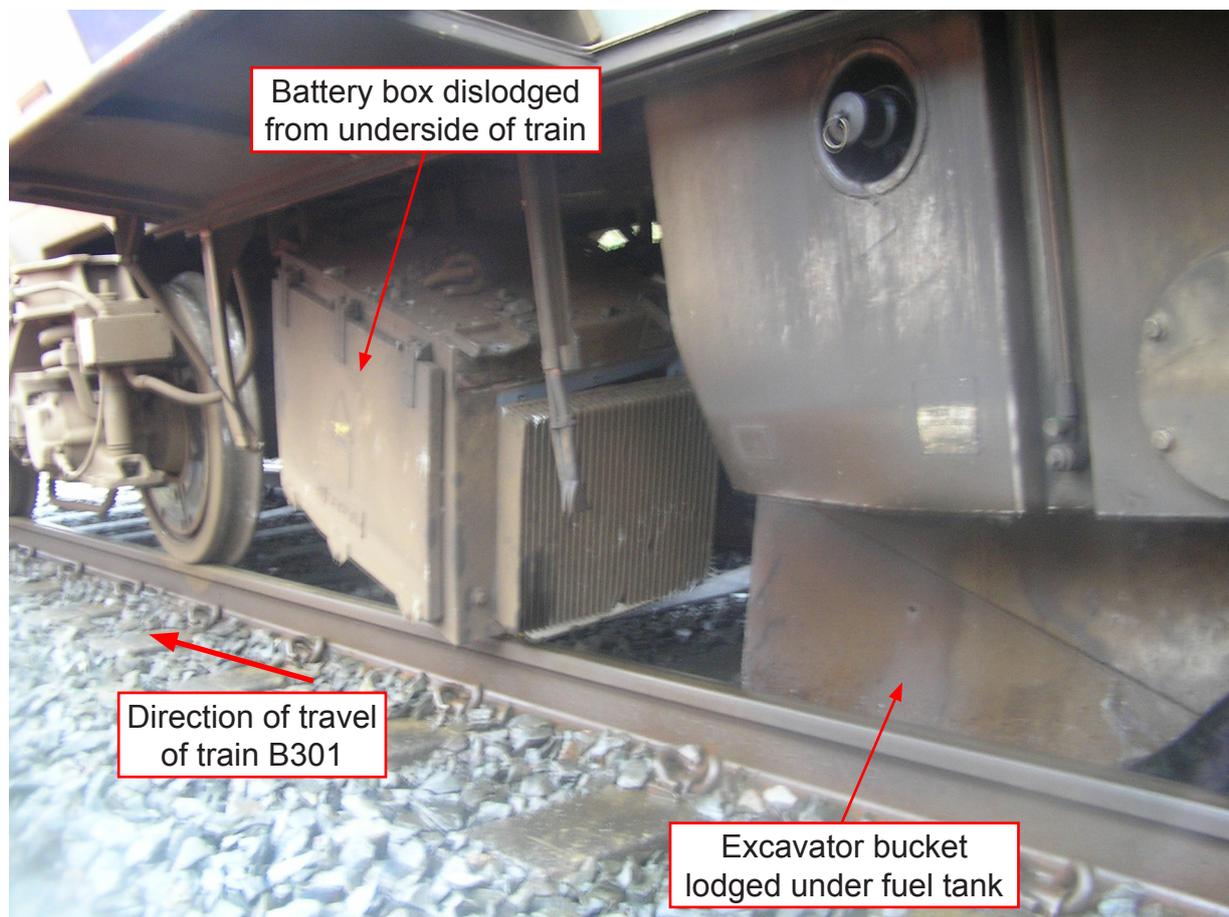
- 41 The leading vehicle remained in line with the track. This was possibly because the bucket remained in contact with the vehicle underside and was prevented from moving sideways. It was constrained by the rails either side of it, which provided some guidance.
- 42 The train stopped 330 metres from the point of initial impact, with the fuel tank of the leading vehicle balanced on top of the bucket. The diesel fuel tank had been punctured during the accident and its contents emptied into the bucket (figure 9).

Figure 9: Vehicle damage and excavator bucket under train B301

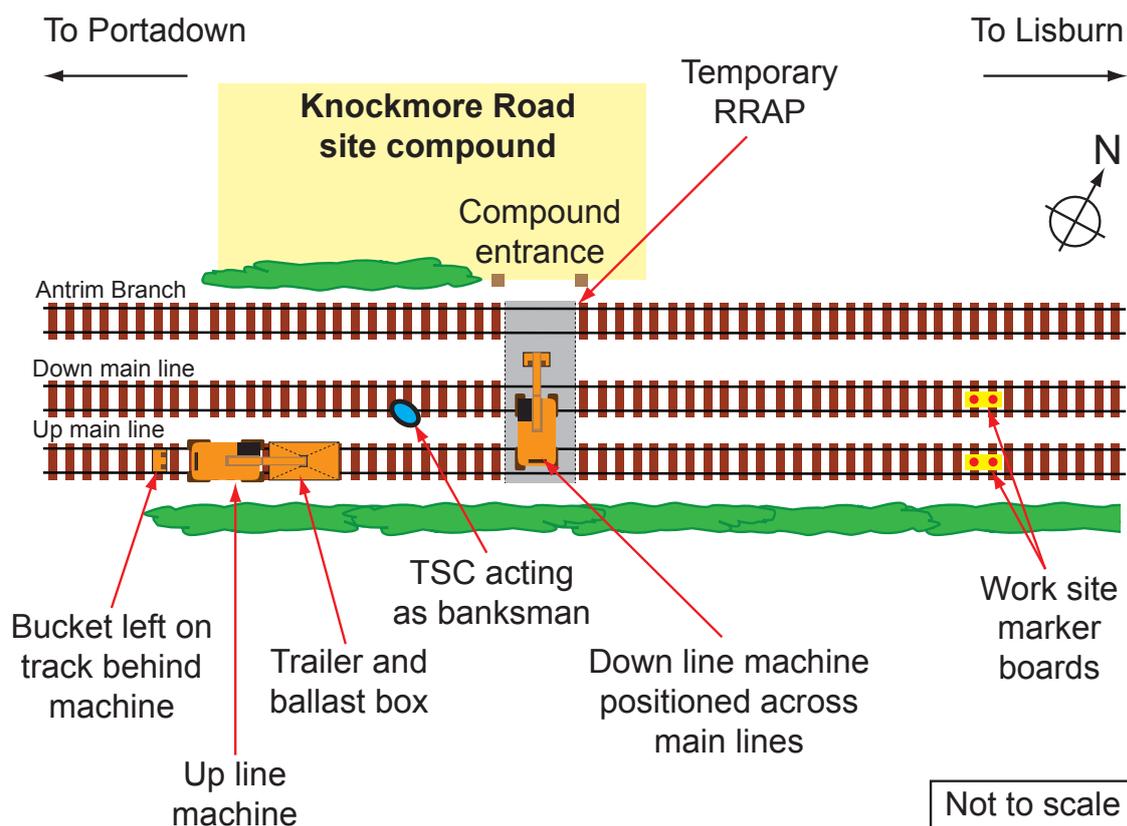
Figure 10: Location of the equipment and the TSC immediately before lifting the trailer and ballast box into the cess

- 60 During the lift, the TSC and machine driver B could not see the excavator bucket as their view was obscured by the machine performing the lift. The TSC stated that he had realised the bucket was no longer on the machine when he reached the RRAP because the lifting chains had already been attached in its place. However, the TSC did not consider where the bucket might have been detached. Machine driver B took his machine into the site compound, before machine driver A had off-tracked. This then meant that the only person remaining at the RRAP who had been aware of the bucket was machine driver A.
