## ACCIDENT

<b>Aircraft Type and Registration:</b>	EV97 Teameurostar UK, Eurostar, G-CDNI
<b>No &amp; Type of Engines:</b>	1 Rotax 912-UL piston engine
<b>Year of Manufacture:</b>	2005 (Serial no: 2321)
<b>Date &amp; Time (UTC):</b>	27 February 2016 at 1128 hrs
<b>Location:</b>	Peterborough/Conington Airport, Cambridgeshire
<b>Type of Flight:</b>	Training
<b>Persons on Board:</b>	Crew - 1                      Passengers - None
<b>Injuries:</b>	Crew - 1 (Serious)      Passengers - N/A
<b>Nature of Damage:</b>	Damaged beyond economic repair
<b>Commander's Licence:</b>	N/A
<b>Commander's Age:</b>	41 years
<b>Commander's Flying Experience:</b>	39 hours (of which 39 were on type) Last 90 days - 4 hours Last 28 days - 2 hours
<b>Information Source:</b>	AAIB Field Investigation

## Synopsis

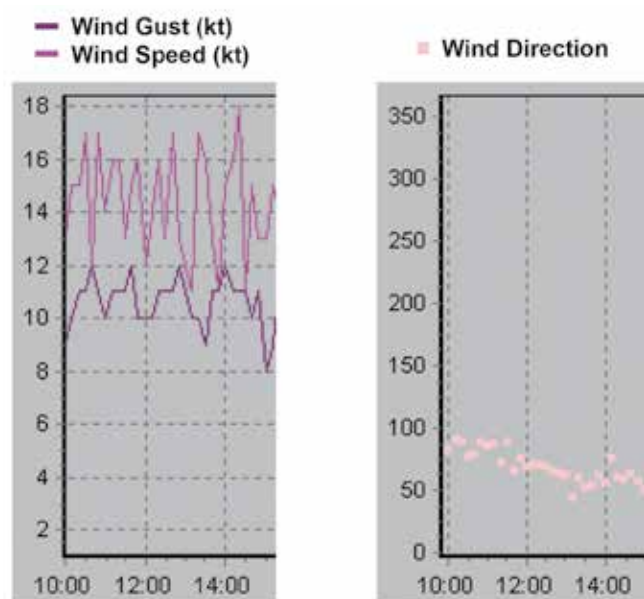
**Figure 1**

The tower, where the Aerodrome Flight Information Service Officer was located, was equipped with an uncalibrated computer-based weather station that recorded the wind speed and direction every 10 minutes, as measured by an anemometer located on a pole at the eastern boundary of the airport. A copy of the wind’s strength and direction over the period of the two flights is shown at Figure 1. During the instructional flight it recorded wind from about 050 to 060° at 10 to 12 kt gusting 17 kt. During the accident flight it was from about 080° at 11 to 12 kt with gusts up to 16 kt.

Recorded wind speed and direction at Peterborough Airport

The wind during the period of the two flights was from about 050 to 080° at 10 to 12 kt with gusts up to 16 kt. While the exact wind at the time of the accident is not known, the recorded wind information in the tower indicated that during the instructional flight the crosswind component was about 11 to 14 kt and during the accident flight about 6 to 7 kt. This is similar for the wind recorded at RAF Wittering soon after the accident. Although the

crosswind during the instructional flight may have been greater than that stated in the flying club's standing orders, it was probably below the limit during the accident flight, except that the gust limit may just have been exceeded.
