#### **SERIOUS INCIDENT**

Aircraft Type and Registration: Boeing 767-322, N642UA

**Location:** En route Heathrow to Chicago

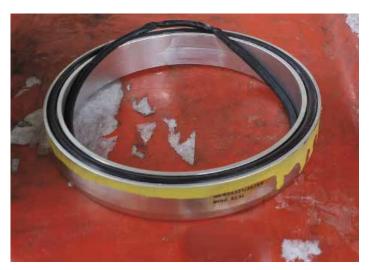
Figure 1

The following day, the aircraft departed Edinburgh on a ferry flight to Chicago. The same flight crew and flight attendants were assigned to the flight, but there were no passengers on board. During the climb-out from Edinburgh flight attendants again observed fuel streaming from the over-wing fuel filler cap on the right wing. The flight crew declared a MAYDAY and returned to Edinburgh. Fuel dumping was not necessary on this occasion as the aircraft was already below the maximum landing weight. The landing at Edinburgh was uneventful and following evaluation by the ARFFS, the aircraft was towed to a remote parking stand where further maintenance investigation revealed that an O-ring in the over-wing fuelling port was damaged (Figure 1).

Damaged O-ring from over-wing fuelling port

The damage to the O-ring indicates that it may have been pinched or improperly seated when it was last installed. There was no record of recent maintenance to the over-wing fuelling port which may have precipitated this damage. It is likely that once damaged, the condition of the O-ring degraded over time to the point where it was no longer able to form an effective seal between the fuelling port and the fuel filler cap, leading to the fuel leaks described in this incident.
