ACCIDENT

Aircraft Type and Registration:	Bombardier Global Express BD-700-1A10, N683GA	
No & Type of Engines:	2 Rolls-Royce BR 700 series engines	
Year of Manufacture:	2003 (Serial no: 9134)	
Date & Time (UTC):	25 March 2016 at 0345 hrs	
Location:	Owen Roberts International Airport, Cayman Islands	
Type of Flight:	Commercial Air Transport (Passenger)	
Persons on Board:	Crew - 2	Passengers - None
Injuries:	Crew - None	Passengers - N/A
Nature of Damage:	Another aircraft, a Saab 340B, registration VP-CKI, suffered damage to its outboard left underwing surface and left engine spinner and propeller	
Commander's Licence:	Not known	
Commander's Age:	Not known	
Commander's Flying Experience:	17,500 hours (of which 600 were on type) Last 90 days - Not known Last 28 days - Not known	
Information Source:	Aircraft Accident Report Form submitted by the pilot and a report from the internal investigation conducted by the airport operator

Synopsis

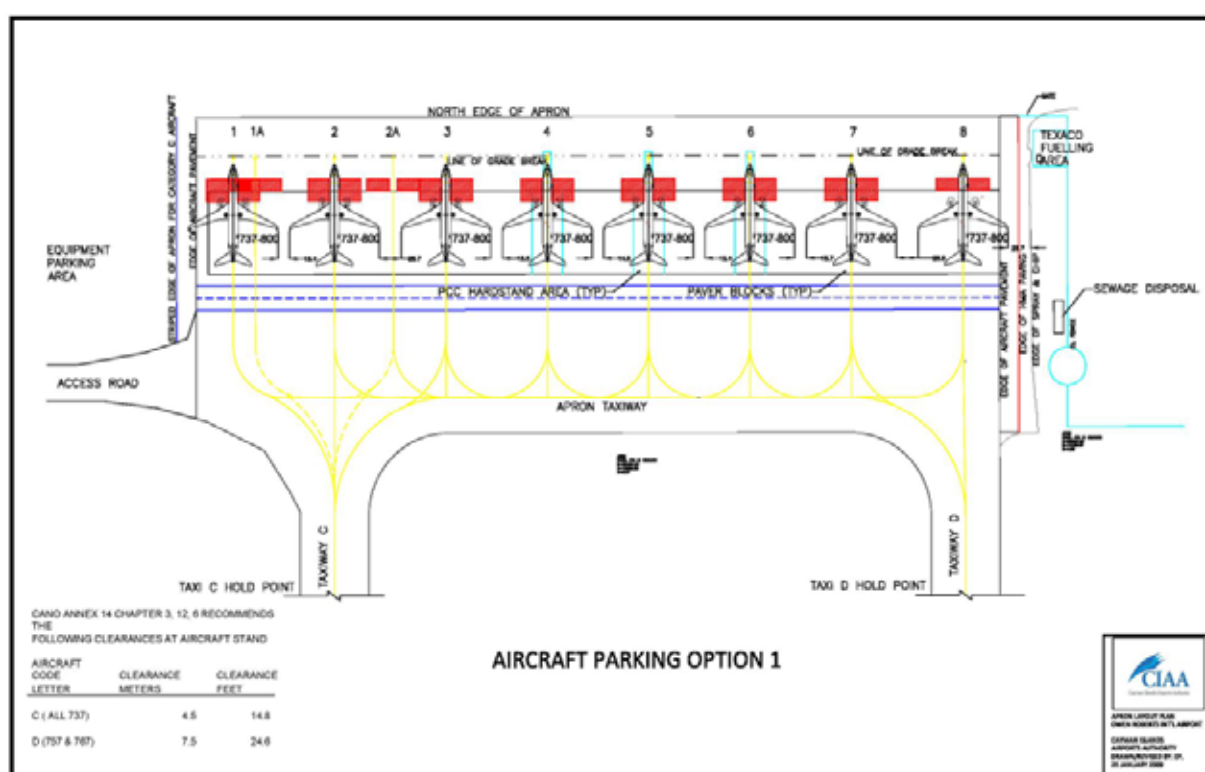
Figure 1

The aircraft arrived at Grand Cayman at 0322 hrs UTC on 25 March (2222 hrs local time on 24 March) and the commander was advised by ATC to proceed to the Commercial Apron. It was dark but the weather was clear. ATC advised that they did not have parking instructions for the aircraft but to expect to park on Stand 8 (see Figure 1).

As the aircraft approached the apron it was marshalled towards Stand 2. A parked Saab 340 was occupying Stand 1, on the left, and a parked Boeing 737 occupied Stand 3, on the right. Both aircraft had been parked for more than 3 hours, and were staying overnight. All the other stands on the apron were clear.

Aircraft parking geometry, commercial ramp, Owen Roberts International Airport

N683GA was parked so that its tail infringed the taxiway, a situation which the ADO considered to be a safety risk that should be addressed immediately. She attempted to resolve the situation by asking the commander to move the aircraft. The required personnel were not present for the task to be completed safely, so, on being asked by the commander, she decided to assist him herself. Communication between the ADO and the aircraft was not effective and the commander believed he was receiving signals to turn to the right, which required high engine power. It is common procedure when taxiing a short distance to use one engine but doing so may create a high power requirement in confined areas, with an associated risk to personnel and equipment. On this occasion, the jet blast caused the adjacent SAAB 340 to move substantially on its stand and collide with ground equipment which should have been removed.
