ACCIDENT

Aircraft Type and Registration:	Piel CP301B Emeraude, G-AZGY	
No & Type of Engines:	1 Continental Motors Corp O-200-A piston engine	
Year of Manufacture:	1968 (Serial no: 122)	
Date & Time (UTC):	16 April 2016 at 1300 hrs	
Location:	RAF Henlow, Bedfordshire	
Type of Flight:	Private	
Persons on Board:	Crew - 1	Passengers - None
Injuries:	Crew - None	Passengers - N/A
Nature of Damage:	Left landing gear, wing skin and propeller	
Commander's Licence:	Light Aircraft Pilot's Licence	
Commander's Age:	56 years	
Commander's Flying Experience:	971 hours (of which 497 were on type) Last 90 days - 2 hours Last 28 days - 2 hours	
Information Source:	Aircraft Accident Report Form submitted by the pilot and further inquiries by the AAIB

Synopsis

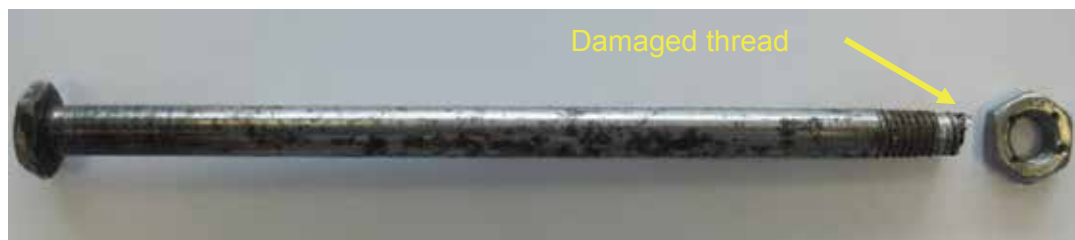
Figure 1

The pilot reported that the threads on the inboard forward attachment bolt appeared to have been stripped and the nut had been pulled off the end (Figure 1). In this condition the landing gear was not adequately restrained. This caused the lower attachment plate to bend, allowing the landing gear leg to twist outboard until it failed just above the lower attachment plate (Figure 2).

Failed landing gear attachment bolt

The pilot reported that the failed bolt appeared to have been homemade. He commented that it seemed to have been poorly manufactured and with a poorly cut thread, that occupied only a small portion of its length. The nut was a half-thickness nut, offering limited thread engagement with the bolt. The nut did not offer a good fit with the threads of the bolt and appeared to have been locked by staking the nut/bolt thread interface with a number of centre punch strikes. No washers were installed. All the landing gear attachment bolts were of a similar construction.

The pilot considered that poor construction of the landing gear attachment bolts was the primary cause of the bolt failure. He also considered that the previous landing on a rutted runway may have served to accelerate the failure of the bolt, but it was unlikely to have to have been causal.

The pilot commented that the landing gear attachment bolts, which had been fitted at some time prior to him acquiring the aircraft, appeared to have been poorly manufactured, with insufficient nut depth to assure good locking. He was not aware until after the accident of the locking technique that had been used, and commented that this locking technique precludes subsequent torque tightening without compromising the locking method. His attempts to tighten the nuts may therefore have been ineffective. The pilot has since replaced all the landing gear attachment bolts with newly manufactured homemade studs and added 'Nyloc' lock nuts and washers. He has also restored what he believed to be original access panels in each wing to facilitate future inspection access.

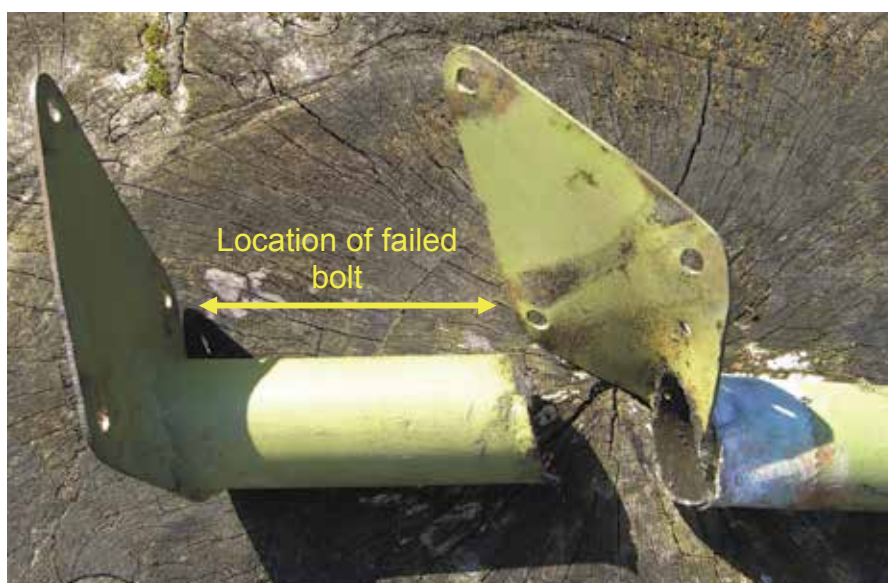
Figure 2

Damage to landing gear leg and attachment plates

The left wing skin was damaged near the landing gear attachment point and one of the wooden propeller blades broke at the tip as it contacted the ground. The pilot considered that a large compression spring, which forms part of the landing gear, allowed the wing to fall slowly to the ground when the landing gear collapsed, minimising damage to the aircraft.
