**ACCIDENT**

<b>Aircraft Type and Registration:</b>	Piper PA-24-250 Comanche, G-ARLB	
<b>No &amp; Type of Engines:</b>	1 Lycoming O-540-A1D5 piston engine	
<b>Year of Manufacture:</b>	1960 (Serial no: 24-2352)	
<b>Date &amp; Time (UTC):</b>	11 June 2016 at 1330 hrs	
<b>Location:</b>	Old Buckenham Airfield, Norfolk	
<b>Type of Flight:</b>	Private	
<b>Persons on Board:</b>	Crew - 1	Passengers - 2
<b>Injuries:</b>	Crew - None	Passengers - None
<b>Nature of Damage:</b>	Propeller blades, lower engine cowl, nose leg, left wing damaged and engine shock-loaded	
<b>Commander's Licence:</b>	Private Pilot's Licence	
<b>Commander's Age:</b>	54 years	
<b>Commander's Flying Experience:</b>	1,541 hours (of which 1 was on type) Last 90 days - 5 hours Last 28 days - 5 hours	
<b>Information Source:</b>	Aircraft Accident Report Form submitted by the pilot

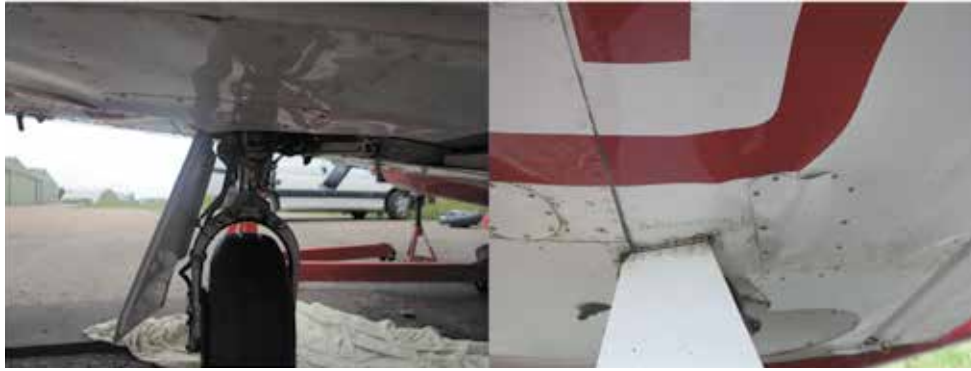
**Figure 1**

The creasing on the underside of the left wing (Figure 1) indicated that there was a higher-than-normal rate of descent on touchdown. The orientation of the nose landing gear drag brace (extended and slightly over-centre) (Figure 2) indicated that the nose landing gear was locked down during the approach. Figure 3 shows that the nose gear piston broke towards its top which suggested that it broke immediately on touchdown before the piston began to move into the nose gear cylinder under the weight of the aircraft's nose section.

Creasing on the underside of the left wing

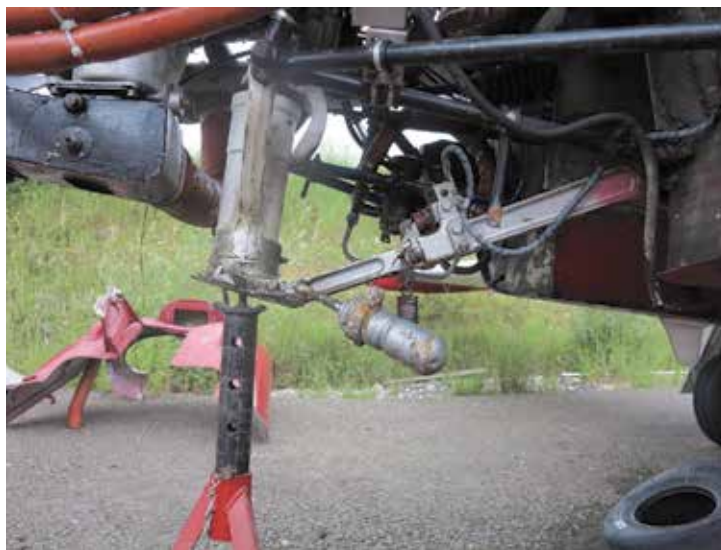
**Figure 2**

Nose landing gear drag brace

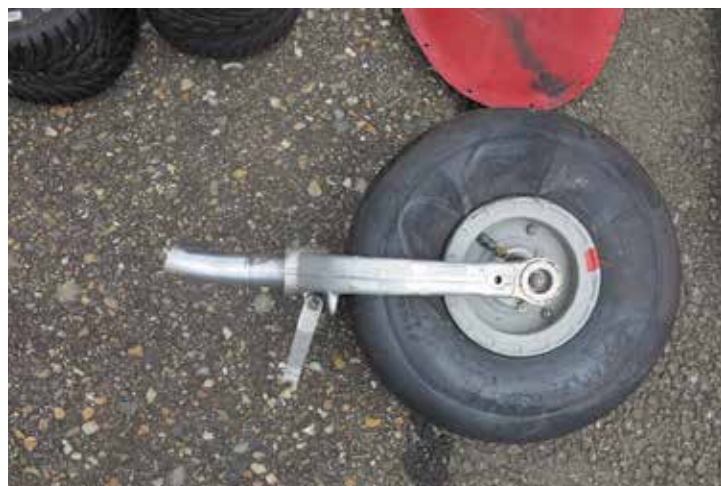
**Figure 3**

Break in the nose gear jack
