ACCIDENT

Aircraft Type and Registration:	Piper PA-28-161 Cherokee Warrior II, G-SVEA	
No & Type of Engines:	1 Lycoming O-320-D3G piston engine	
Year of Manufacture:	1979 (Serial no: 28-7916082)	
Date & Time (UTC):	25 June 2016 at 1423 hrs	
Location:	On the A40 trunk road between Abergavenny and Raglan, Monmouthshire	
Type of Flight:	Training	
Persons on Board:	Crew - 2	Passengers - 1
Injuries:	Crew - 2 (Minor)	Passengers - 1 (Minor)
Nature of Damage:	Substantial	
Commander's Licence:	Commercial Pilot's ILcence	
Commander's Age:	44 years	
Commander's Flying Experience:	1,909 hours (of which 800 were on type) Last 90 days - 88 hours Last 28 days - 22 hours	
Information Source:	Aircraft Accident Report Form submitted by the pilot

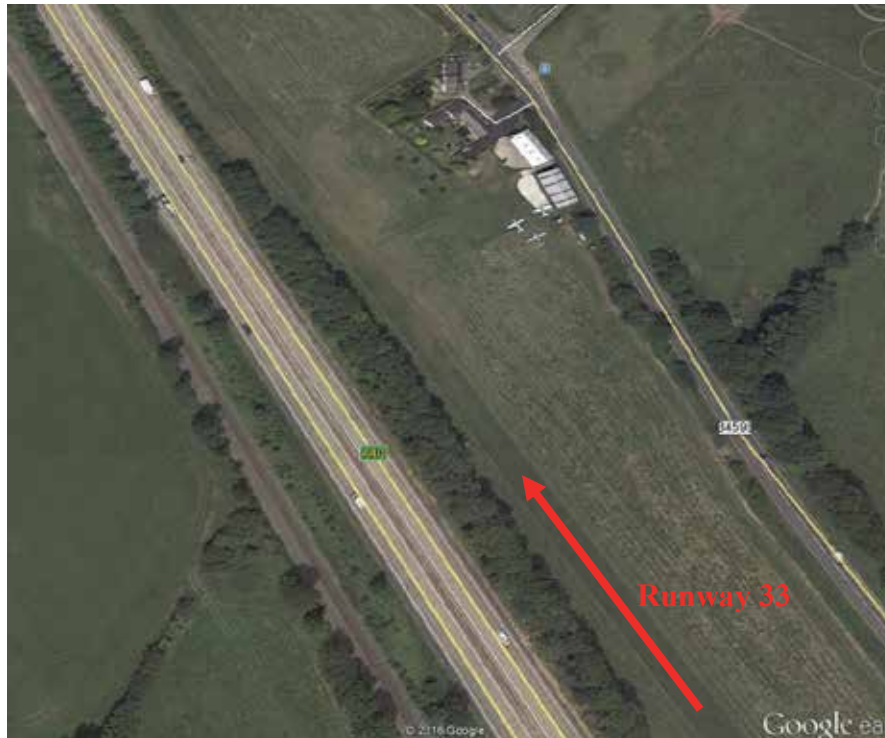
Figure 1

Aerial view of airfield, showing proximity of trees to mown strip
