ACCIDENT

Aircraft Type and Registration:	Piper PA-28-161 Cherokee Warrior III, G-BZDA	
No & Type of Engines:	1 Lycoming O-320-D3G piston engine	
Year of Manufacture:	2000 (Serial no: 2842087)	
Date & Time (UTC):	27 June 2016 at 1125 hrs	
Location:	White Waltham Airfield, Berkshire	
Type of Flight:	Training	
Persons on Board:	Crew - 2	Passengers - None
Injuries:	Crew - None	Passengers - N/A
Nature of Damage:	Engine, propeller, engine bearer, nose landing gear, lower firewall	
Commander's Licence:	Commercial Pilot's Licence	
Commander's Age:	41 years	
Commander's Flying Experience:	370 hours (of which 154 were on type) Last 90 days - 27 hours Last 28 days - 19 hours	
Information Source:	Aircraft Accident Report Form submitted by the pilot

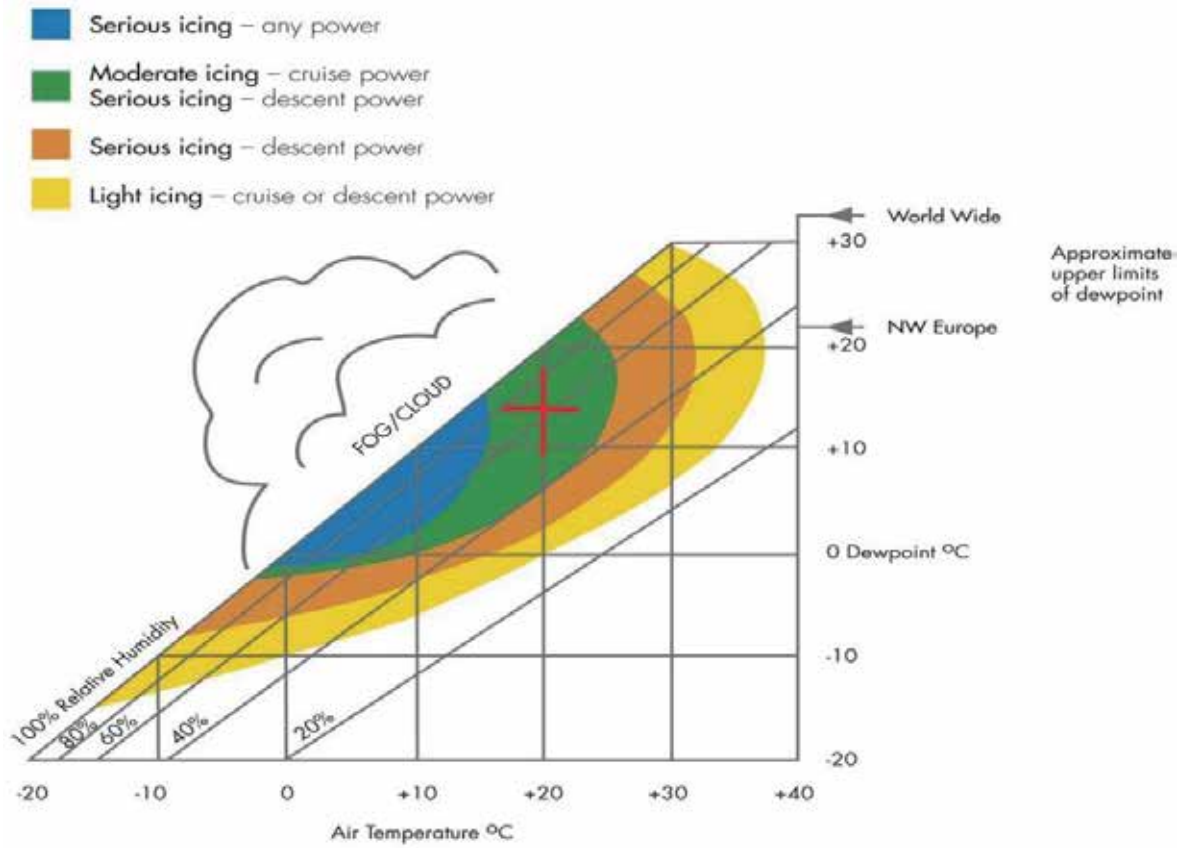
Figure 1

When the temperature and dew point were plotted on the CAA icing conditions chart contained in '*Safety Sense Leaflet 14, Piston Engine Icing*', it indicated that moderate icing could be expected at cruise power and serious icing at descent power. (See Figure 1.)
