ACCIDENT

Aircraft Type and Registration:	Pitts S-1S Special, G-MAXG	
No & Type of Engines:	1 Lycoming IO-360-B1B piston engine	
Year of Manufacture:	2001 (Serial no: PFA 009-13233)	
Date & Time (UTC):	17 April 2016 at 1222 hrs	
Location:	Brighton Aerodrome, Yorkshire	
Type of Flight:	Private	
Persons on Board:	Crew - 1	Passengers - None
Injuries:	Crew - None	Passengers - N/A
Nature of Damage:	Impact damage to propeller, landing gear, wings, rudder and rear fuselage	
Commander's Licence:	Private Pilot's Licence	
Commander's Age:	52 years	
Commander's Flying Experience:	450 hours (of which 159 were on type) Last 90 days - 3 hours Last 28 days - 3 hours	
Information Source:	Aircraft Accident Report Form submitted by the pilot

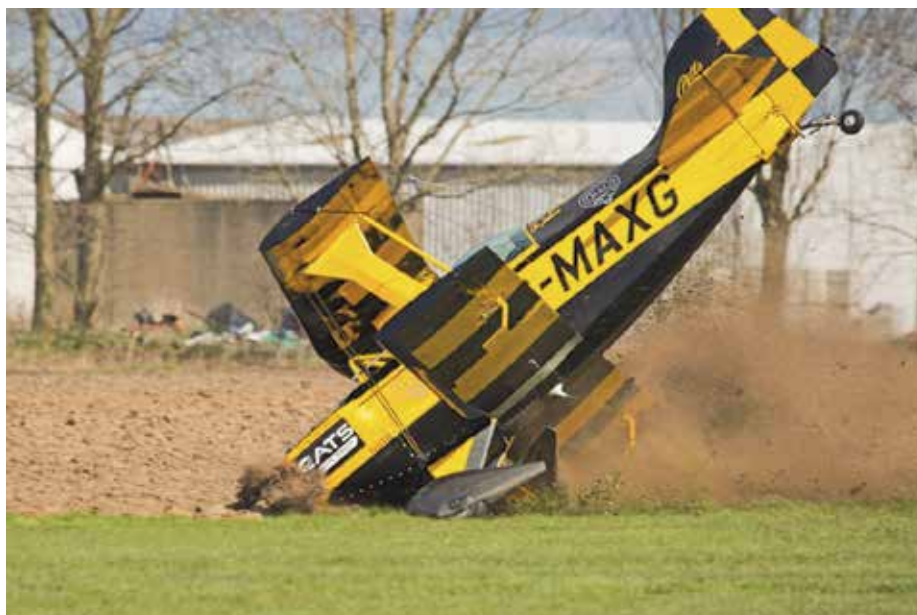
The pilot was on approach to landing after completion of his final flight during an aerobatic competition. Due to an area of the grass runway being waterlogged he had been advised to use the right side of the runway of the grass runway in use, Runway 28L, which was marked by cones. During his final approach, behind other landing traffic, he held off until the runway was clear and then set up for a normal three-point landing. The aircraft touched down close to the runway edge and after a small bounce the aircraft violently pitched forward and rotated through approximately 210°, coming to rest off the runway. The landing gear, propeller, wings, rudder and rear fuselage were damaged during the incident. The pilot was uninjured. Figure 1 shows the accident taking place.

The pilot's analysis of the incident led him to conclude that in holding off he had been side-slipping to the left, normal for the conditions, and had not appreciated that his aeroplane had drifted right. His attention had been taken by the aircraft ahead and he had not realised that his aircraft was now too close the runway edge. On touchdown the right mainwheel ran off the runway into a deeply ploughed surface and the combination of asymmetric drag and forward speed caused the aircraft to pitch forward and rotate before coming to rest.
