## SERIOUS INCIDENT

<b>Aircraft Type and Registration:</b>	Robinson R44 Astro, G-BZGO	
<b>No &amp; Type of Engines:</b>	1 Lycoming O-540-F1B5 piston engine	
<b>Year of Manufacture:</b>	2000 (Serial no: 757)	
<b>Date &amp; Time (UTC):</b>	13 June 2016 at 1547 hrs	
<b>Location:</b>	Approx 8 miles north of Manchester Barton Airport	
<b>Type of Flight:</b>	Training	
<b>Persons on Board:</b>	Crew - 2	Passengers - None
<b>Injuries:</b>	Crew - None	Passengers - N/A
<b>Nature of Damage:</b>	Left windscreen broken	
<b>Commander's Licence:</b>	Commercial Pilot's Licence	
<b>Commander's Age:</b>	57 years	
<b>Commander's Flying Experience:</b>	4,000 hours (of which 1,900 were on type) Last 90 days - 110 hours Last 28 days - 39 hours	
<b>Information Source:</b>	Aircraft Accident Report Form submitted by the pilot and additional inquiries by the AAIB

### Synopsis

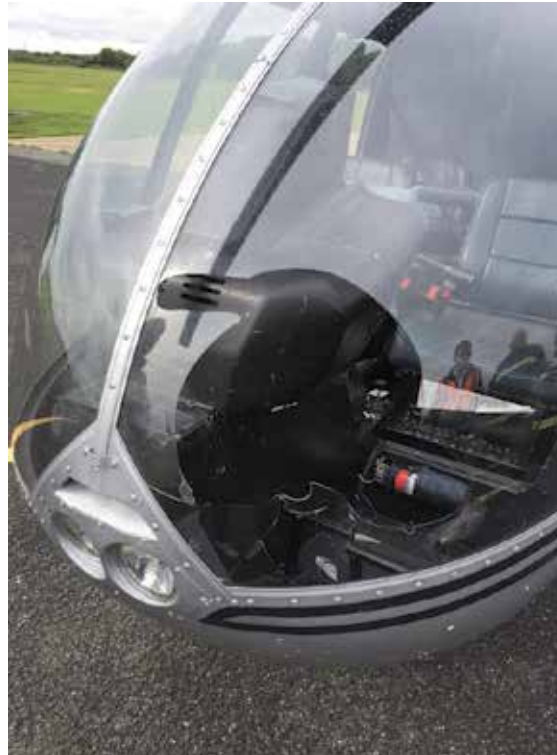
**Figure 1**

The Robinson R44 windscreen is not designed to withstand birdstrikes and the design requirements do not require it to do so. The United States (US) Federal Aviation Administration (FAA) is reviewing birdstrike protection requirements for Normal category rotorcraft.

The commander had just taken control of the helicopter when a bird struck and broke through the left windscreen. The bird was killed on impact and entered the cockpit with its wings unfolded. The pilot in the right seat took control and the helicopter lost approximately 700 ft in altitude whilst the crew dealt with the incident. They declared a MAYDAY and returned to Barton for an uneventful landing (Figure 1). Neither crew were injured.

Damage to left windscreen of G-BZGO

The bird was not sent for analysis, but photographs showed that it was most likely a Herring Gull. The pilot reported that the bird weighed approximately 0.6 kg.

The NTSB advise that the helicopter manufacturer is investigating tougher windscreen materials to improve occupant protection in the event of a birdstrike.
