Rail Accident Investigation Branch

# Rail Accident Report

## Collision between a train and a piece of equipment at Barrow-upon-Soar, Leicestershire, 14 February 2016

Report 21/2016  
October 2016

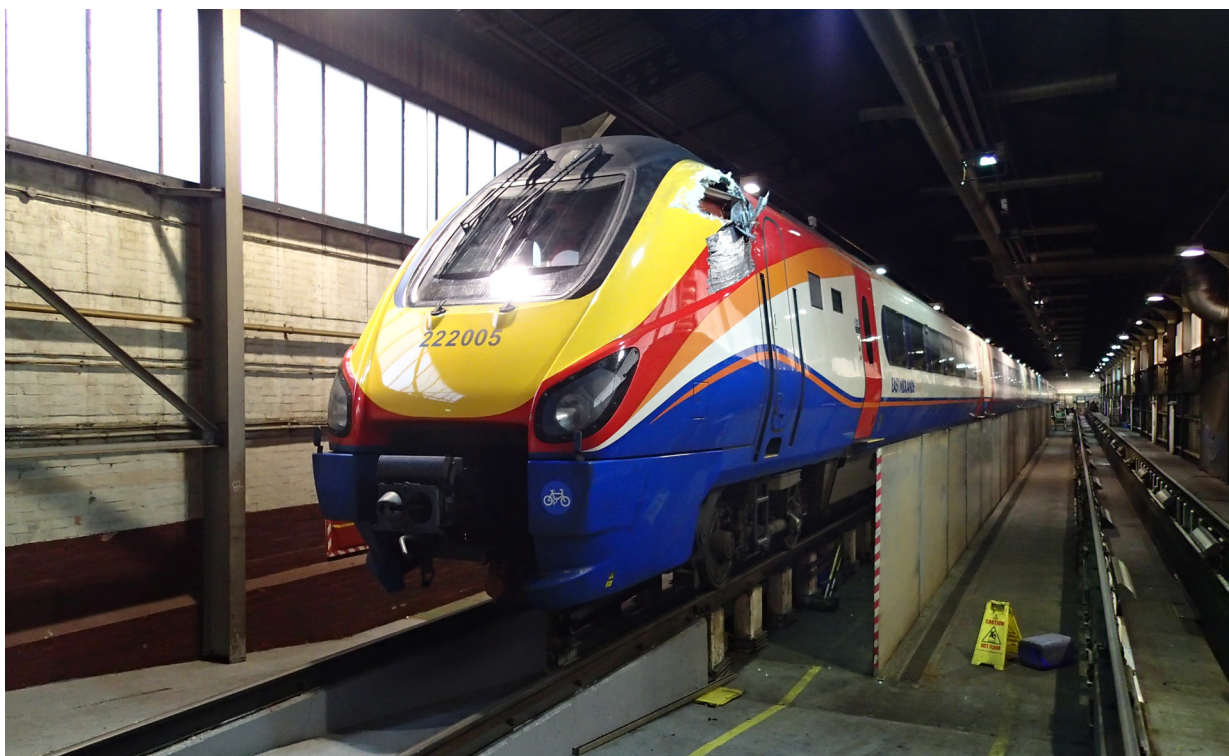
Figure 3: The damaged train

- 4 Two of the cars of the train were damaged by the impact, but did not derail (figure 3). The unloading wagon conveyor boom was also damaged.
- 5 A *fitter*, who had been working on the unloading wagon, was seriously injured and was taken to hospital by air ambulance. Nobody on the train was injured, but the driver was badly shaken.

- 40 The incident train was then taken to the EMT depot at Derby where the RAIB later examined it. The damage to the train is shown in figure 3. Figure 8 shows the wagon shortly after the collision, and after a winch had been attached to the boom ready to pull it back clear of the main line.

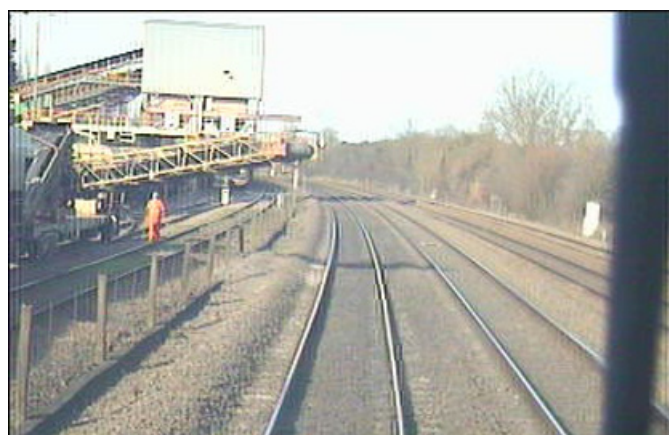
*Figure 7: View from train's FFCCTV just before the collision (image courtesy of East Midlands Trains)*

- 33 GS1 ran to the control room and used the dedicated line to the signaller at the EMCC to ask for trains to be stopped, but the train collided with the boom just as the call started at 10:26 hrs. Figure 7 shows the position of the boom, and fitter 1, just before the collision, as captured by the FFCCTV system on the train.

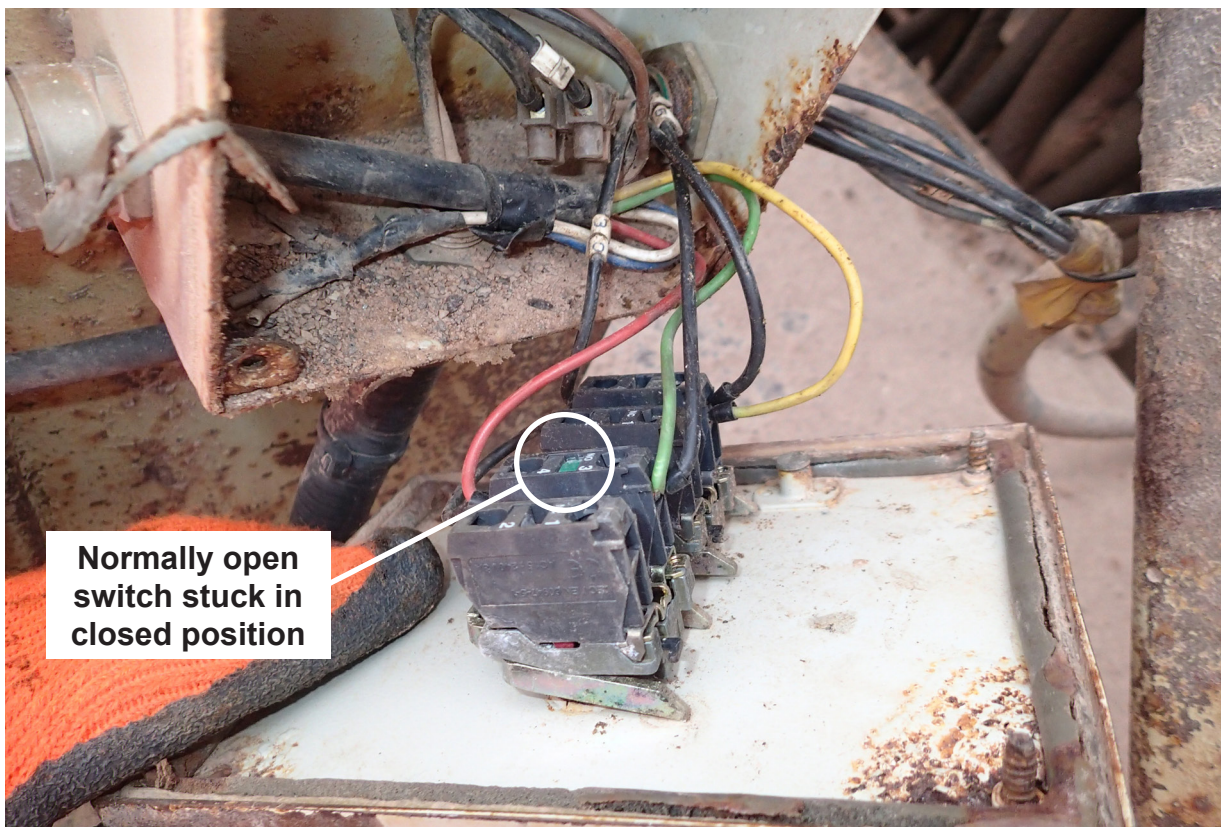
Figure 11: Normally open switch on 'out' button on main line side of wagon stuck in closed position during RAIB test of wagon on 8 March 2016

- 67 The solenoids were reconnected and the accident sequence recreated. The out button on the main line side was held in while the out button on the other side of the wagon was pressed. The test found that the movement of the boom continued in the outwards direction towards the main line when the button on the other side was pressed. This demonstrated that, during the accident with the out switch on the main line side stuck in the 'on' position, pressing the out button on the other side of the wagon would have had no effect on the boom.
- 68 It is probable that this switch stuck because:
- the moving part of the normally open switch contact block had become coated with corrosion product (paragraph 69);  
which in turn was most likely caused because;
  - the switch was used in environmental conditions that it was not rated to withstand (paragraph 76).

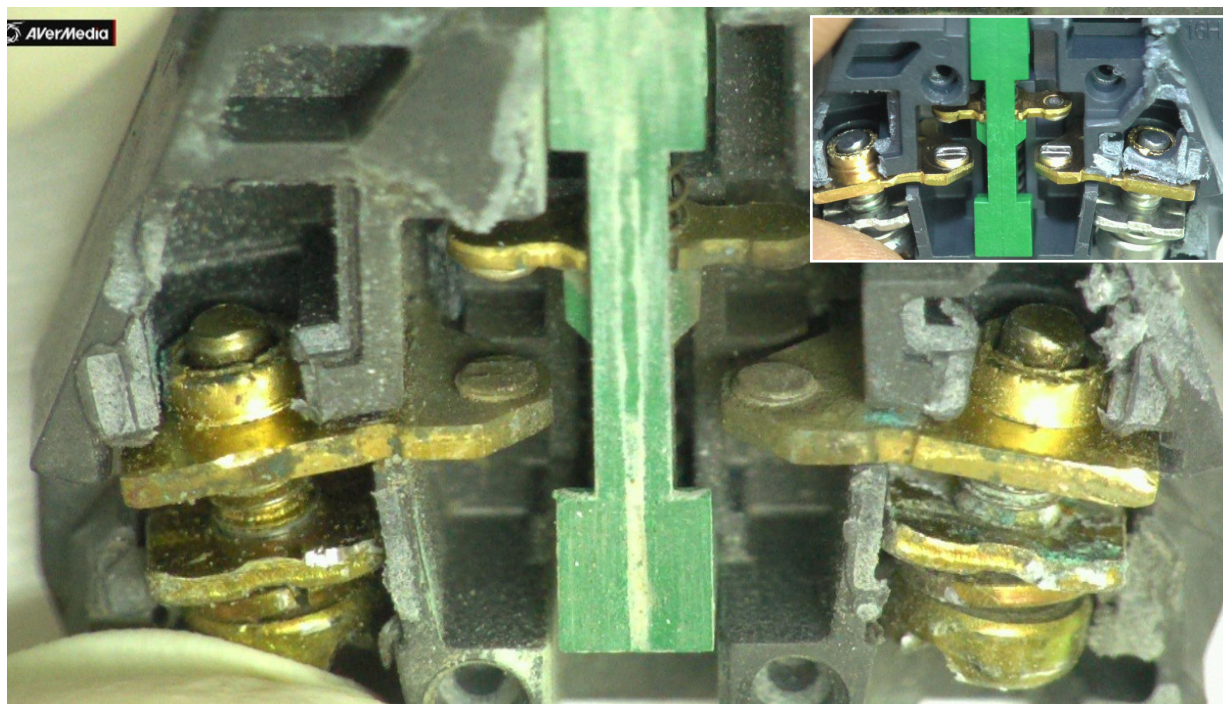
- 74 The switch contact block was then broken open (it is not designed to be taken apart). No foreign bodies or defects were found inside. There was evidence of some corrosion of the metal parts (figure 12), but not sufficient to have caused the switch to stick. There was some blackening of the contacts, as would be expected from a switch that was 15 years old, but no evidence of welding of the contacts.

Figure 12: Interior of normally open switch from 'out' button on main line side of wagon (inset shows corresponding view of new switch) (images courtesy of Schneider Electric)

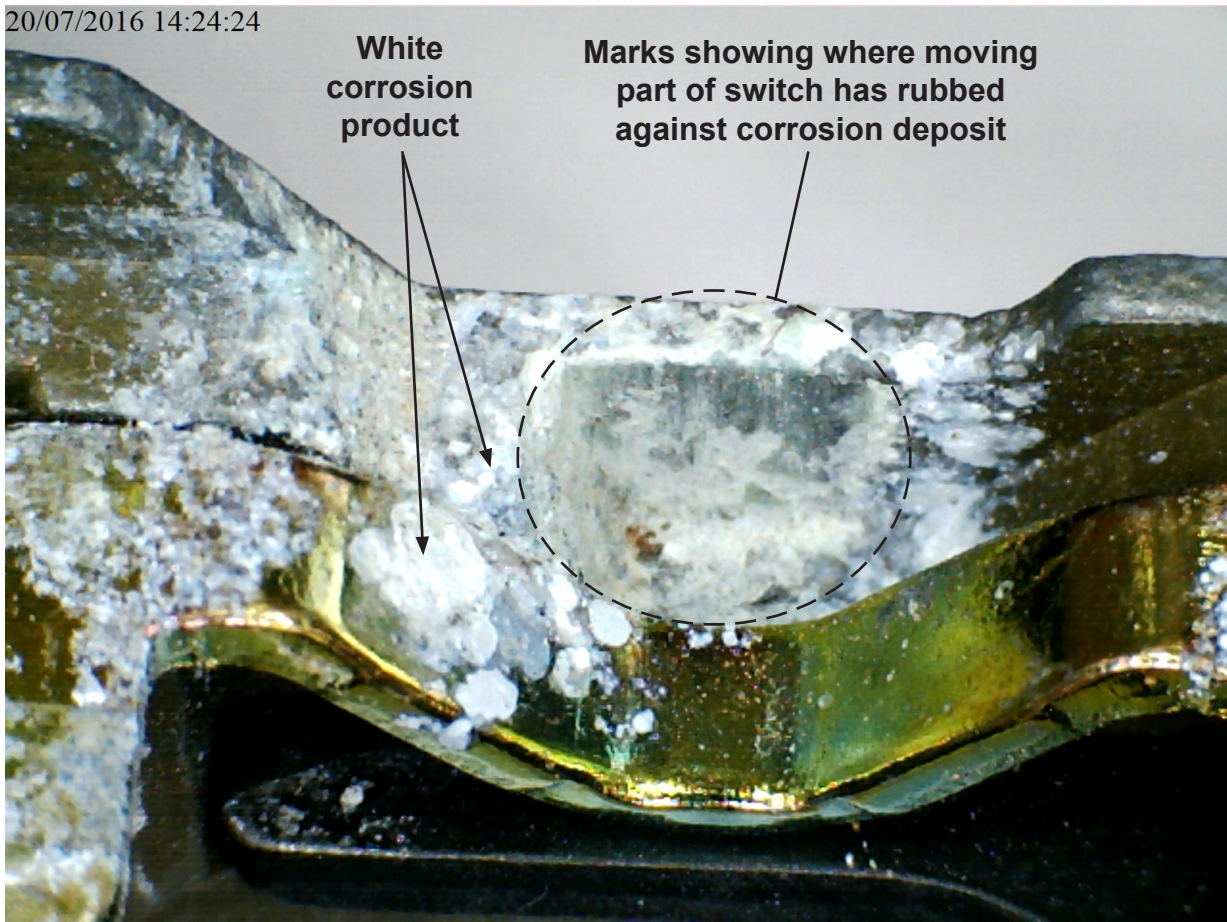
Figure 14: Close-up of diecast metal bracket (collar) from 'out' button on main line side of wagon

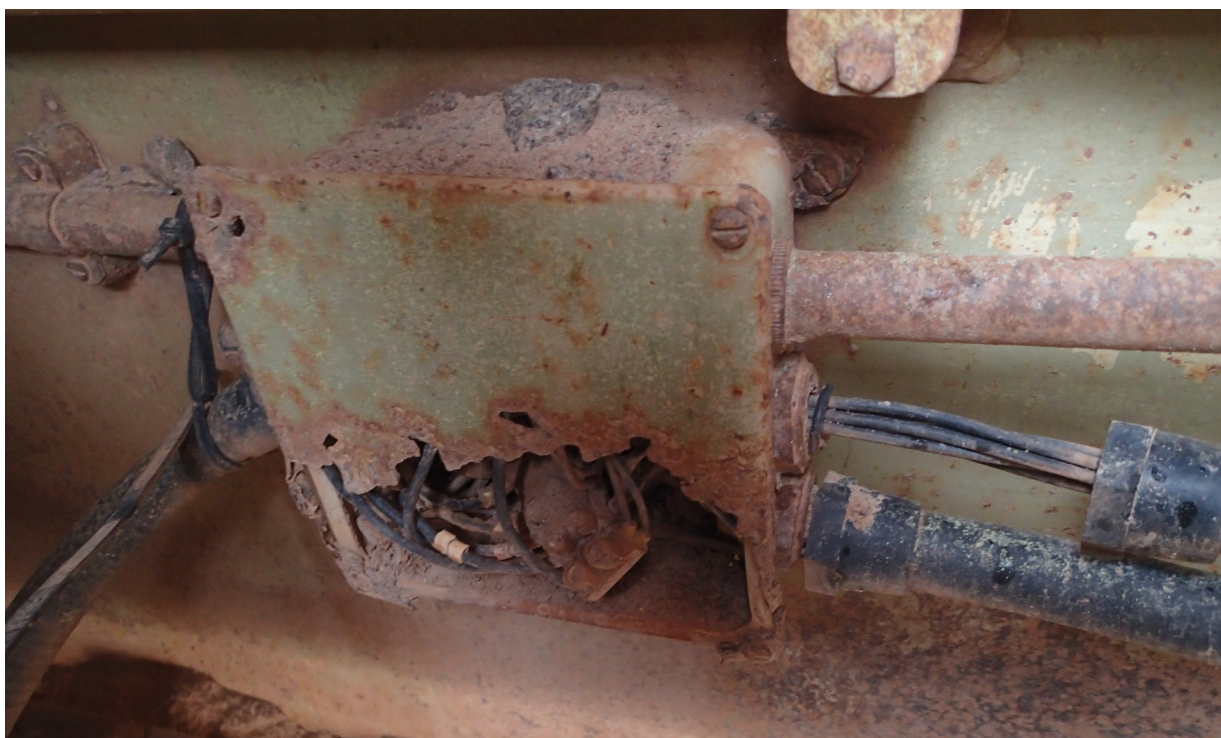
Figure 16: Wiring junction box beneath 'spider' switch

80 The RAIB examined other electrical junction boxes and panels on the wagon. These were also found to be badly deteriorated, with part of the lid completely corroded away in one case (figure 16 shows the junction box for the 'spider' switch cables).

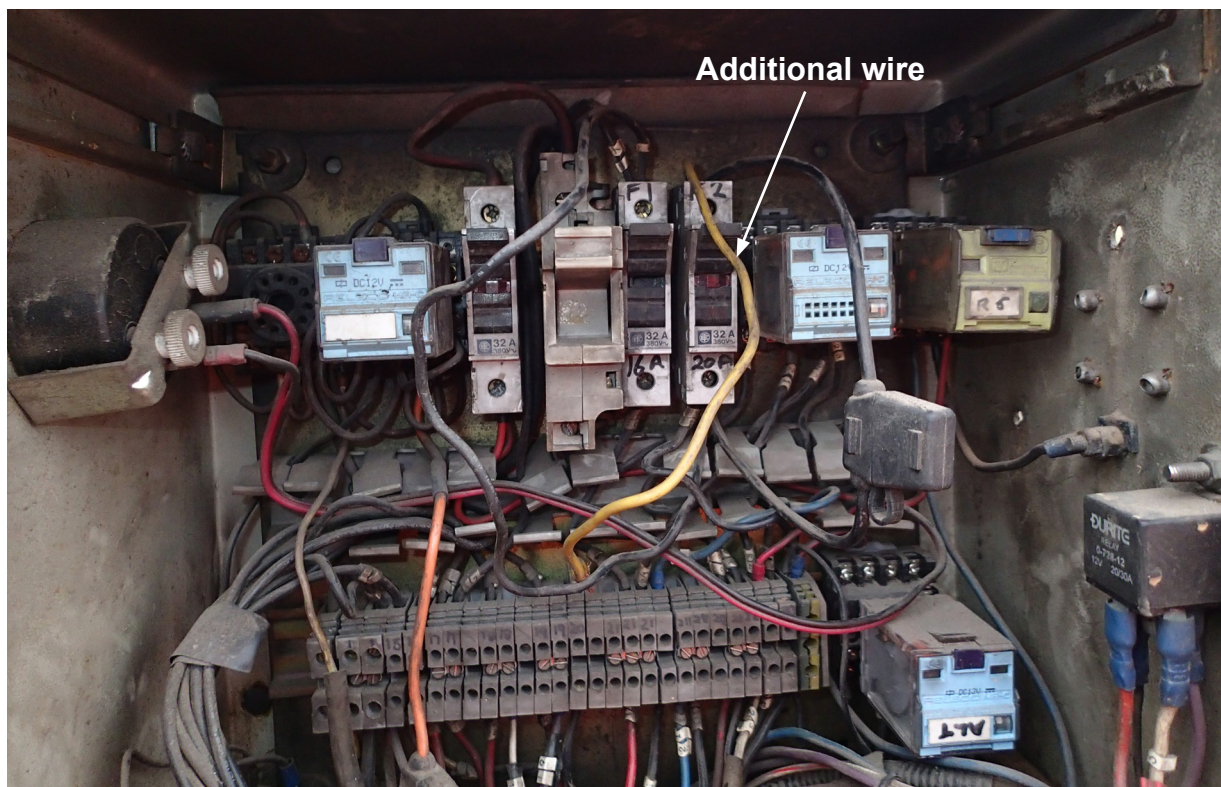
Figure 17: Interior of engine control panel enclosure

124 When tested by the RAIB after the accident, the push button on the side furthest from the main line was jammed with stone dust and could not be operated. The stop button on the main line side of the wagon was free to operate but did not stop the conveyor belt or the engine, as it was intended to do. The control circuit for the emergency stop buttons was traced and tested. It was found to contain an additional feed wire (figure 17). This wire supplied 12V from the battery to a point in the circuit which should have been capable of being de-energised by the push buttons. This false feed prevented the push buttons from having any effect.
