Man overboard and subsequent loss of *Harvester* (M999) off the Pembrokeshire Coast 28 April 2016

SUMMARY

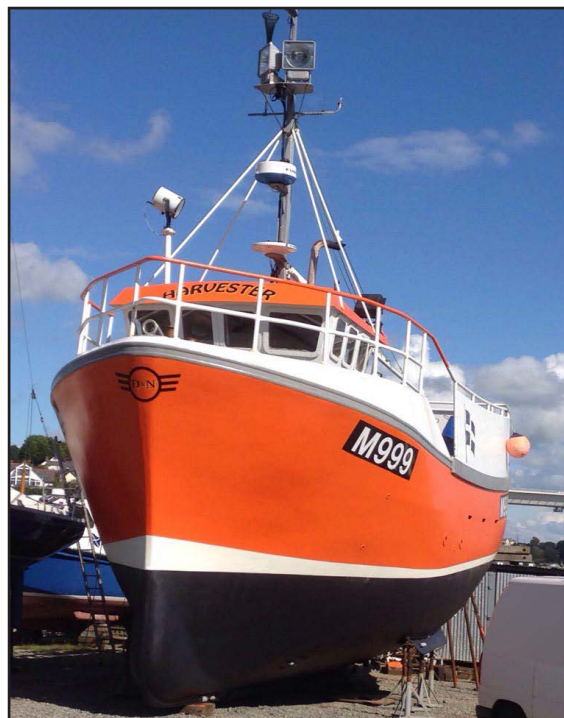
Figure 1: *Harvester* (M999)

At 1424 (BST¹) on 28 April 2016, the 11.6 metre potter *Harvester* (**Figure 1**) grounded on rocks in Abereddy Bay, North Pembrokeshire, and foundered a short time later. There was no indication of any crew on board at the time of the grounding. A large-scale search and rescue operation commenced and the body of Gareth Willington was recovered from the water 3 miles from where *Harvester* had foundered. He was not wearing a lifejacket or other buoyancy aid. The second crew member, Daniel Willington, has not been found despite an extensive search.

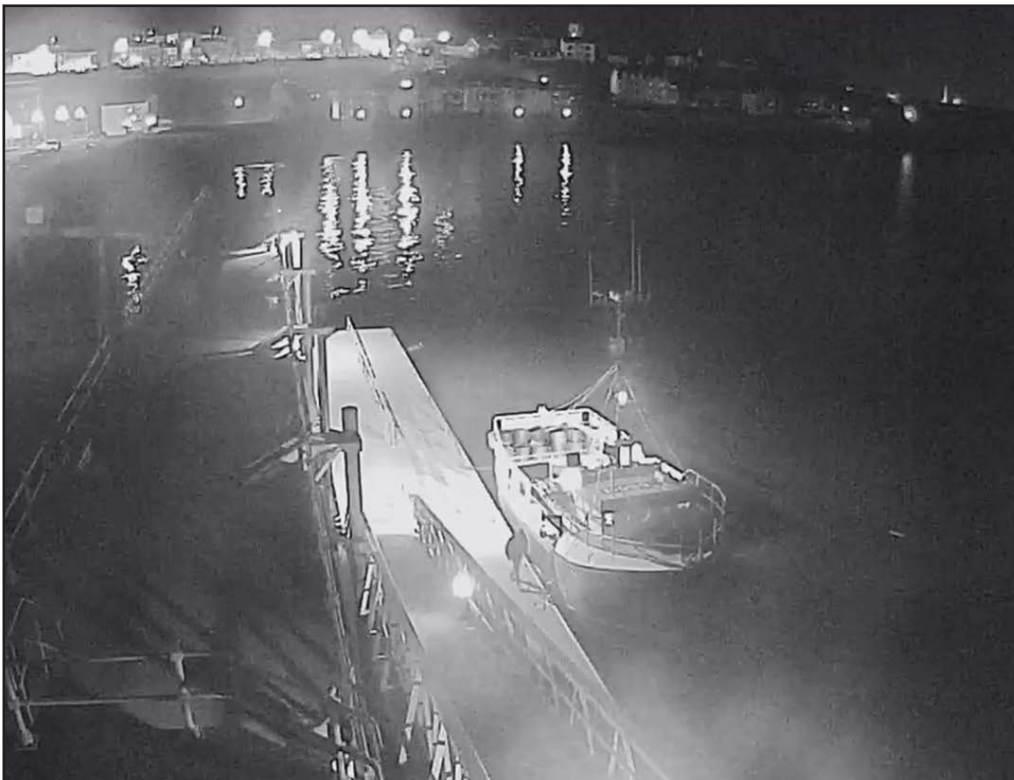
Figure 2: *Harvester* about to leave Milford Docks at 0314 on 28 April

At 0314 on 28 April, having loaded bait, Gareth and Daniel Willington departed from Milford Haven marina on board *Harvester* (**Figure 2**) and headed to the fishing grounds around Ramsey Island.

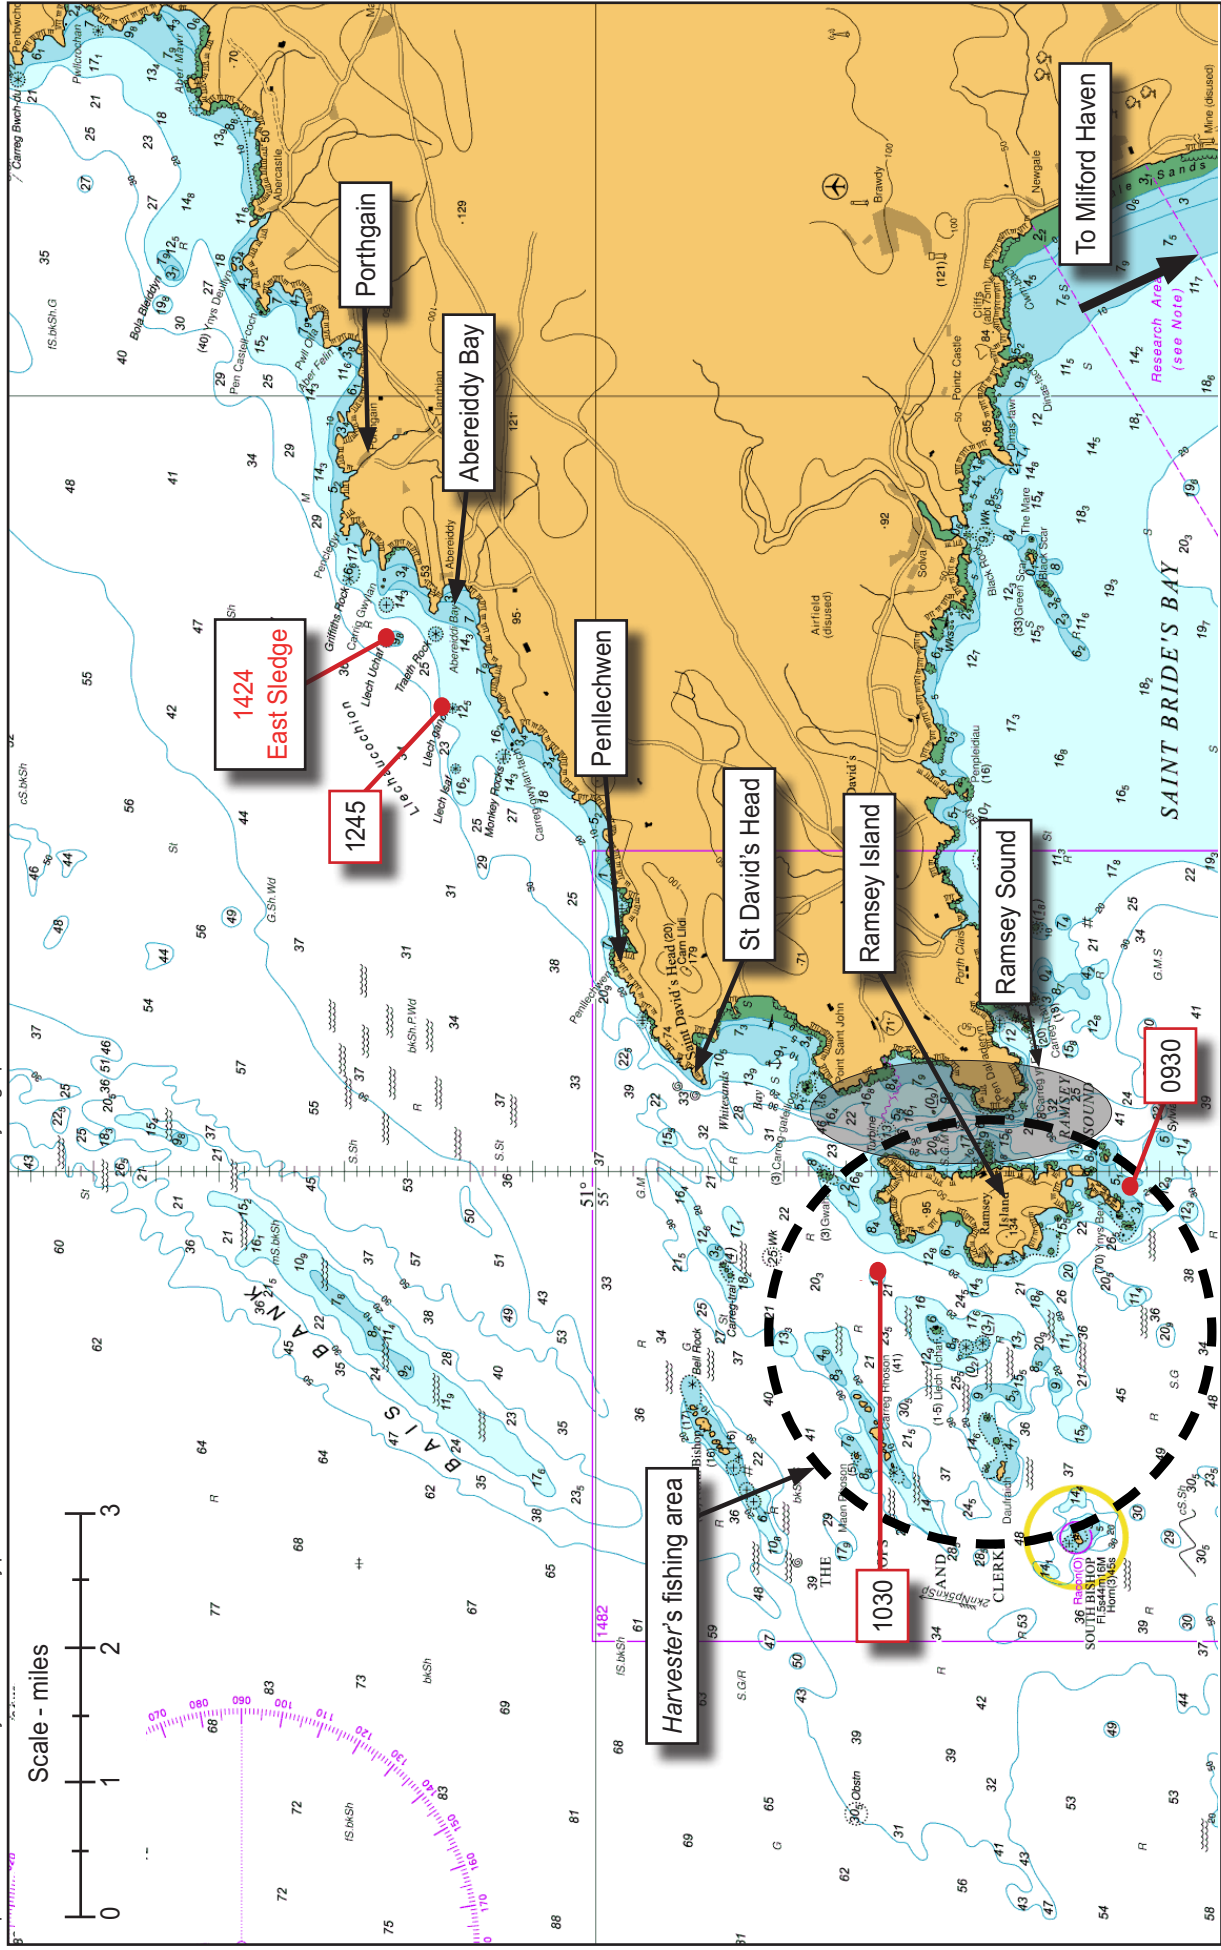
Figure 3: Harvester fishing grounds and witness sightings (note: all positions approximate)

The skipper of a passenger tour vessel saw *Harvester* to the north of Ramsey Island at around 1030 (**Figure 3**).

At 1800, R187 located Gareth Willington in the water close to Penllechwen (**Figure 3**). Gareth was winched on board and transferred to hospital, where he was pronounced deceased. The postmortem examination indicated that Gareth had died as a result of asphyxiation due to drowning.

Wreckage from *Harvester* spread extensively; a GRP² section of the vessel's bow was recovered on the shore on 29 April, in Ramsey Sound (**Figure 3**), 8.5 miles from the grounding position.

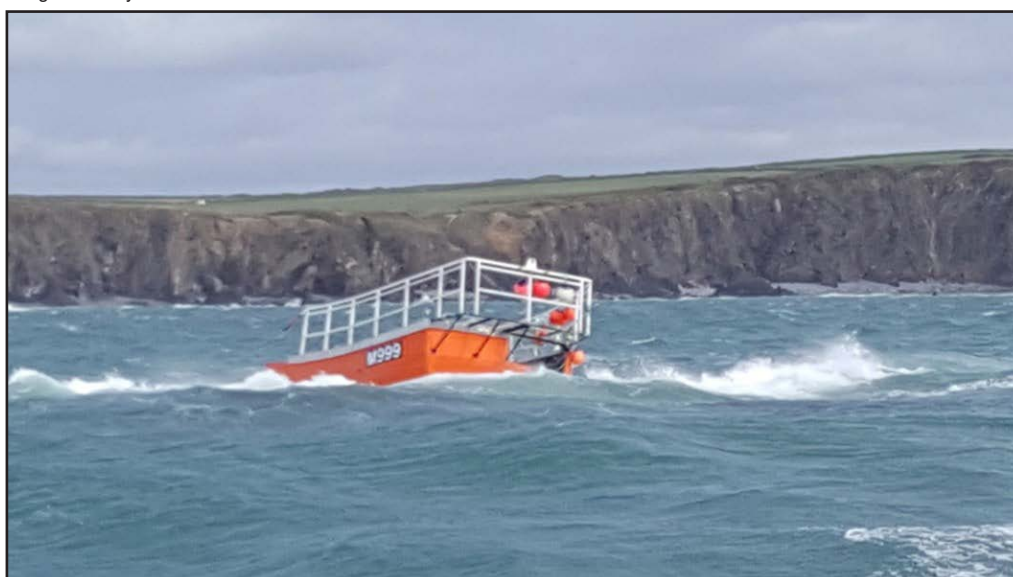
At 1451, *Onward* arrived on scene to find *Harvester* aground on East Sledge with its engine still running. *Harvester* began to break up soon afterwards. Initially the bow section detached and fell forward with the stern section of the hull remaining on the rock (**Figure 4**). Buoys and debris from the wreckage began to disperse into the water surrounding the vessel. *Onward's* crew did not see any crew members on *Harvester*. The stern section began to break up on the rock soon after the St David's ILB arrived on scene.

Figure 4: *Harvester* aground on East Sledge

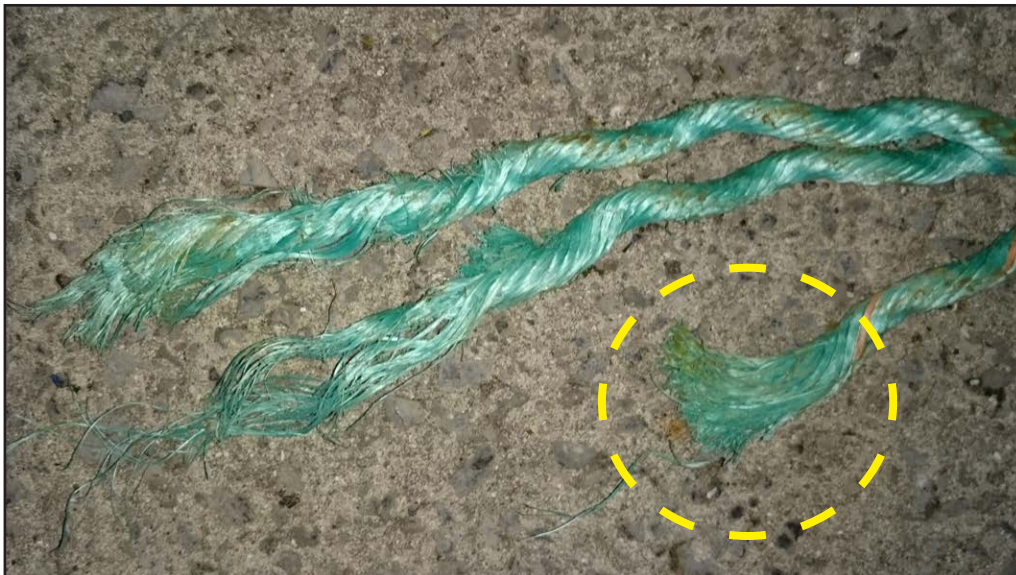
One fleet of pots located to the south of Black Rocks was fouled in rough ground and the back rope had parted. On another fleet of pots, located to the west of Ramsey Island, the back rope was also found parted and it appeared that at least one of the rope's three strands had been cut (**Figure 5**).

Figure 5: Broken back rope, indication that at least one strand had been cut

One of *Harvester's* fleets of pots, recovered to the west of Ramsey Island, had a parted back rope. While it is unknown if Daniel or Gareth had access to a sharp knife, there is evidence to suggest that an attempt had been made to cut the rope to free one or both of them.

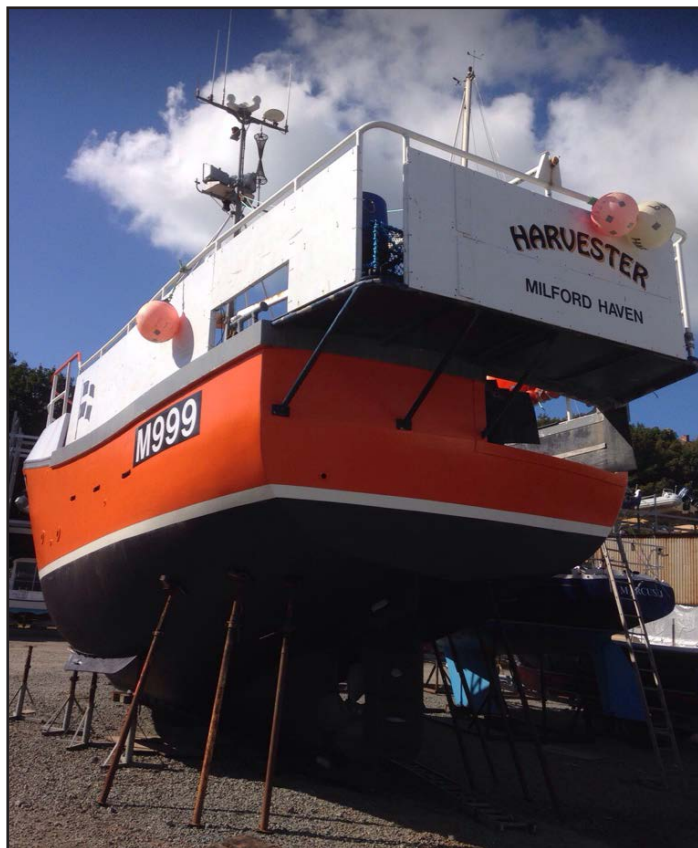
Harvester was built in 1993 of GRP construction. The vessel had a forward wheelhouse, accessed via an aft doorway from a flush working deck. A large opening was situated in the starboard side of the transom bulwark through which pots were deployed during shooting operations (**Figure 6**). A hydraulic hauler used for recovering the pots was situated on the starboard side aft of the wheelhouse. There was a sorting table aft of the hauler. Plywood boards had been fitted to the bulwark guardrails to provide the crew working on deck with some protection from the elements.

Figure 6: Opening in transom

A likely scenario is that Daniel, who would probably have been on deck, became entangled in the back rope as a fleet was being shot. Gareth could then have left the wheelhouse to assist Daniel, resulting in both men going overboard through the large opening in the transom.

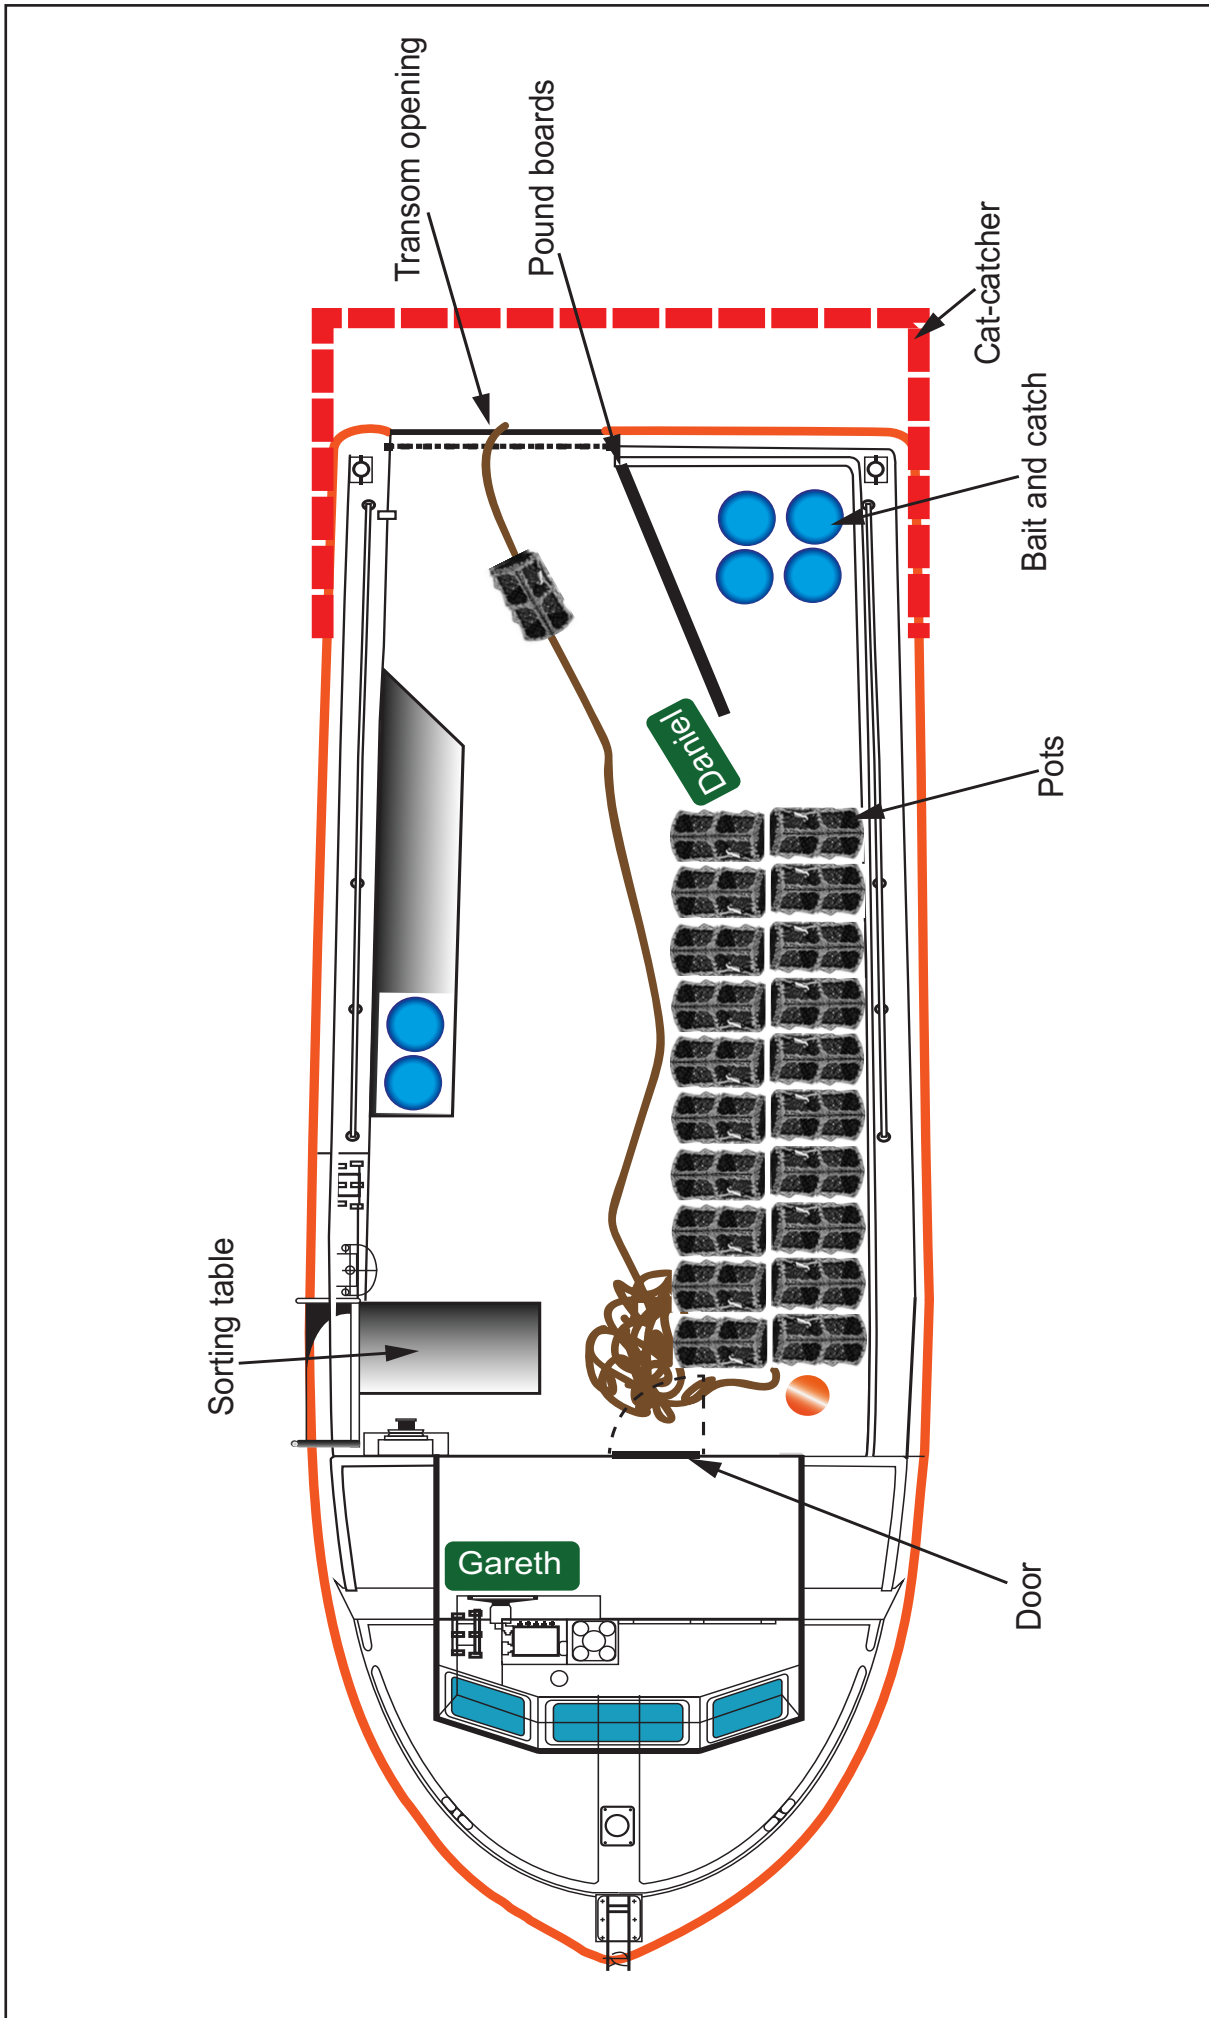
While shooting pots, Gareth was in the wheelhouse. The back rope was coiled on the working deck aft of the wheelhouse access door. Daniel was stationed on deck, ensuring the pots ran freely (**Figure 7**).

Figure 7: Harvester assumed shooting arrangement

While shooting pots, it is not unusual for the gear to become tangled and move in unexpected ways across the deck. Therefore, crew remaining on deck but not physically separated from the gear as it is being shot is inherently dangerous and, in accordance with published advice, should be avoided. The presumed system of work for shooting pots on *Harvester* did not sufficiently separate Daniel from the running gear to prevent the accident.

Owners and skippers of potting vessels must take responsibility and ensure that a safe system of work is put in place, with vessels modified as required, to ensure adequate separation from running gear during shooting operations.
