**Fatal man overboard from *Apollo* (INS 179)
30nm north-west of the Orkney Islands
18 April 2016**

SUMMARY

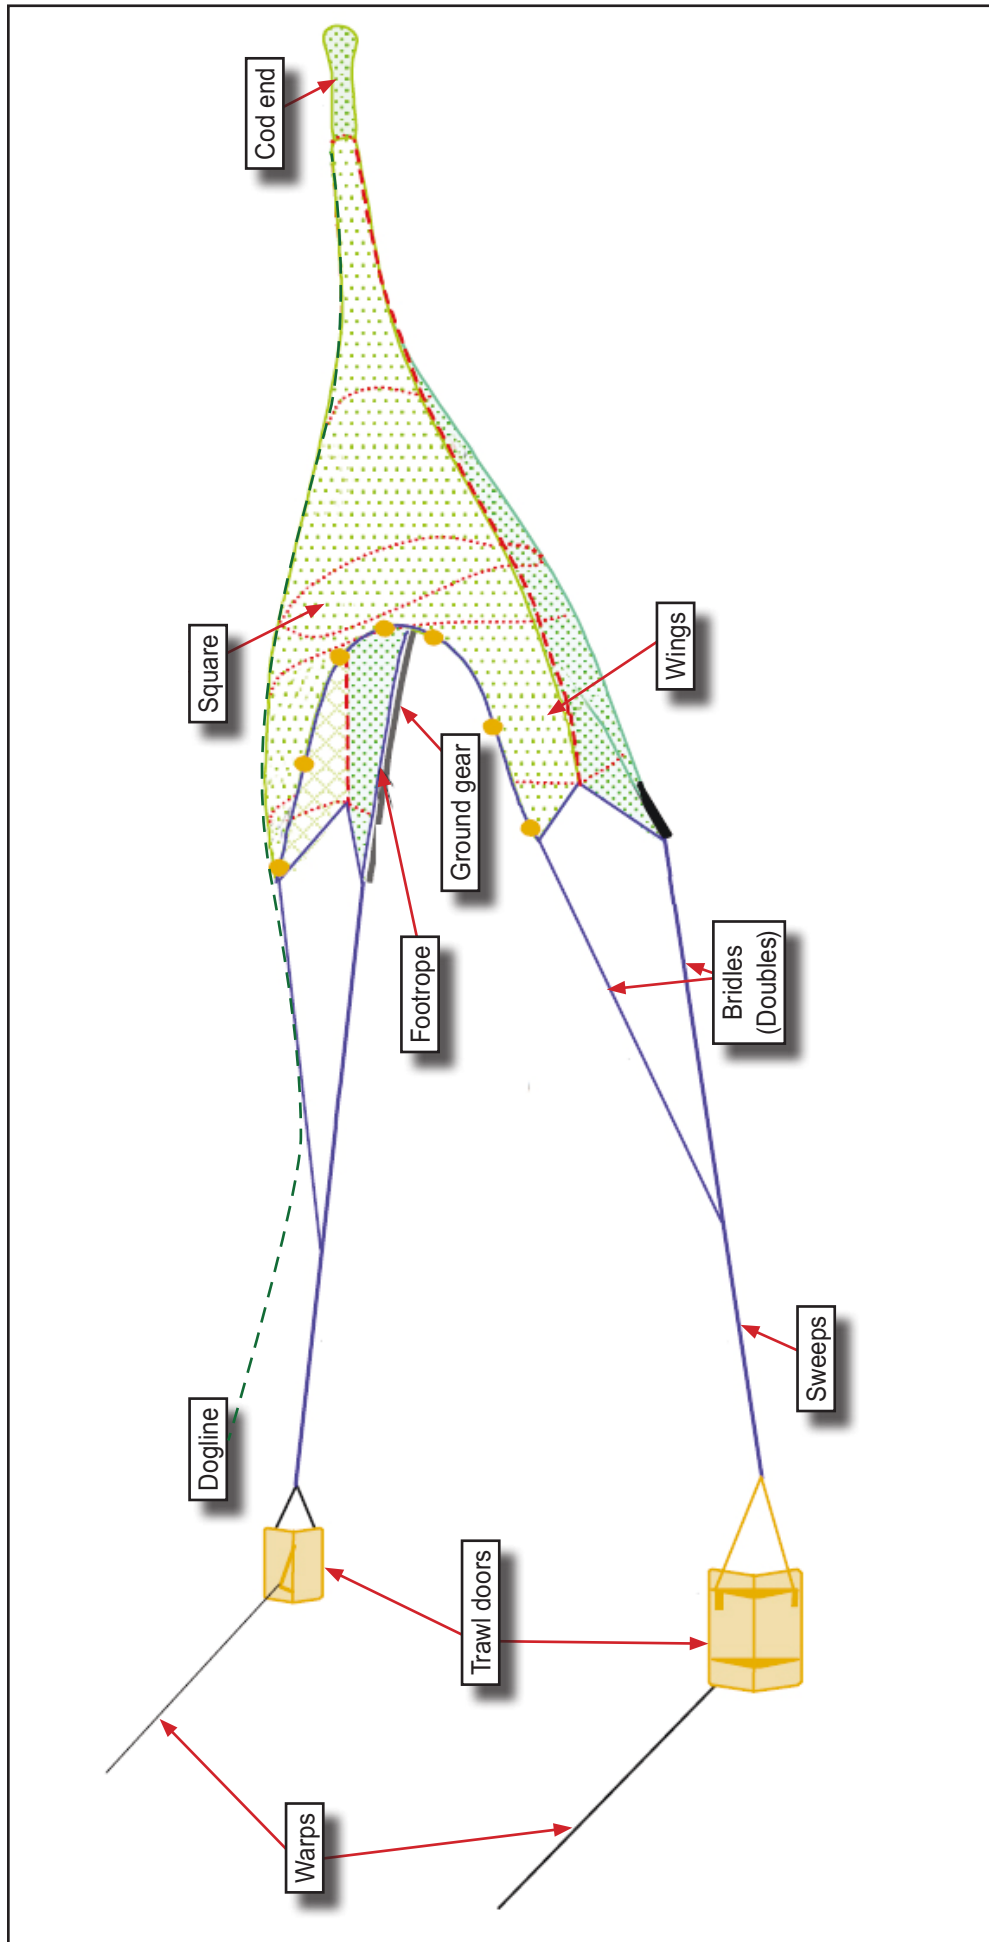
Figure 2: Trawl gear in use on Apollo

At 0620 the trawl doors were recovered and secured, and the sweeps and bridles³ (**Figure 2**) were then transferred onto the forward starboard net drum (**Figure 3**).

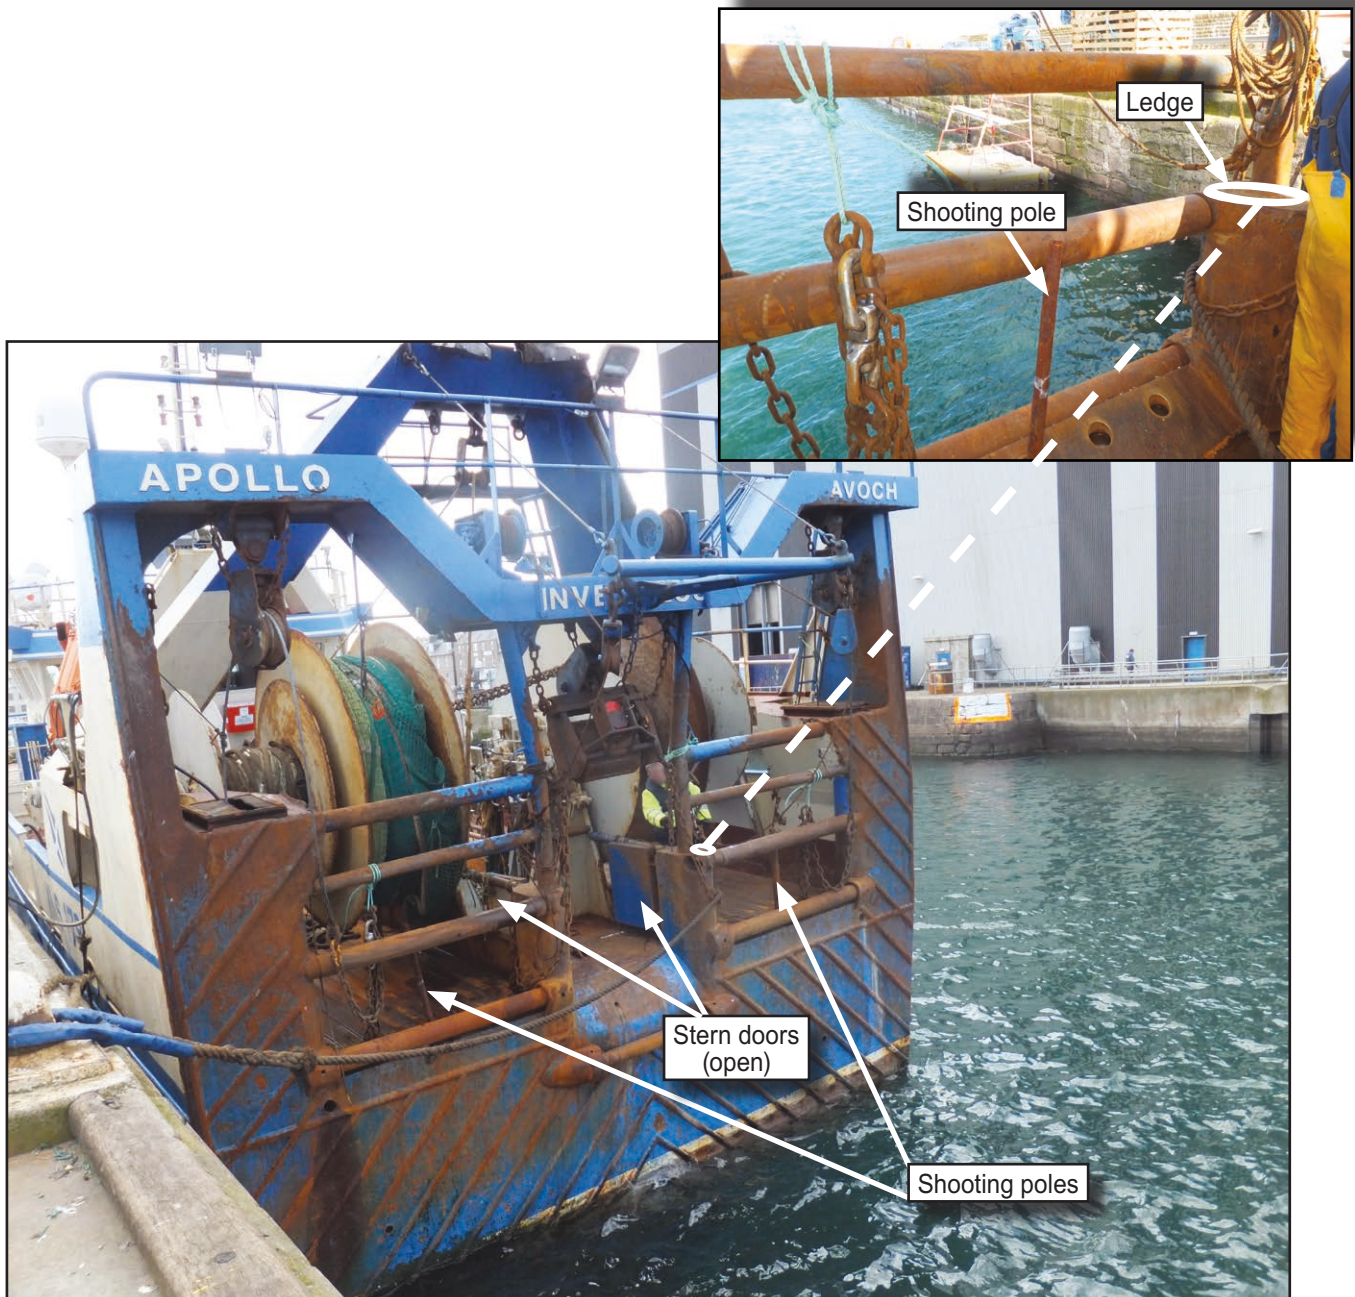
Figure 4: *Apollo* – stern doors and shooting poles
(inset: shows the ledge where Craig was standing at the time of the accident)

Craig had been standing on a narrow ledge at the stern (**Figure 4 inset**), 1m above deck level, when the shooting pole was pulled out. He was then seen to fall and land on his side in the unguarded area aft of the bagging hatch, the stern doors having already been opened in preparation for the recovery of the cod end of the net.

When the shooting pole was dislodged, Craig was standing on a narrow ledge at *Apollo*'s stern, 1.0m above deck level, and he was holding onto a section of the stern gantry.

The ledge was not designed to be used as a platform and there were no dedicated hand-holds or protective barriers. However, crew members had regularly used this ledge when hauling nets, particularly in rough weather, to avoid getting their feet wet when waves were washing over the deck, as on this occasion.

It is known that there was a loud noise when the pole was violently dislodged, and that this occurred just before Craig was seen to fall from the ledge. There is no evidence to suggest that the pole hit Craig but it is thought probable that the sudden noise of the pole being pulled out and falling to the deck, combined with the movement of the vessel, caused him to lose his grip and fall to the deck.

Following the accident, the task of lifting out the shooting poles on *Apollo* was reviewed and mechanised by the installation of a remotely controlled winch that lifted a wire attached to the top of the pole. Substituting a winch mechanism for the manual method of removing the shooting poles was a more effective control measure than requiring the crew to wear PPE for the task as it has removed the need for a crewman to stand at the stern while hauling nets.

- Introduced a mechanical system for lifting the shooting pole to avoid the need for a crewman to lift it from its housing.
- Issued each crewman with an ISO 12402 PFD and mandated that the crew wear their PFD and hard hat when working on deck.
- Purchased and trained the crew in the use of a new man overboard recovery system.
- Re-emphasised to the crew that safety harnesses and lanyards must be worn when working in elevated or exposed locations on board.
