**SERIOUS INCIDENT**

<b>Aircraft Type and Registration:</b>	Saab-Scania SF340B, G-LGNC	
<b>No &amp; Type of Engines:</b>	2 General Electric Co CT7-9B turboprop engines	
<b>Year of Manufacture:</b>	1992 (Serial no: 340B-318)	
<b>Date &amp; Time (UTC):</b>	20 July 2016 at 0545 hrs	
<b>Location:</b>	On takeoff from Glasgow Airport	
<b>Type of Flight:</b>	Commercial Air Transport (Passenger)	
<b>Persons on Board:</b>	Crew - 3	Passengers - 13
<b>Injuries:</b>	Crew - None	Passengers - None
<b>Nature of Damage:</b>	Left hand upper nacelle fairing 451AT damaged at leading edge and damage to the trailing edge of all four propeller blades on the left hand engine.	
<b>Commander's Licence:</b>	Airline Transport Pilot's Licence	
<b>Commander's Age:</b>	37 years	
<b>Commander's Flying Experience:</b>	5,020 hours (of which 4,700 were on type) Last 90 days - 131 hours Last 28 days - 32 hours	
<b>Information Source:</b>	Aircraft Accident Report Form submitted by the pilot, and information provided by the operator

**Synopsis**

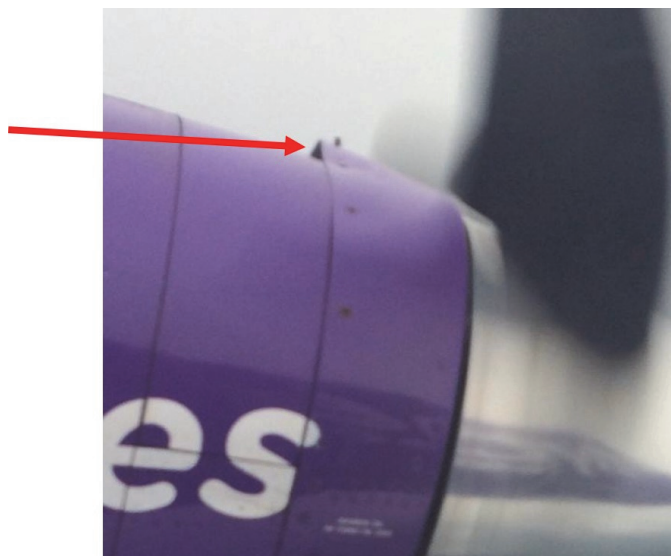
**Figure 1**

After departure from Glasgow Airport, on passing FL090, the commander noticed that the top section of the left engine 'Figure of 8' cowling was flapping in the airflow (Figure 1). He decided to return to Glasgow, and stopped the aircraft's climb at FL100. He then carried out two orbits to give the cabin crew time to secure the cabin, during which the loose cowling started to vibrate violently. Slowing the aircraft to the minimum clean speed reduced the vibration. The aircraft then returned to Glasgow where it landed safely.

Picture taken in flight by a passenger showing the outboard section of the loose cowling

A section of the loose cowling was found to be worn on its forward face, and a small section of the cuff section of all four propeller blades had been damaged by contact with the cowling.

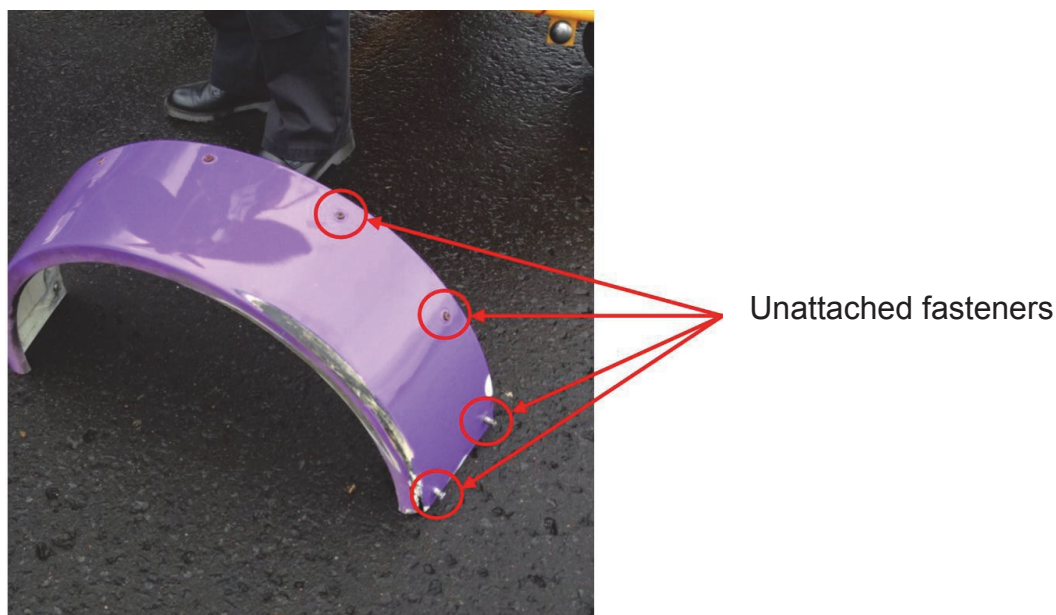
**Figure 2**

The operator determined that a member of engineering staff had been distracted during a maintenance task performed the previous day, and had not secured the cowling before dispatch. The unsecured latches (shown in Figure 2) were then not spotted by engineering staff during before-flight checks, or by the flight crew during the pre-flight external check.

Cowling removed with unattached fasteners highlighted

Further investigation by the operator determined that some of the fasteners fitted were of an incorrect length and protruded when secure, making it more difficult to spot insecure fasteners by comparison.

The operator issued a safety notice to remind its personnel of the need to adhere to the correct procedures, and the importance of routine inspections.
