ACCIDENT

| Aircraft Type and Registration: | DH82A Tiger Moth Tiger Moth, G-ANMY | |

Synopsis

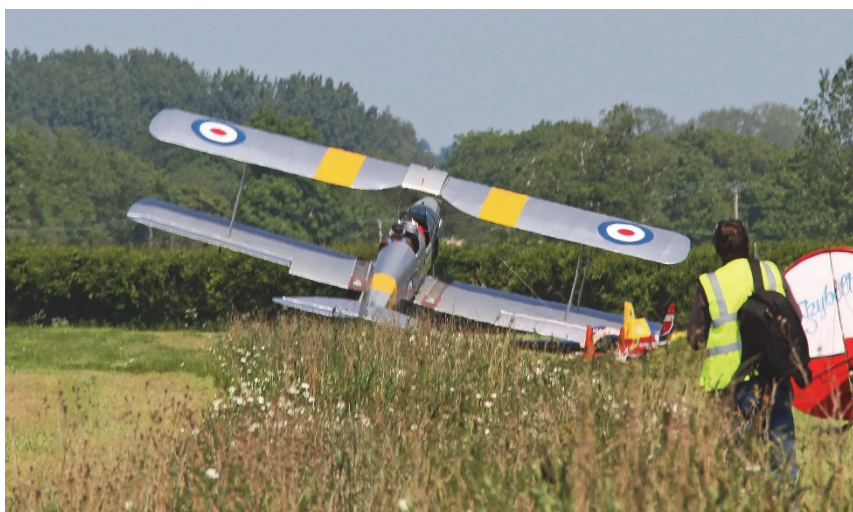
Figure 1

G-ANMY shortly before the accident
