The grounding of French fishing vessels *Saint Christophe 1* (CN666535) and *Sagittaire* (CN764603) while alongside in Dartmouth resulting in the flooding and sinking of *Saint Christophe 1* on 10 March 2016

SUMMARY

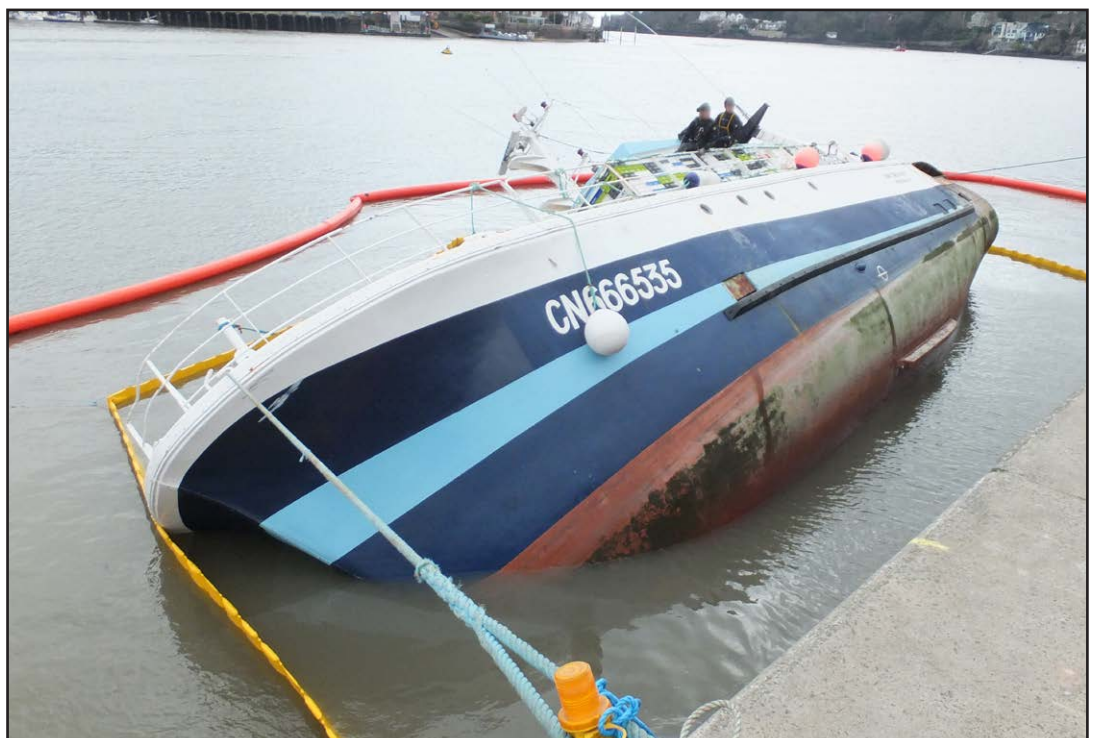
At about 2300 on 9 March 2016, the French fishing vessels, *Saint Christophe 1* and *Sagittaire* grounded and started to list on the falling tide while they were berthed alongside in Dartmouth harbour, where they had taken refuge from bad weather. *Sagittaire*'s crew raised the alarm and rigged chains to support the vessel as the tide fell, but *Saint Christophe 1* rolled onto its side and started to flood (**Figure 1**). *Sagittaire* re-floated as the tide rose, but *Saint Christophe 1* continued to flood and was almost fully submerged at high water. Both crews were evacuated from their vessels without incident, and there was minimal pollution. *Saint Christophe 1* was salvaged on 2 April 2016, but was declared a constructive total loss by its insurance company.

Figure 1: *Saint Christophe 1* sunk alongside South Embankment Quay

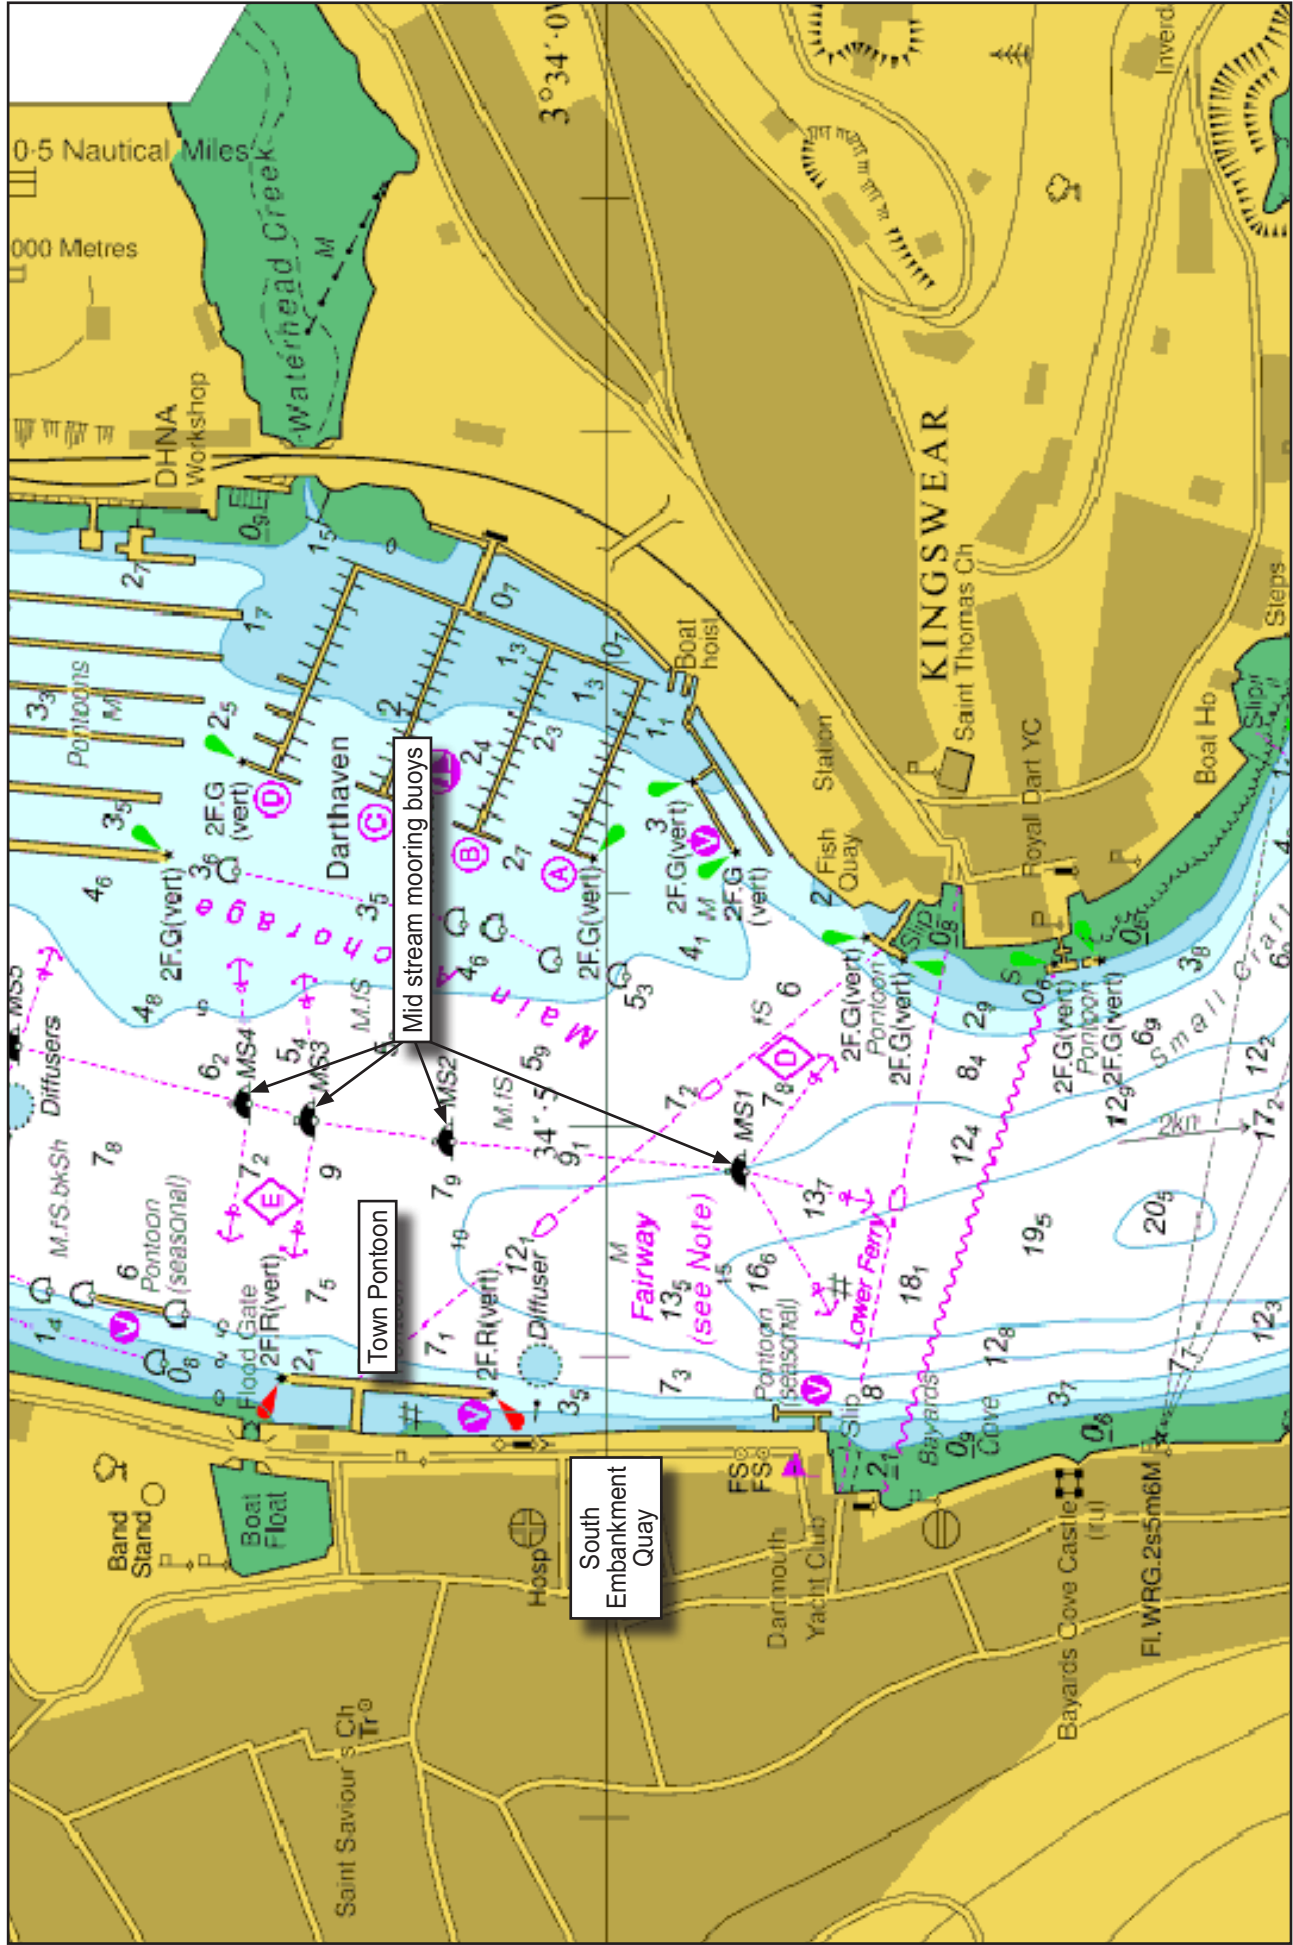
The DHM's preferred option was to secure the vessels on the harbour authority's mid-river mooring buoys (**Figure 2**). However, the prevailing weather conditions made it unsafe for the harbour staff to operate the buoys, so he decided to berth the visiting fishing vessels on Dartmouth's Town Pontoon and South Embankment Quay. The DHM then instructed two of his river officers to use the harbour launch to intercept the vessels at the harbour entrance and escort them to their berths. The launch met the vessels at about 1515 and, using a series of hand signals, the river officers guided them up the river to their allocated berths.

Figure 2: Chart showing Town Pier and South Embankment Quay

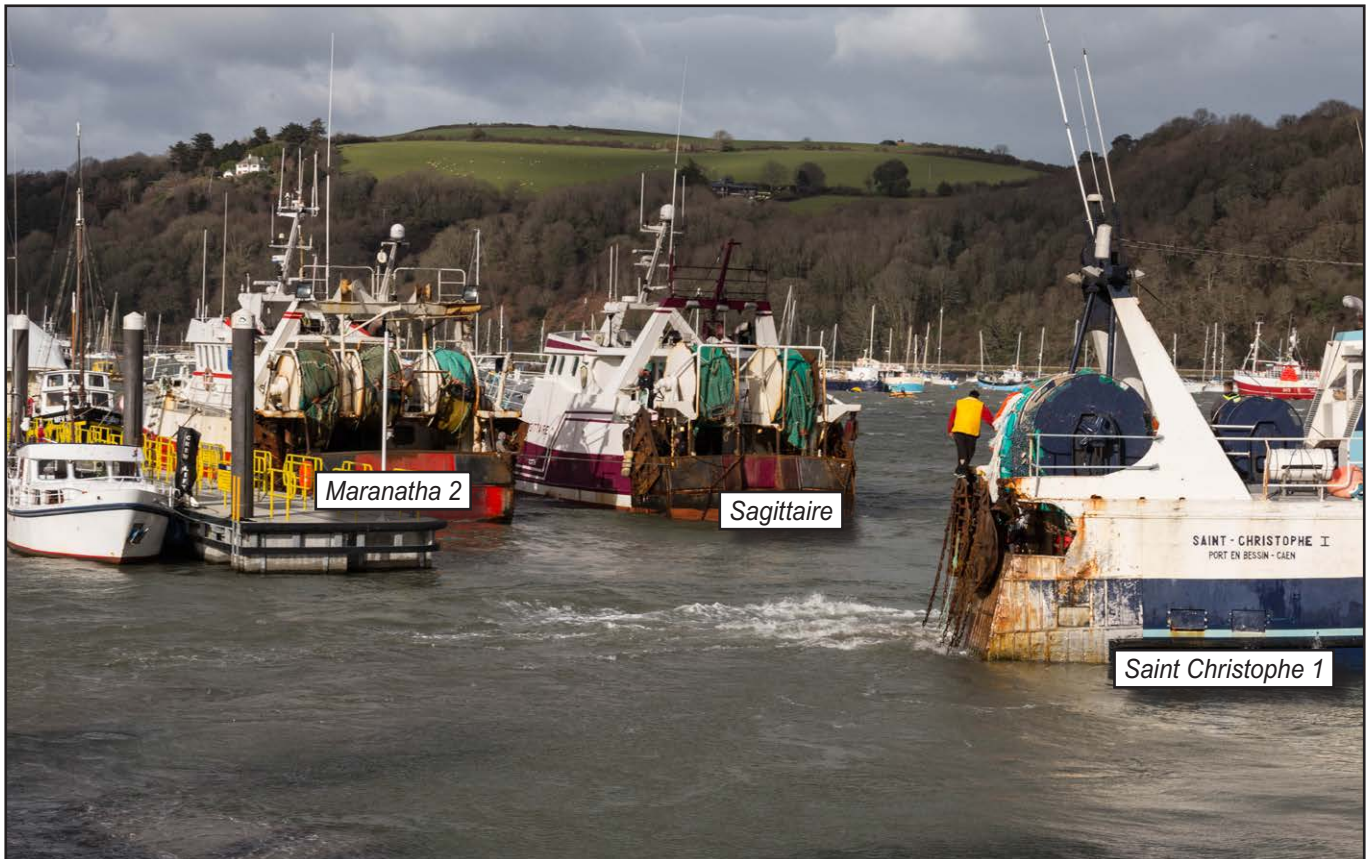
Figure 3: *Maranatha 2* and *Sagittaire* alongside Town Pontoon

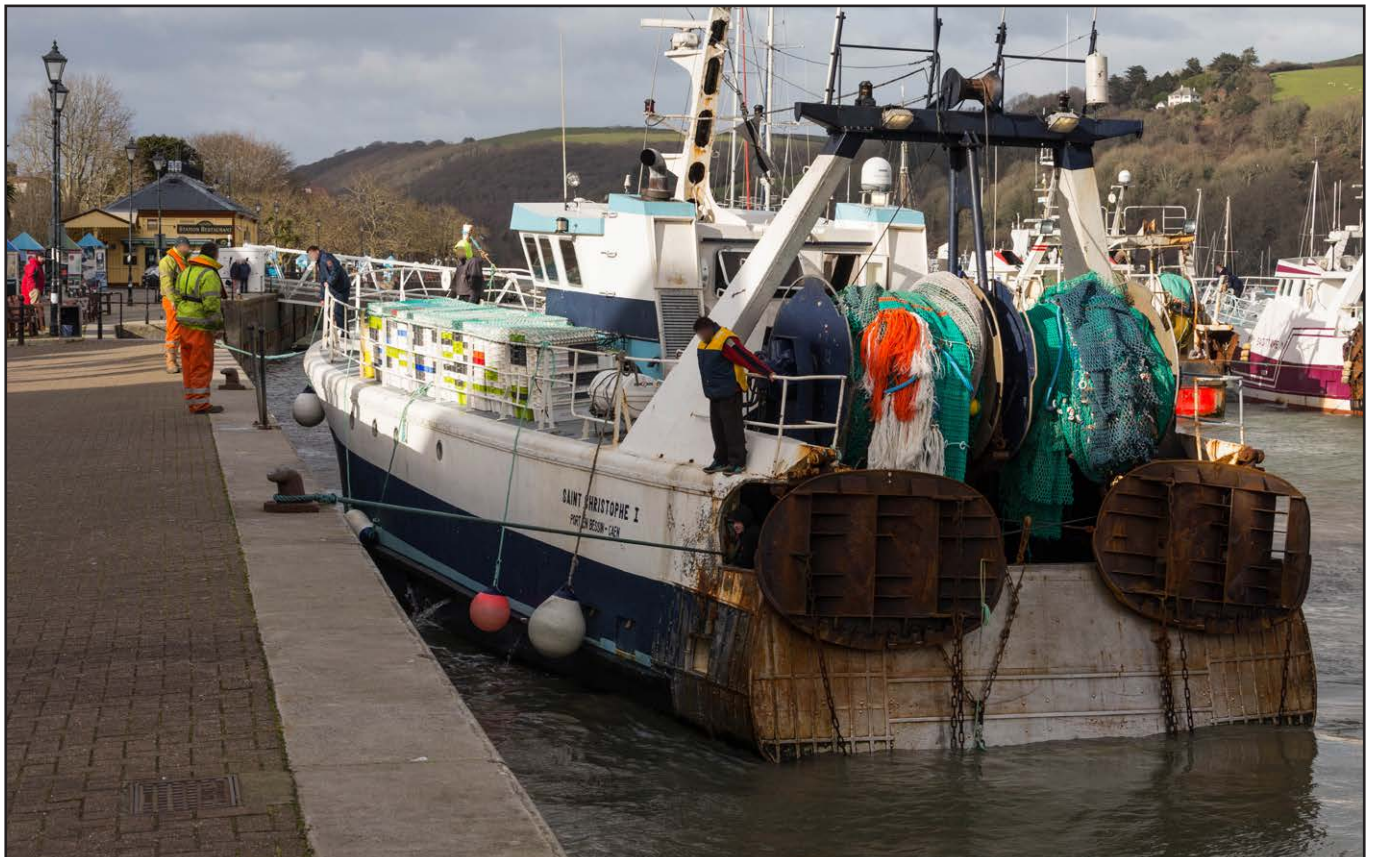
Saint Christophe 1 was based in Port-en-Bessin on the north coast of France, where it would remain afloat at all tidal states. It was designed to sit starboard side alongside to land fish and load stores and, therefore, it was usually starboard side heavy. On arrival in Dartmouth it had a draught of about 2.8m and a slight starboard list (**Figure 4**).

Figure 4: *Saint Christophe 1* berthing alongside South Embankment Quay
Note: the slight starboard list

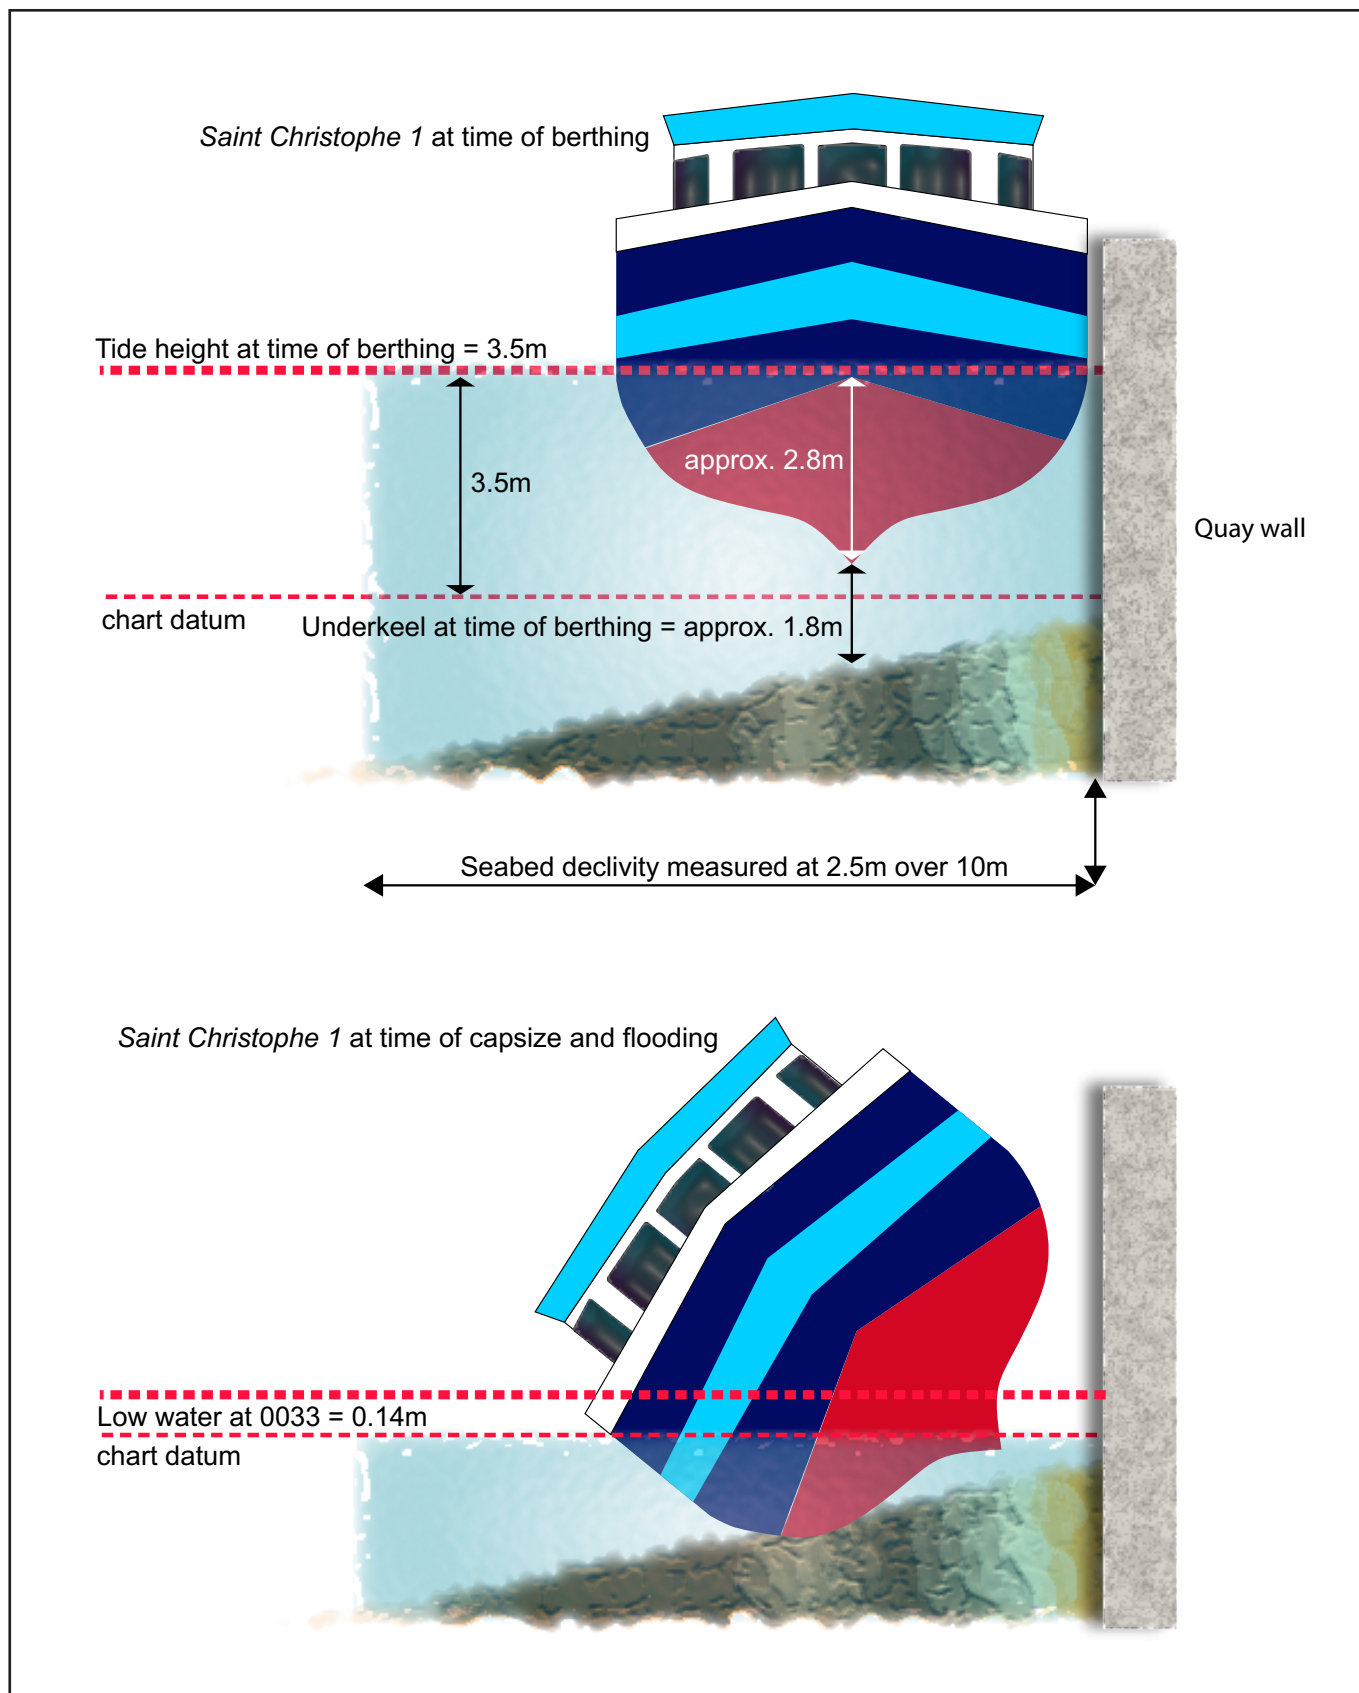
In January 2015, the harbour seabed had been surveyed on behalf of the DHNA. The depths alongside South Embankment Quay where *Saint Christophe 1* and *Sagittaire* berthed were found to be between 0.9m and 1.4m below chart datum. The charted depth beneath *Saint Christophe 1* was 0.4m less than the depth below *Sagittaire*, and, having a similar draught, this meant that *Saint Christophe 1* grounded

just before *Sagittaire*. The survey indicated that the seabed, which consisted of mud and loose compacted silt, sloped away from the quay wall. Measurements taken by divers after the accident found a 2.5m increase in depth over a distance of 10m away from the quay wall (**Figure 5**).

Figure 5: *Saint Christophe 1* water depth on arrival and when capsized

Saint Christophe 1 and *Sagittaire* listed heavily away from the South Embankment Quay because they grounded on a steeply sloping bed of compacted mud and silt as the tide ebbed. *Saint Christophe 1* rolled past its downflooding points because, unlike *Sagittaire*, its crew did not respond quickly enough to secure the vessel to the quay to arrest the developing list.
