# Rail Accident Report

## **Derailment of a passenger train at Ealing Broadway 2 March 2016**

Report 24/2016  
December 2016

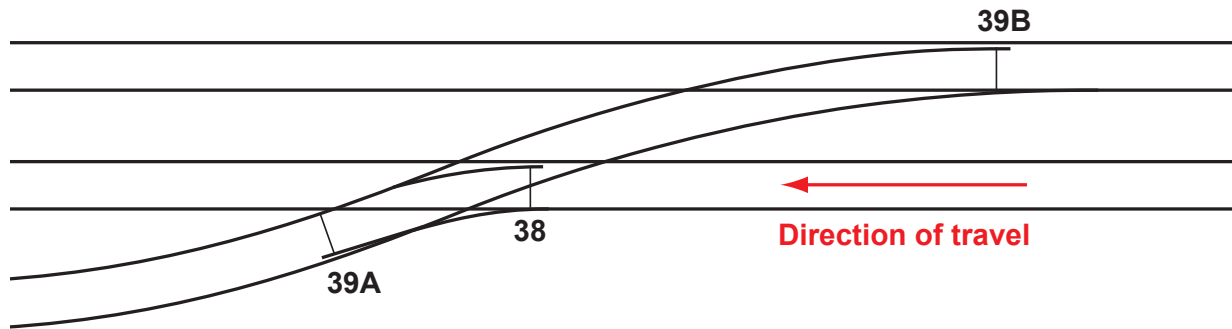
Figure 5: Diagram to show the track layout at 38, 39A and 39B points (points shown in normal position)

- 14 Both sets of points were locked in the *reverse* position during the accident. For the train to have been successfully routed to platform 7, 38 points needed to be in the reverse position, but 39A points should have been in the *normal* position.

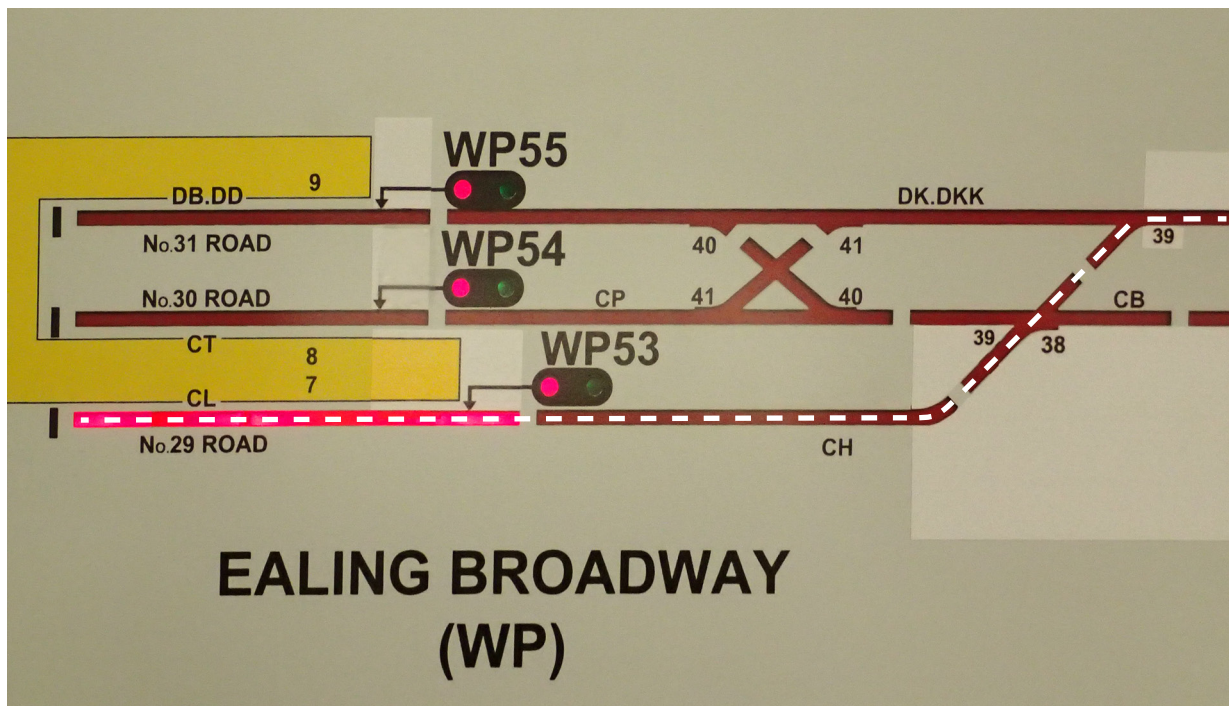
Figure 7: The signaller's overview panel showing the route train 064 took from platform 7 to eastbound line, the location of CB track circuit and signal WP54

71 Track circuit CB failed to clear after the passage of the eastbound train 064 at 00:31:04 hrs. Track circuit failures are not uncommon on the railway and there are systems and processes in place to mitigate their effect on railway operations. In this case the consequences of the failure included points 39A remaining locked in the position they had been in when the previous train passed over them, and signal WP17 being held at danger.

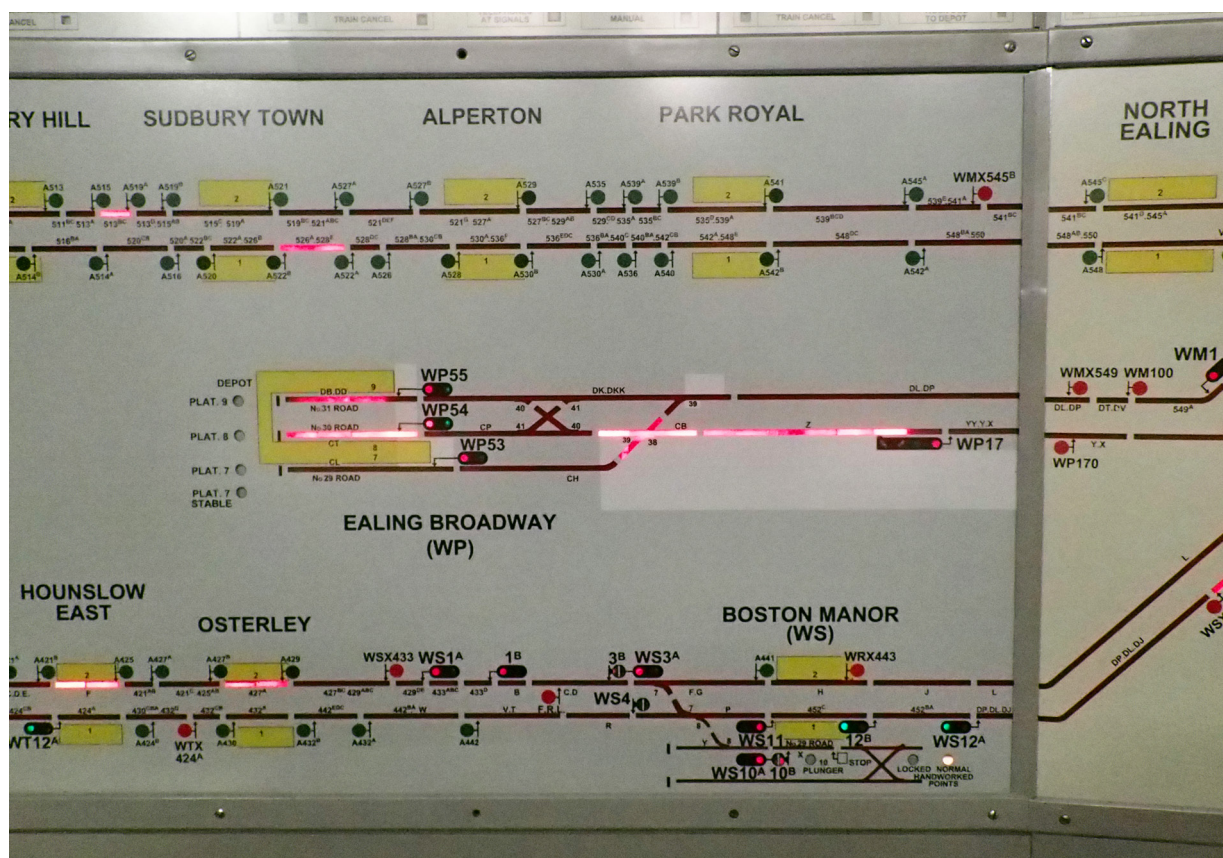
Figure 8: Signaller's overview panel in Earl's Court signal control centre

83 The signaller had the overview panel (figure 8), the centralised train following system screen (figure 9) and an out of date A4 version of the Traffic Controller's Diagram (figure 10) available to assist him with understanding the track layout at Ealing Broadway. Neither of the first two gave any indication of the position the points were in, and only the Traffic Controller's Diagram gave any information about which point positions were normal and which reverse. There was an up to date version of the Traffic Controller's Diagram at the front of the signaller's log book, but he was not aware of its presence.

84 The overview panels in the Earl's Court control room do not show which position of the points is normal, and which reverse, and they do not indicate which position the points are actually in. Most railway signalling displays include information on normal/reverse position, and more modern displays allow the signaller to identify the position the points are lying. The former practice of LUL and its predecessors was not to include this information. However, the signalling of LUL's sub-surface railway, including the District line, is to be completely renewed in the near future, and this will include the provision of better information and displays for control room staff.

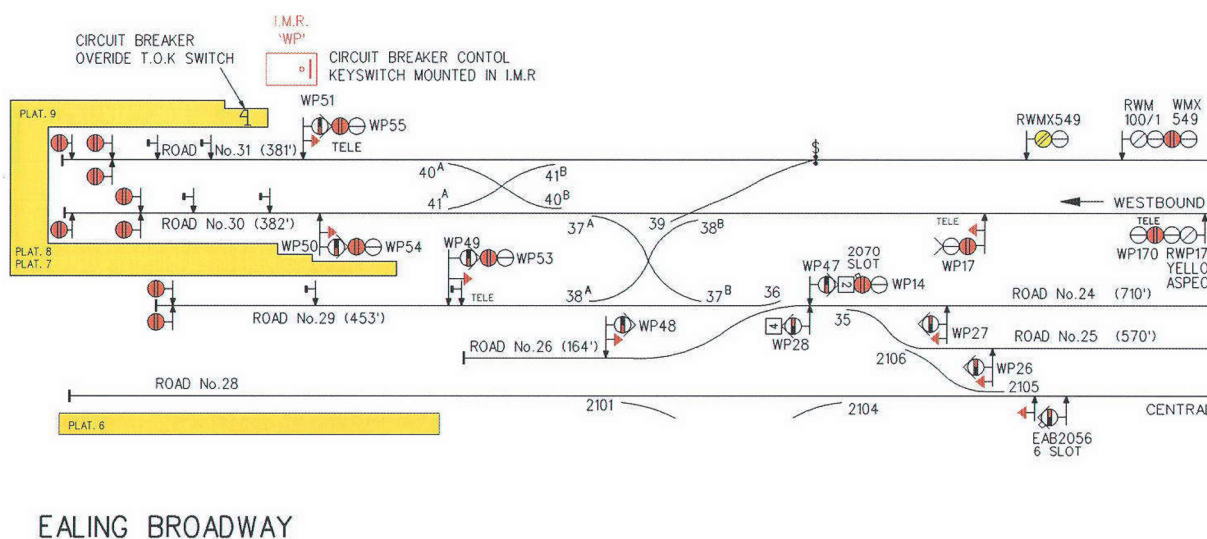
Figure 10: Out of date Traffic Controller's Diagram available to the signaller

85 The diagram available to the signaller (figure 10) was inconsistent with the overview and the centralised train following system in that it showed an extra crossover, point ends numbered differently and some sidings. The centralised train following system and the overview panel did not give the signaller sufficient information about the points or their positions, and so he became confused.

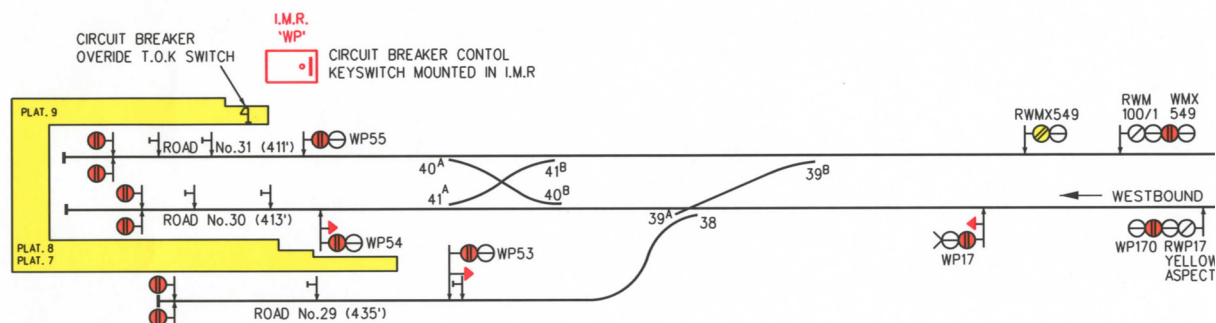
Figure 11: Version of the Traffic Controller's Diagram available to the District line service controllers

- 86 The District line service controllers had a later version of the diagram (figure 11) and *Tracknet* (figure 12) to inform their decision making (although LUL company standards state that the Tracknet system must not be used as the basis of safety critical decisions).
