**Loss of a crewman overboard from the potter  
*Our Sarah Jane* (NN710)  
English Channel  
9 June 2016**

## SUMMARY

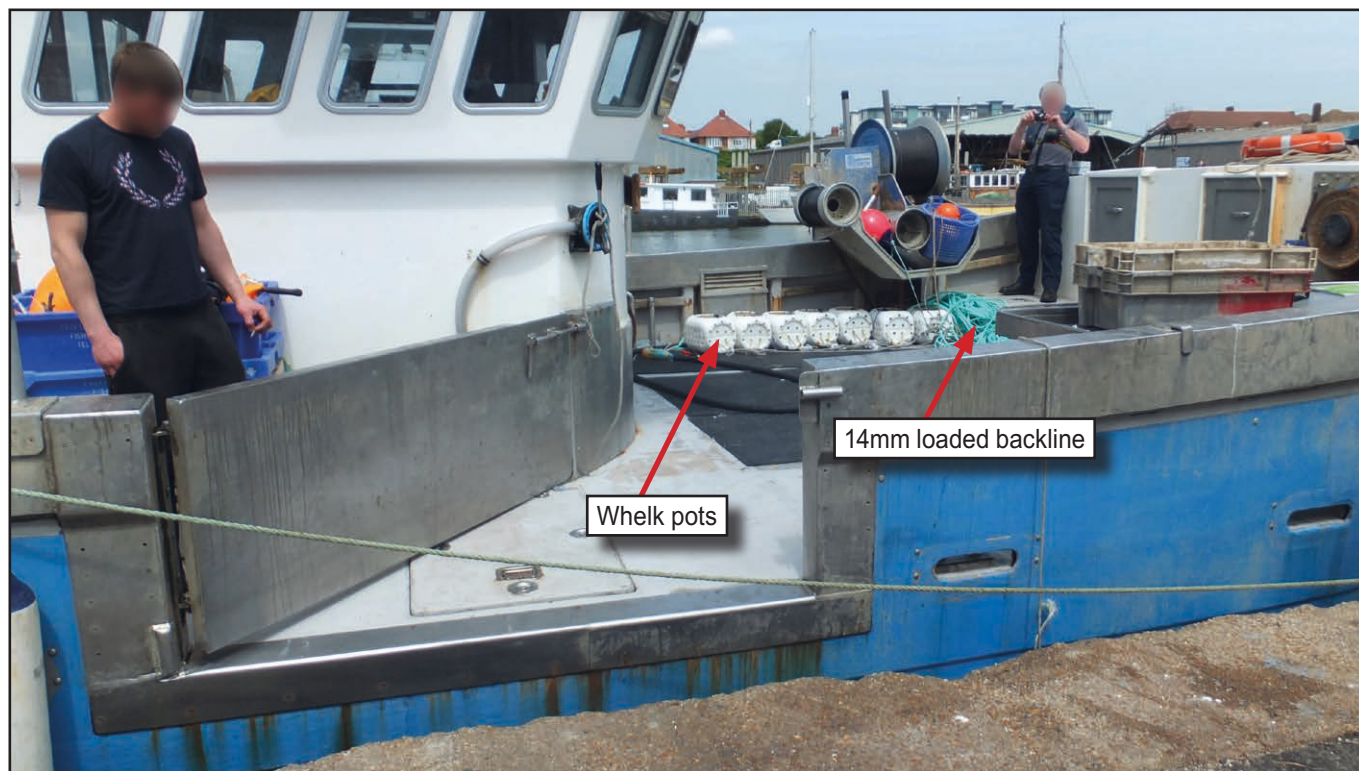
**Figure 2:** Shooting gate

Between 1120 and 1145, *Our Sarah Jane*'s crew hauled, emptied and re-baited a second string of pots. The pots were stacked on the port side of the working deck, forward of the wheelhouse. The vessel was then turned onto a heading of 135° at a speed of 3kts<sup>2</sup>. At 1151, the crew started to shoot the pots on deck. The skipper was in the wheelhouse, one of the deckhands was preparing bait aft of the wheelhouse, and the other deckhand, Darren Brown, was on the port side of the working deck, throwing each pot in turn towards the shooting gate on the vessel's starboard side (**Figure 2**).

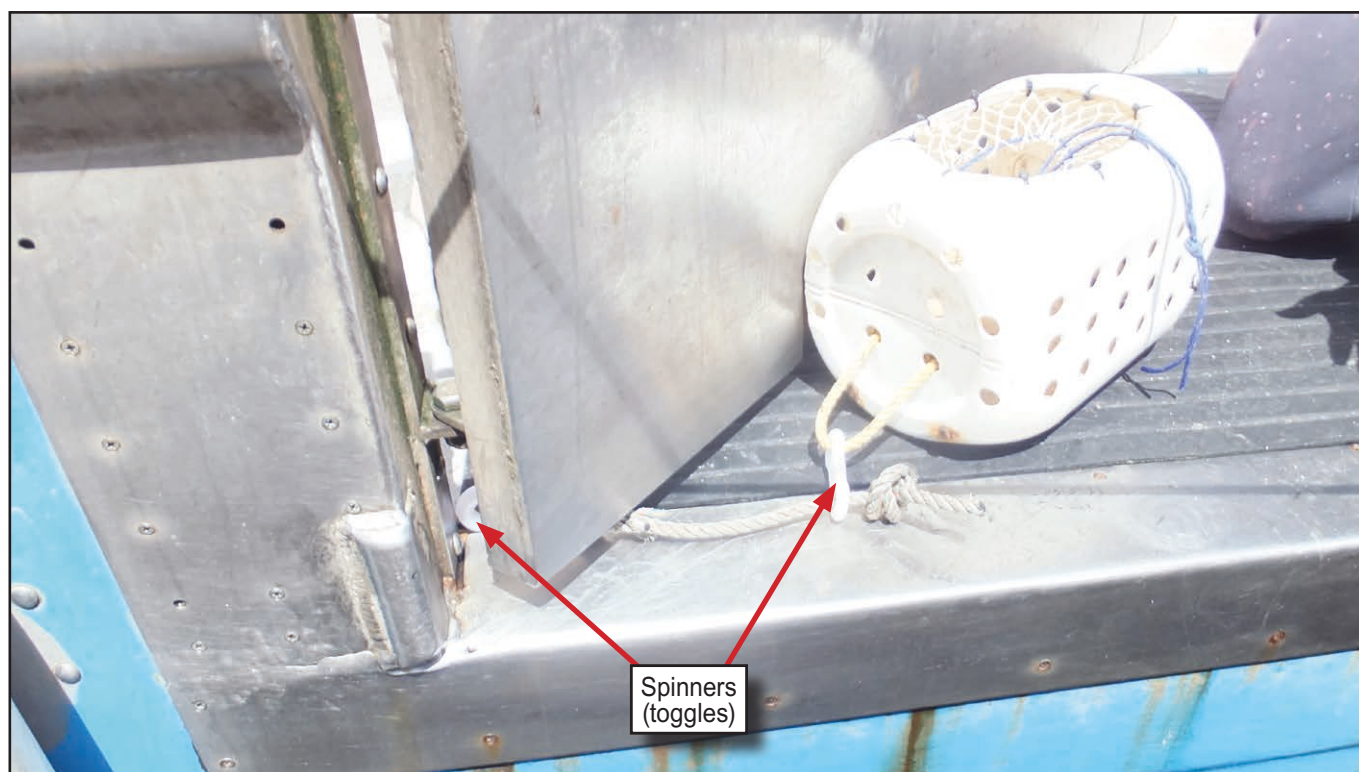
**Figure 3:** Reconstruction of snagged whelk pot

At around 1158, one of the spinners (toggles) used to secure the whelk pots to its line jammed between the underside of the hinged side of the shooting gate and a rubber deck mat (**Figure 3**). The skipper immediately reduced the speed of both engines to idle and the two deckhands then released the snagged pot. However, the 14mm backrope connecting the pots was under tension and, as it ran overboard, two of the remaining nine pots on deck were pulled into the water. The starboard engine stalled and the skipper realised that the lines attached to the pots had fouled the starboard propeller. He then put the port engine to 'neutral'.

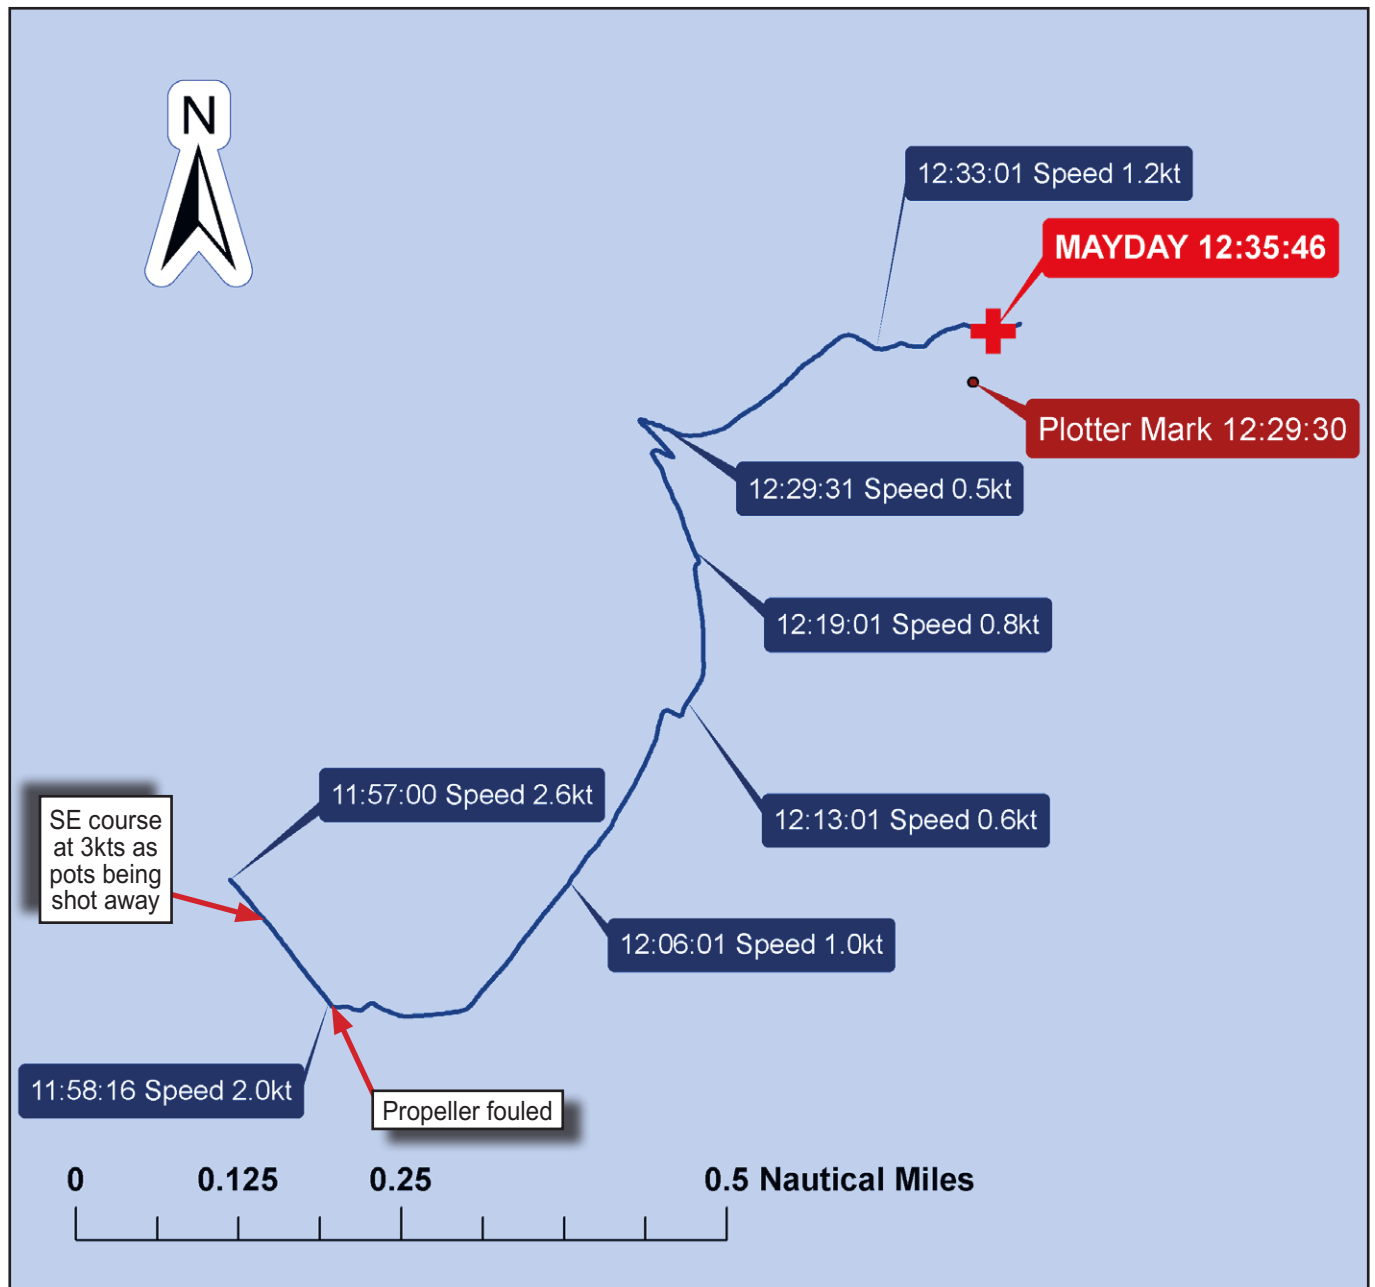
**Figure 4:** Plot of vessel's track (1157 - 1236)

*Our Sarah Jane*'s skipper immediately informed *Billiris* that Darren had jumped into the sea. He also, at 1229:30, input a mark into the Furuno Max Sea electronic chart plotter (**Figure 4**); the plotter's man overboard mark function was not used. The skipper then went to the shooting gate. By the time he arrived at the gate, Darren was 1m forward of the bow and was shouting for help. The rate of the tidal stream was now over 2kts.

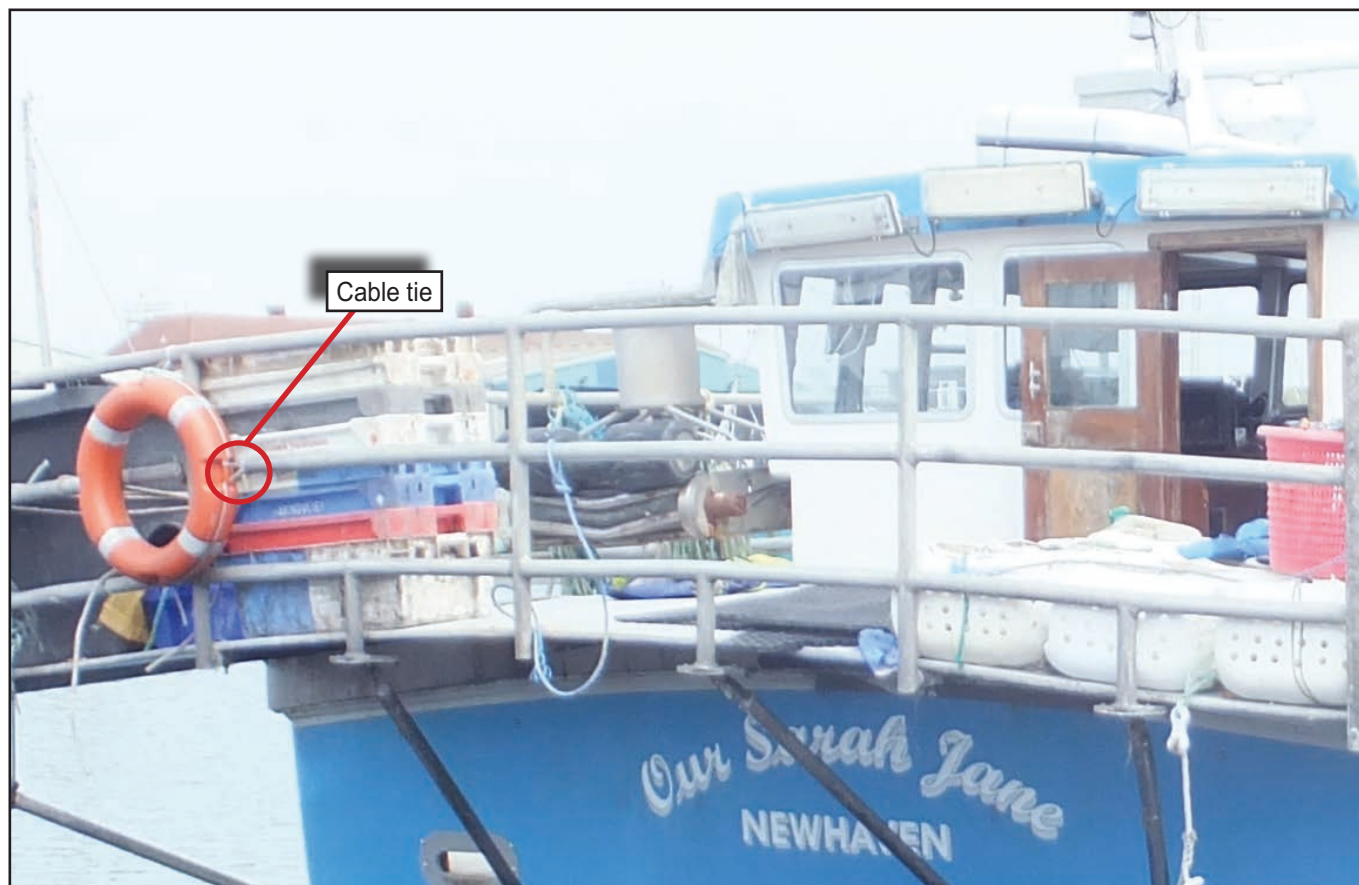
**Figure 6:** Port lifebuoy

Two lifebuoys were secured to the aft rails on the cat catcher. The lifebuoy secured on the starboard side was secured with rope using a clove hitch and the lifebuoy on the port side was secured with cable ties (**Figure 6**). Neither of the lifebuoys on the cat catcher had a line attached. A third lifebuoy fitted with a 10m length of 6mm polypropylene was stored in a deck locker along with two lifebuoy brackets. The skipper was not aware of the lifebuoy in the locker and none of the lifebuoys were marked.

However, the lifebuoys secured on the cat catcher were not fitted with lifelines and the skipper was unaware of the lifebuoy and lifeline in the deck locker. Although it would have taken only seconds to tie the polysteel rope to the lifebuoy, Darren was being carried away at a rate of about 3m every 6 seconds. Consequently, when the lifebuoy was eventually thrown into the 20kts wind, it landed too far from Darren for him to reach. In hindsight, Darren's likelihood of survival might have been increased by the immediate deployment of a free floating lifebuoy without a lifeline attached. However, it is likely that the skipper was concerned at the rate at which Darren was being carried away from his vessel.

- Introduced a policy requiring all fishermen working on the open deck on board *Our Sarah Jane* and *Imogen Leigh* to wear a PFD.
- Attached throwing lines to *Our Sarah Jane's* lifebuoys.
