SERIOUS INCIDENT

Aircraft Type and Registration:	Airbus A319-111, G-EZFJ	
No & Type of Engines:	2 CFM CFM56-5B5/3 turbofan engines	
Year of Manufacture:	2009 (Serial no: 4040)	
Date & Time (UTC):	14 April 2016 at 0847 hrs	
Location:	Malaga Airport, Spain	
Type of Flight:	Commercial Air Transport (Passenger)	
Persons on Board:	Crew - 6	Passengers - 157
Injuries:	Crew - None	Passengers - None
Nature of Damage:	None	
Commander's Licence:	Airline Transport Pilot's Licence	
Commander's Age:	57 years	
Commander's Flying Experience:	21,000 hours (of which 4,000 were on type) Last 90 days - 200 hours Last 28 days - 78 hours	
Information Source:	AAIB Field Investigation

Synopsis

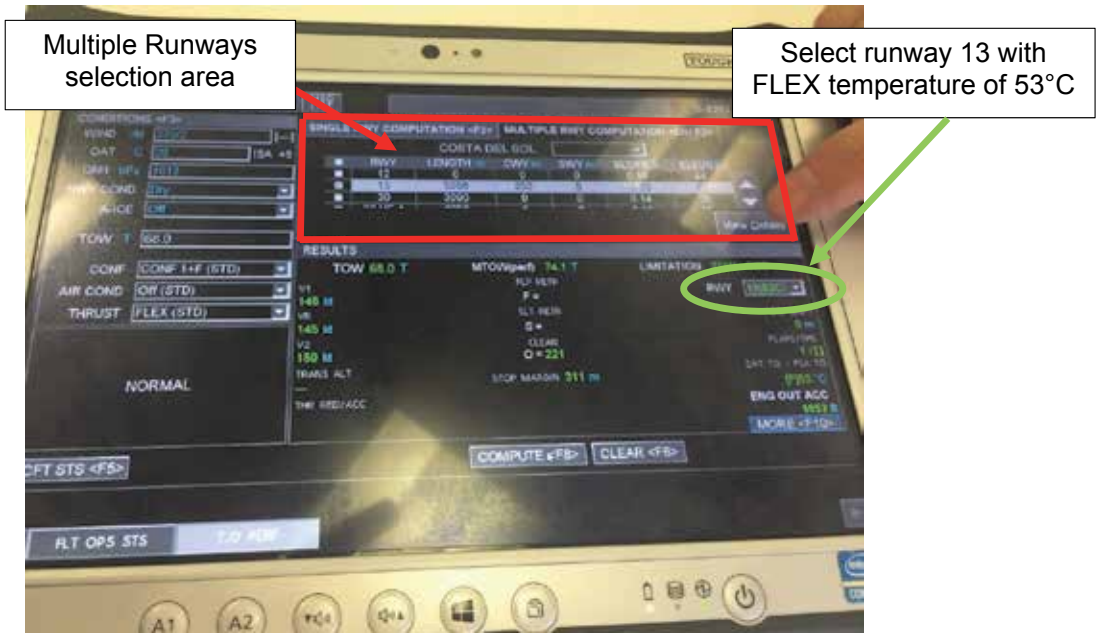
Figure 2

Takeoff performance data is then displayed in the 'RESULTS' section. The selected runway in the 'RESULTS' section will be that with the highest FLEX temperature for the chosen runways (Figure 2). Other chosen runways can then be selected using this drop-down menu.

At this stage, specific runway information such as length, elevation and engine-out information is not displayed. To retrieve this information, the user has to select 'VIEW DETAILS'. The runway information will be selected but the 'RESULTS' screen will be obscured. The manufacturer commented that it should not be possible to display detailed runway information and the 'RESULTS' screen at the same time.

Results page for multiple runway computations

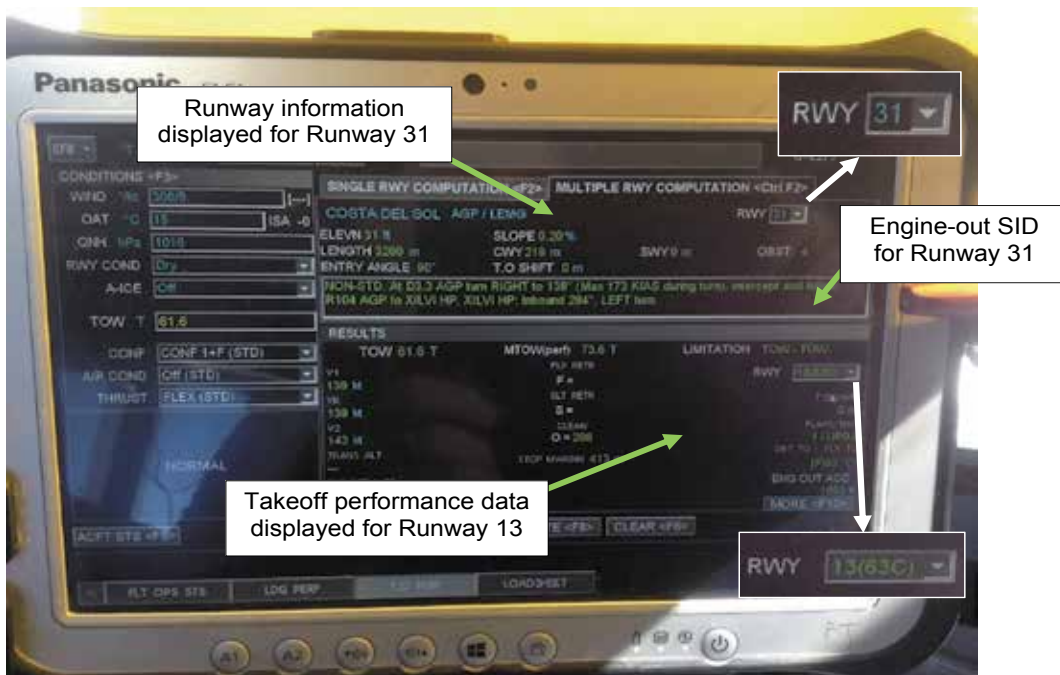
In the cruise, as a result of the commander's pre-takeoff observation regarding the speeds, he decided to check the calculations. He checked the co-pilot's EFB and noticed that with MRC selected, although Runway 31 was displayed with correct runway length and the correct engine out procedure, the takeoff performance figures displayed on the same screen were for Runway 13. The Runway 13 selection was in a small drop-down menu on the screen in a different place to where the runway was normally verified. He believes this was not noticed due to the subtle icon selection, the small text size and because the runway selection was normally verified in a different location on the screen. To help him to explain this upon his return he took photographs of the EFB screen (Figure 3).

The sequence of events detailed by the flight crew suggested that the FlySmart software could display detailed information for one runway but with takeoff performance data for a different runway. Figure 3 shows a photo taken by the flight crew which confirmed this.

Photograph of EFB taken by G-EZPJ flight crew

A specific sequence of events discovered by the operator confirmed this was possible which was also reproduced by the AAIB and demonstrated to the manufacturer. This sequence of events differed from typical usage described by the operator in that, just prior to selecting 'COMPUTE', the crew switched to the load sheet screen to update it which ultimately updated the takeoff weight. Switching back to the takeoff performance screen and then selecting 'COMPUTE' allowed the display of detailed information for one runway but with takeoff performance data for a different runway to be reproduced.

The flight crew took off from Runway 31 using the takeoff performance data for Runway 13 at Malaga Airport. This incorrect data was provided by the EFB which contained an anomaly that allowed detailed runway information for one runway to be displayed alongside takeoff performance data for another runway. The flight crew, operator and manufacturer were unaware of the anomaly at the time of the event.

- The operator sent an email to all pilots on 22 April 2016 highlighting this specific anomaly.
- The MRC function was disabled across the operator's fleet in May 2016.
- The operator has reviewed and proposed further modification to their SOPs.
- In the L6.x versions of FlySmart, it has been verified by the manufacturer that the MRC function is not affected by this anomaly.
- The manufacturer has sent Flysmart Communication reference X46D16018565 to operators highlighting the anomaly discovered during this investigation and recommending that the affected operators disable the MRC option.
- The manufacturer sent Flight Operations Transmission (FOT) 999.0095/16 to all operators reminding them of the manufacturer's recommended procedures for EFB use. This involves each crew member performing their own independent calculations, the results of which are then cross-checked.

The operator has disabled the MRC function and other affected operators have since been informed of this anomaly with a recommendation to disable the MRC function. The L6.x versions of the software do not exhibit this MRC function anomaly.
