ACCIDENT

Aircraft Type and Registration:	Diamond DA42 Twin Star, G-CTCB	
No & Type of Engines:	2 Thielert TAE 125-02-99 piston engines	
Year of Manufacture:	2005 (Serial no: 42.083)	
Date & Time (UTC):	28 April 2016 at 1603 hrs	
Location:	Bournemouth Airport, Dorset	
Type of Flight:	Training	
Persons on Board:	Crew - 2	Passengers - 1
Injuries:	Crew - None	Passengers - None
Nature of Damage:	Failure of left landing gear drag brace rib	
Commander's Licence:	Commercial Pilot's Licence	
Commander's Age:	32 years	
Commander's Flying Experience:	2,051 hours (of which 146 were on type) Last 90 days - 137 hours Last 28 days - 56 hours	
Information Source:	Aircraft Accident Report Form submitted by the pilot and further enquiries by the AAIB

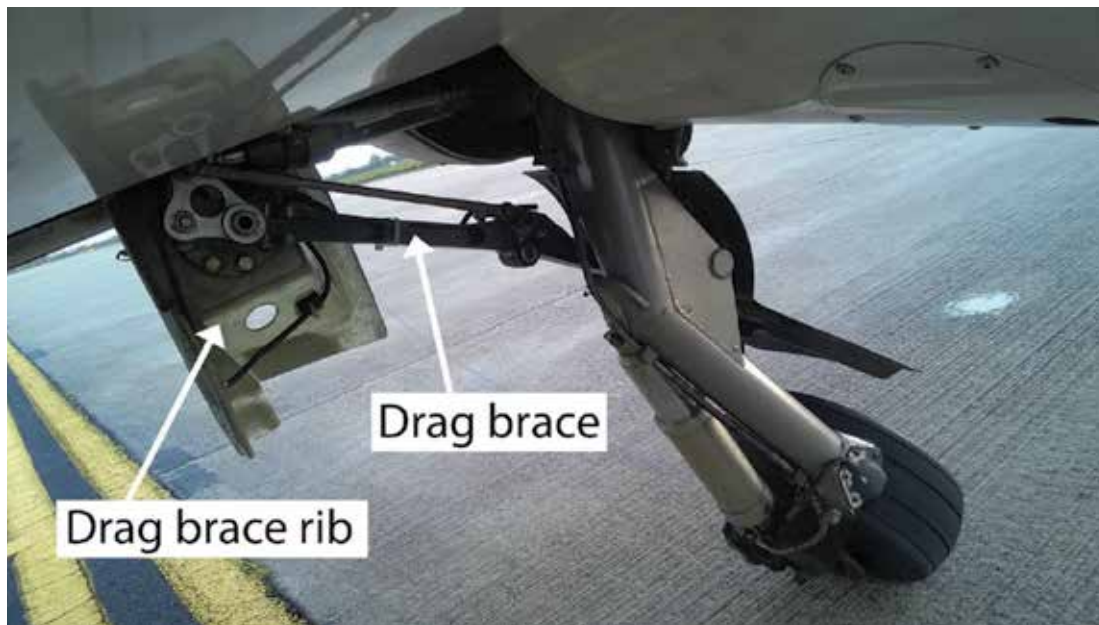
Figure 1

The composite drag brace rib, which secures the left main landing gear drag brace to the centre wing section, had detached (Figure 1), causing the left main landing gear leg to partially collapse. The aircraft manufacturer examined the aircraft and removed the failed rib for further detailed examination. They determined that the failure pattern was typical for an overload failure of the bonding between the composite rib and the composite centre wing section. They concluded that some damage had occurred during a previous hard sideslip landing and then the final failure occurred on the day of the accident.

View of left main landing gear leg (looking aft) showing detached drag brace rib
