DRUG ALERT

CLASS 4 MEDICINES DEFECT INFORMATION

**Mirena 20 micrograms / 24 hours intrauterine
delivery system**

Information about an observed Insertion Tube Defect UK Batch TU01BPE

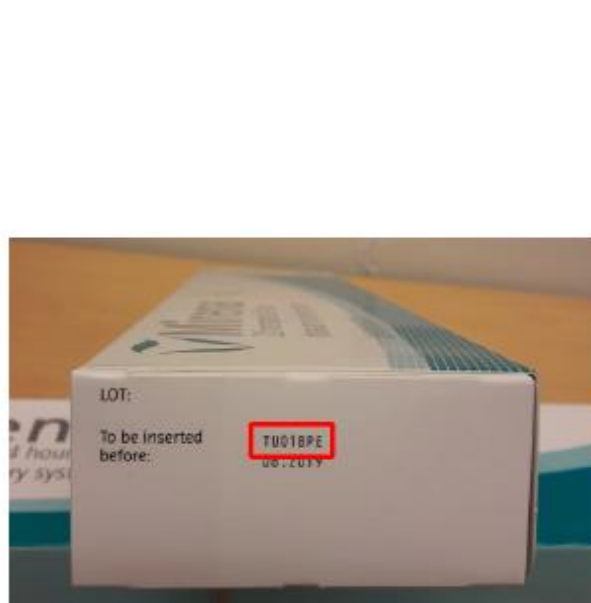
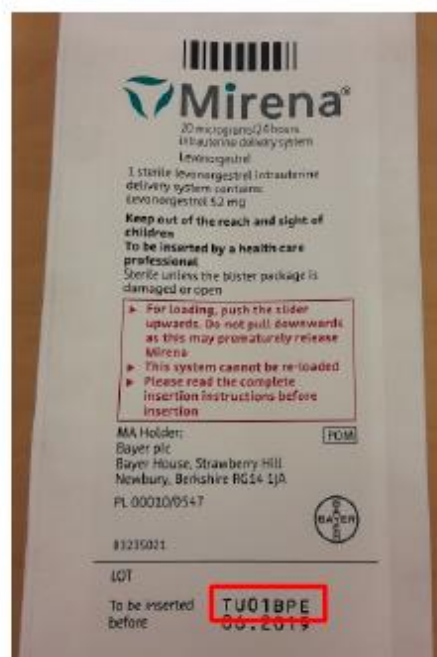
The affected batch is TU01BPE.

The batch number is printed on the side of the folding box and the immediate packaging as shown in the following pictures:
