ACCIDENT

Aircraft Type and Registration:	Pegasus Quantum 15, G-MZCR
No & Type of Engines:	1 Rotax 503-2V piston engine
Year of Manufacture:	1996 (Serial no: 7234)
Date & Time (UTC):	16 July 2016 at 1430 hrs
Location:	East Haxted Farm Airstrip, near Edenbridge, Kent
Type of Flight:	Private
Persons on Board:	Crew - 1 Passengers - None
Injuries:	Crew - 1 (Serious) Passengers - N/A
Nature of Damage:	Wing, trike and propeller damaged
Commander's Licence:	Private Pilot's Licence (A) Microlight aircraft
Commander's Age:	90 years
Commander's Flying Experience:	368 hours (of which 261 were on type) Last 90 days - 2 hours Last 28 days - 1 hour
Information Source:	AAIB Field Investigation

Synopsis

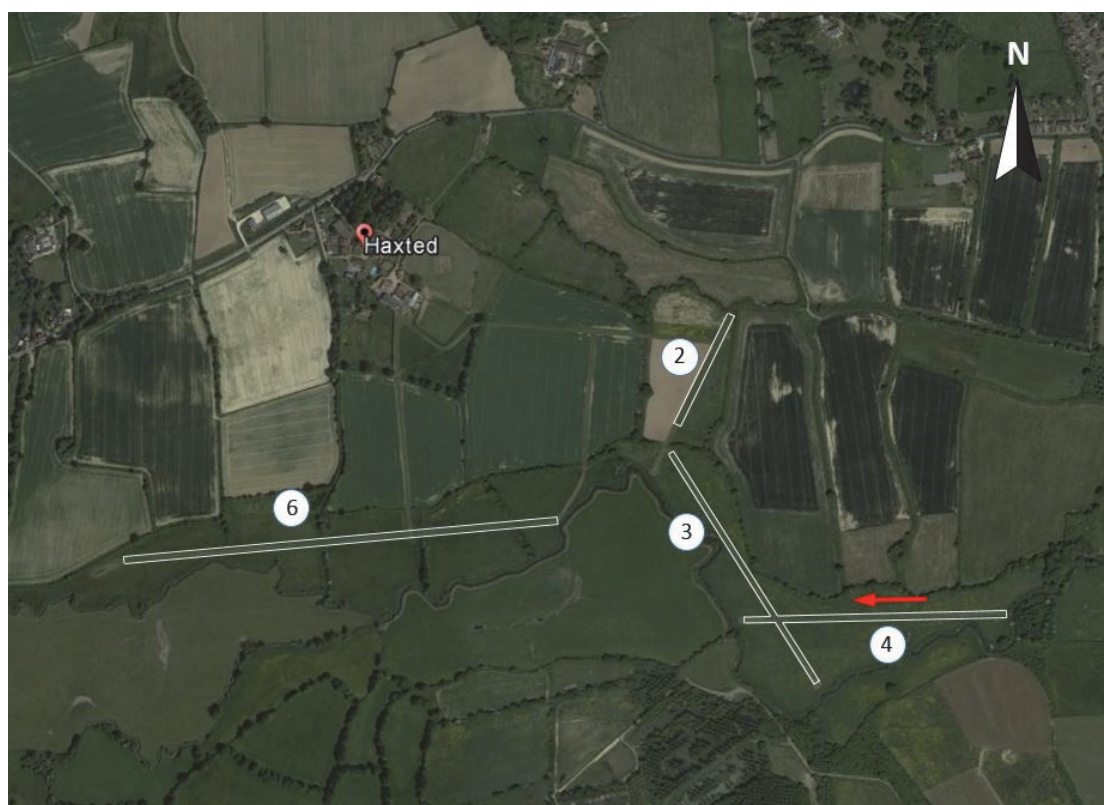
Figure 1

East Haxted Farm layout, including Strip 4 (indicated by red arrow).
Circled numbers indicate strip designations.

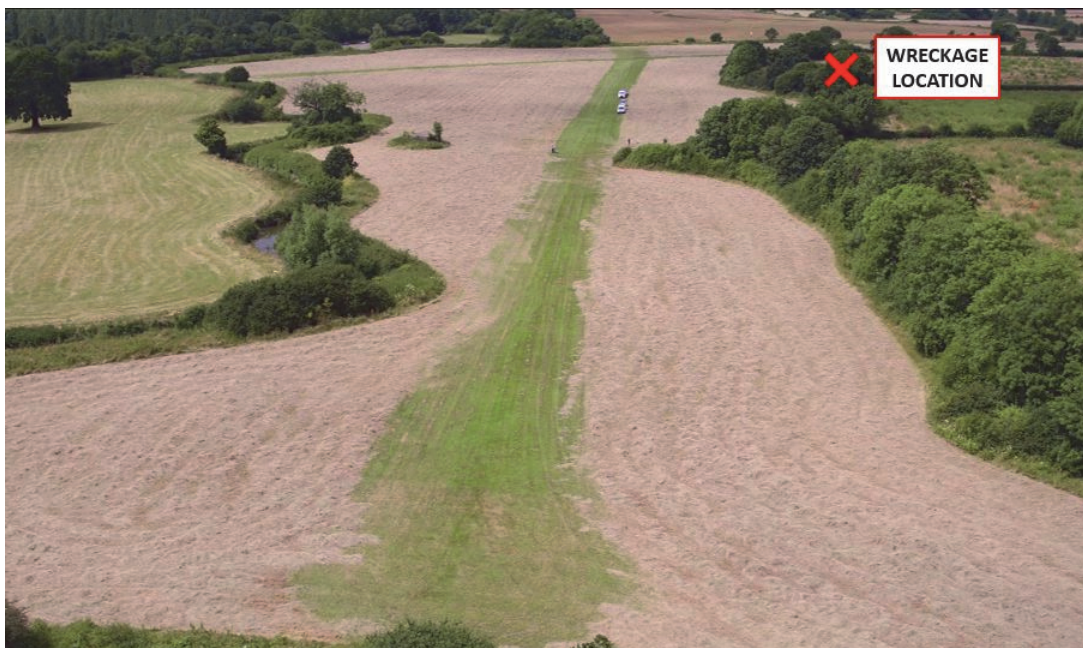
Figure 2
View of Strip 4 from east

The aircraft crashed into a 20 m tall oak tree approximately halfway along Strip 4 at East Haxted Farm. The tree was part of a boundary hedge, displaced approximately 60 m to the north of the runway centreline (Figure 2).
