ACCIDENT

| Aircraft Type and Registration: | Piper PA-28-161 Cherokee Warrior II, G-CDER | |
| Information Source: | AAIB Field Investigation | |

Synopsis

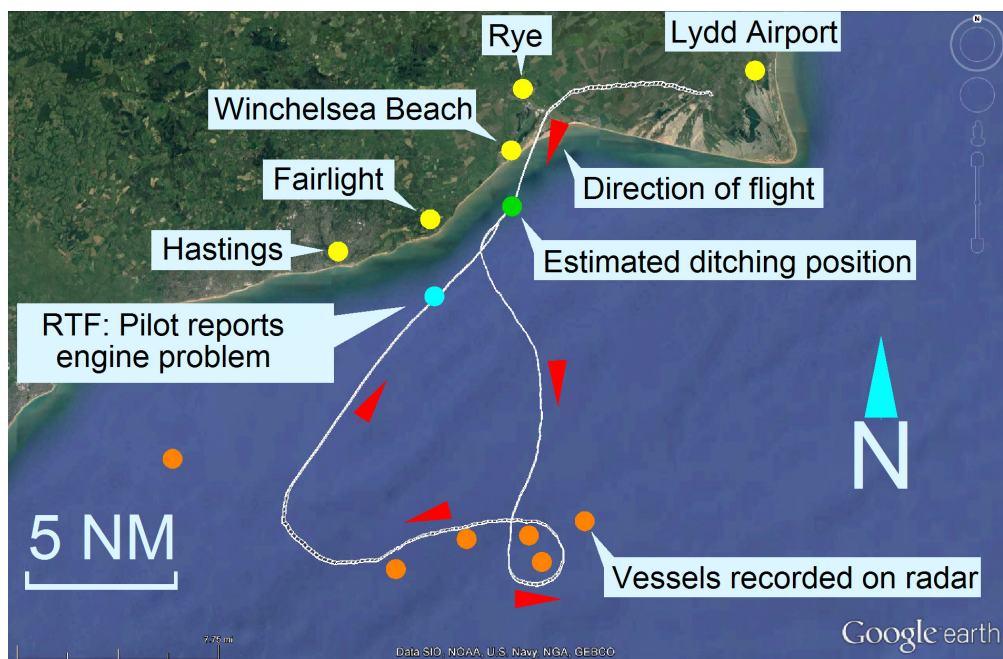
Figure 1

The first radar point was recorded at 1530 hrs, shortly after the aircraft had taken off from Runway 21. The initial route was towards the village of Rye, located 7.5 nm west of Lydd Airport. As the aircraft passed to the south of Rye the pilot transmitted a position report and confirmed the aircraft was at 2,200 ft amsl, which was the previously stated target altitude.

The aircraft then flew 1.2 nm off-shore before turning onto a south-westerly heading, to fly approximately parallel to the shore line. When the aircraft was abeam the village of Fairlight, it altered course towards the south whist maintaining an altitude of about 2,200 ft amsl. The aircraft continued to fly in a southerly direction until it was about

12 nm off shore, where a left hand orbit was flown before it altered heading towards the west. Evaluation of ship movements in conjunction with the aircraft's track, indicates that the pilot may have flown out to sea to look at several vessels which were operating in the area.

At 1552 hrs, the aircraft turned onto a north-westerly course, before making a further turn onto a north-easterly track of about 040°; if maintained, this would position the aircraft back towards Rye VRP.

Flight from Lydd (Pease Pottage radar)

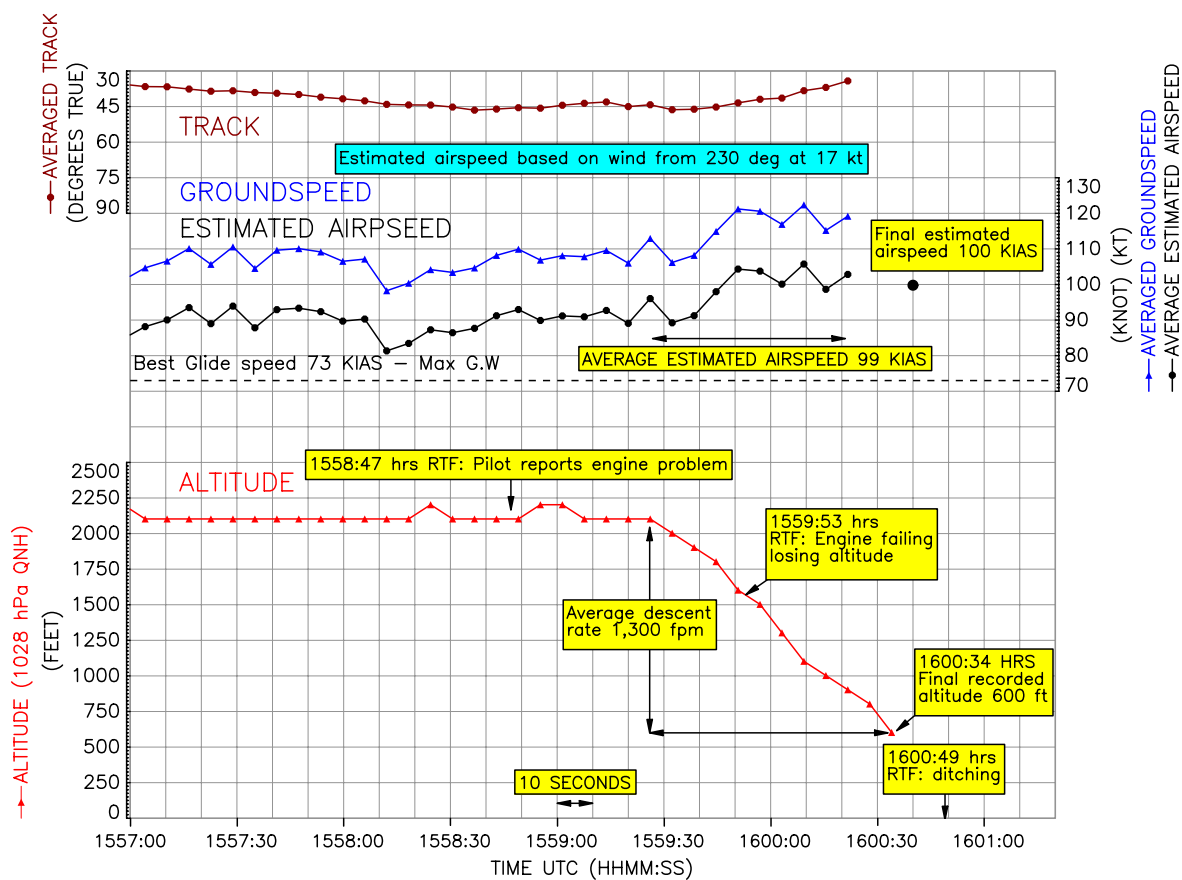
Figure 2

The aircraft proceeded to maintain its course towards the shoreline near Rye. At 1559:26 hrs, the aircraft started to descend at an average rate of 1,300 fpm and an estimated average airspeed (based on a wind from 230° at 17 kt³) of 99 KIAS. At 1559:53 hrs, the pilot transmitted "LYDD APPROACH I'M GOING TO NEED ASSISTANCE EH ENGINE NOW BEGINNING TO FAIL I'M LOSING ALTITUDE". This was acknowledged by the controller and the pilot provided a position report, advising he was 10 nm from Lydd and 3.5 nm south of Winchelsea "OVER THE SEA". He further added that he was unable to restart the engine stating that it was "POPPING". The aircraft was now at an altitude of about 1,600 ft amsl and 1.5 nm from the nearest shoreline which was near Fairlight. This was still within the glide range of the aircraft.

The aircraft maintained a track that was almost parallel to the shoreline whilst continuing to descend. At 1600:34 hrs the final radar return was recorded. The aircraft was at an altitude of 600 ft amsl, its estimated airspeed was about 100 KIAS, and 1.42 nm from the beach near Pett Level village (this was now beyond the glide range of the aircraft). Shortly after, at 1600:49 hrs the pilot made his last RTF transmission, when he stated that he was ditching the aircraft.

Accident flight data from Pease Pottage radar

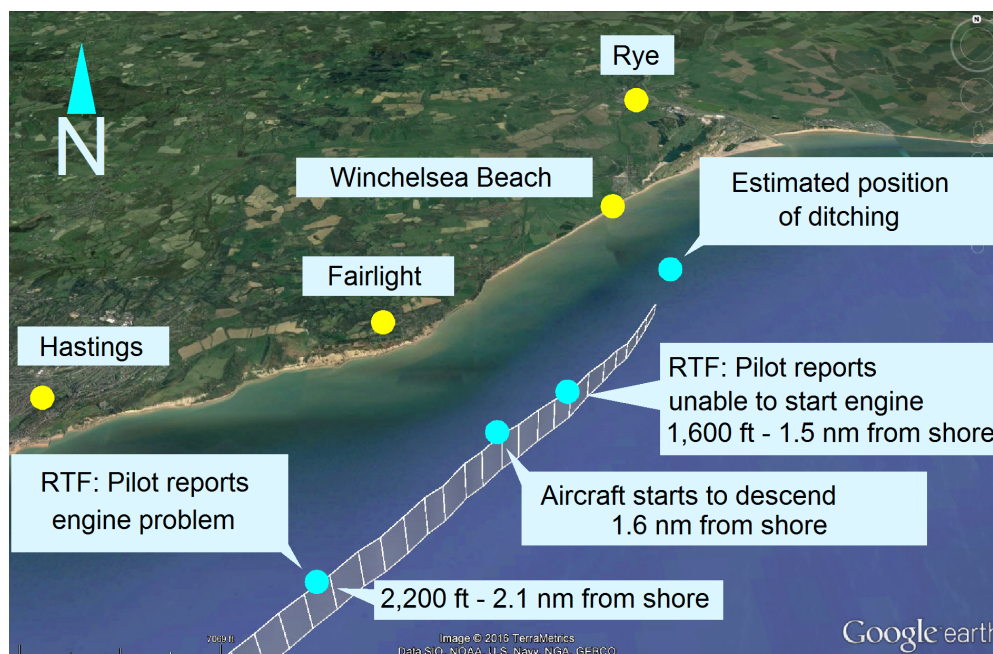
Figure 3

Based on the estimated glidepath of the aircraft, witness information and position of an "oil slick" observed on the surface of the sea shortly after the accident by a SAR helicopter, the aircraft struck the water approximately 1.2 nm from the shoreline of Winchelsea Beach.

Final radar points (Pease Pottage radar)

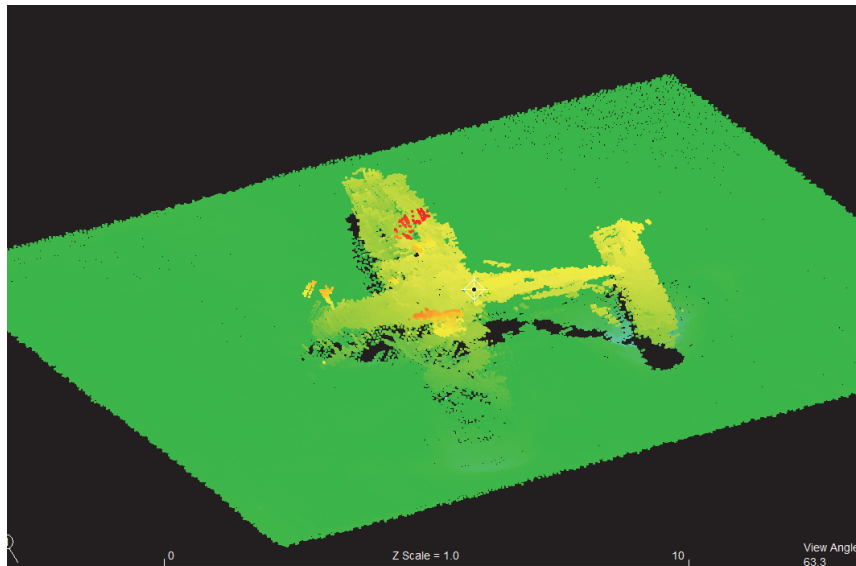
Figure 4

On 10 August 2016 a side-scan sonar equipped survey vessel, with SALMO and AAIB personnel on board, located the aircraft on the sea bed at a depth of between 5 m and 9 m, close to the marker buoy. Sonar imagery showed that the aircraft appeared to be intact and was inverted (Figure 4).

Sonar image of the aircraft

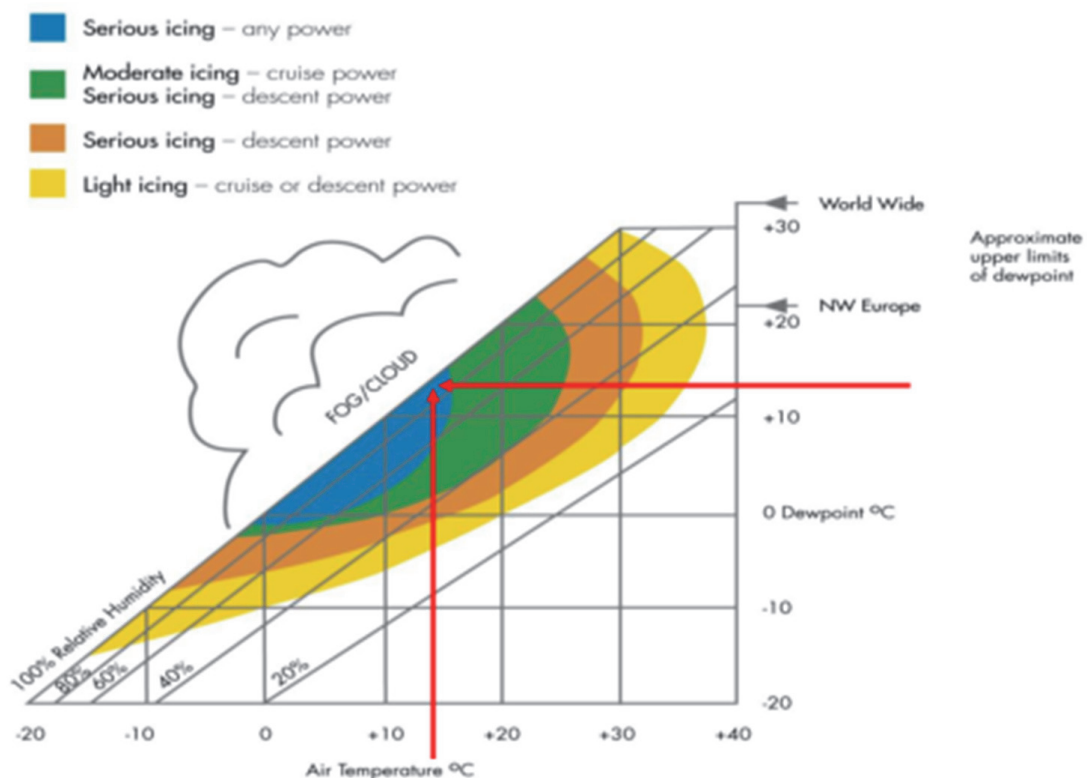
Figure 5
Carburettor Icing

At a temperature of 14°C with a dewpoint of 13°C the aircraft is in the area where severe carburettor icing can occur at any power. In order to minimise the possibility of carburettor icing becoming a problem, pilots are taught to apply carburettor heat at routine intervals. In addition to applying carburettor heat the pilot would also check that all engine indications were normal.

The carburettor icing chart, Figure 5, indicated that the aircraft was operating in conditions where carburettor icing would be expected at any engine power setting. Other events, both reported and anecdotal, from aircraft operating in the same weather system confirmed that carburettor icing may have been prevalent.
